This report is prepared exclusively for **Some Customer**
Inspected On: **2022-11-25**

Domicile Consulting LLC
847.712.7874

This property was a mid sized commercial structure that was nearly 30 years old. There was some deferred maintenance on the exterior and the HVAC systems need replacement and significant attention in the not too distant future. It is highly recommended that the buyer read the report carefully, especially with regards to the future costs that may be incurred.

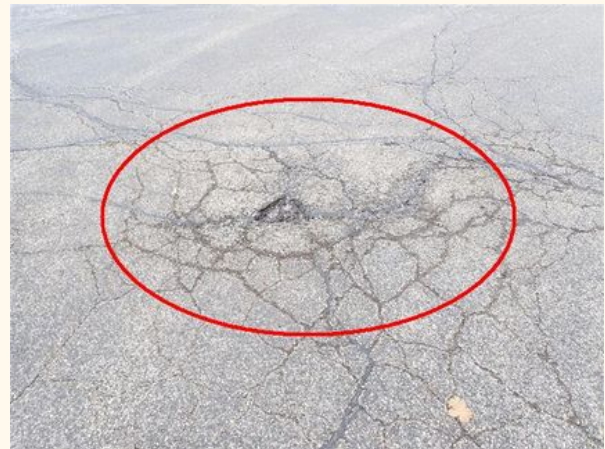
🔧 (IGPC-4) Repair: The asphalt paving is cracked and deteriorated and the open joints exacerbate further deterioration from moisture either saturating and softening the base or from freeze/thaw action in winter. In order to prolong the life of the asphalt the severely deteriorated portions should be removed and patched, minor cracks should be filled and the entire paved area should then be seal coated. Evaluation and repair by a qualified asphalt contractor is recommended.

Cracked Paving by Curb

Severely Deteriorated Asphalt Areas Noted

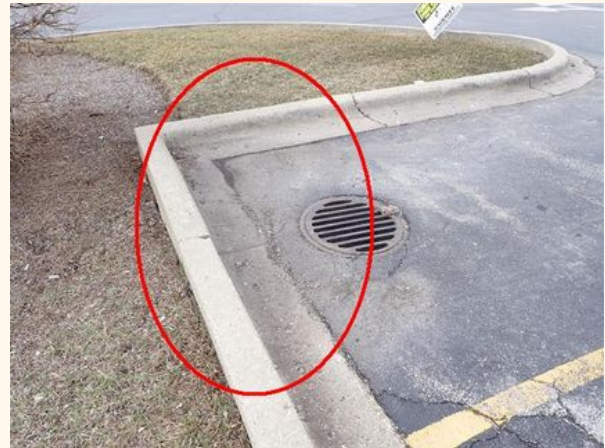
Cracked Curb Sections

Curb Area by Inlet Holding Water

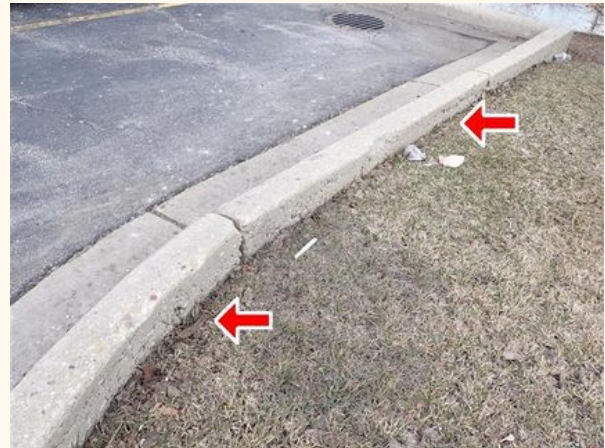
Drop-offs Behind Curbs

Unsupported Curb Backs

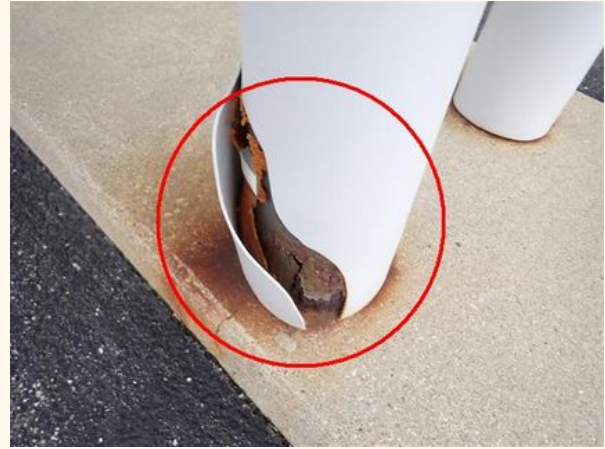
🔧 (IGPC-7) Repair: The plastic covering on one of the bollards by the drive-thru was cracked and the bollard beneath was heavily corroded. It is unknown if the plastic covering is accelerating the corrosion of the bollard or the bollard is corroding from exposure. In order to provide the intended protection for the drive-thru lanes, it is recommended that the corroded bollard be evaluated and repaired or replaced by a qualified concrete contractor and at least one covered bollard should be more closely examined in order to determine if there is a widespread problem.

Damaged and Corroded Bollard

Corroded Bollard in Drive-thru

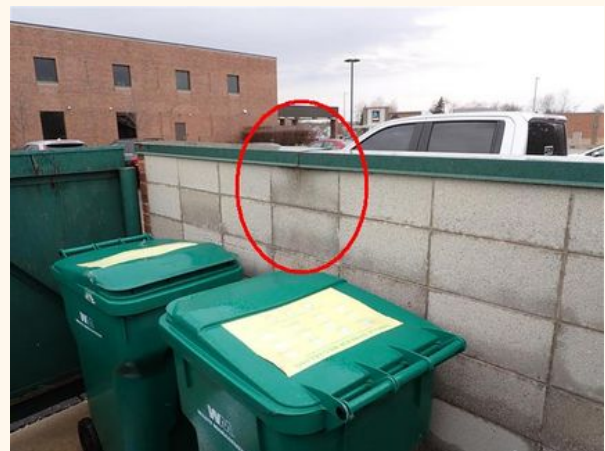
Unsealed Corner Joints on Caps

Moisture Stains Below Cap Joint

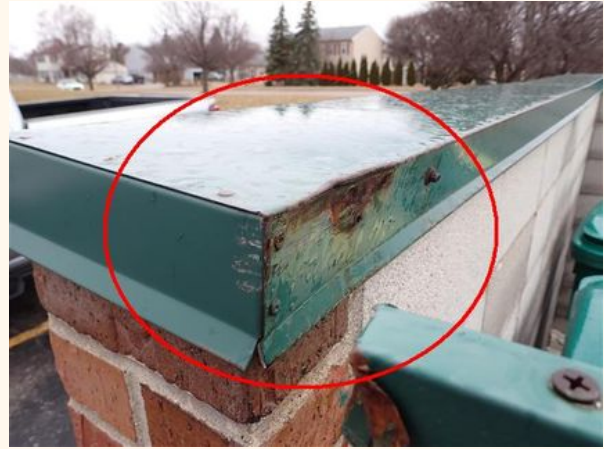
Cracks Noted in Masonry Below Cap

Damage and Corrosion on Cap

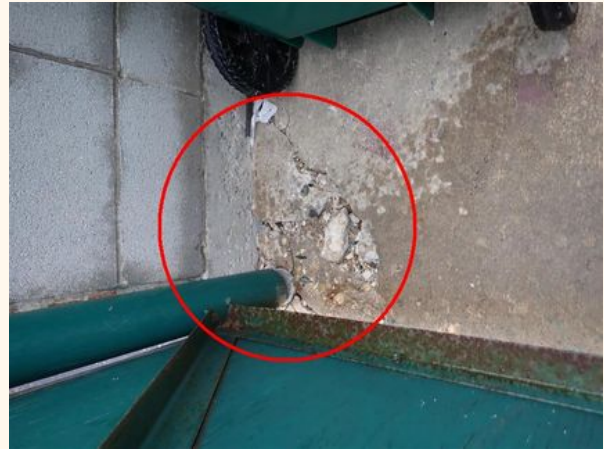
Kyner Coping

Cracked Areas by Posts

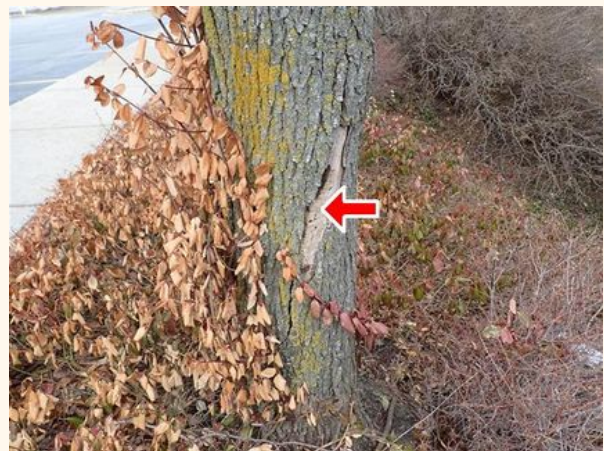
Decay and Disease on Trees

Large Split in Tree

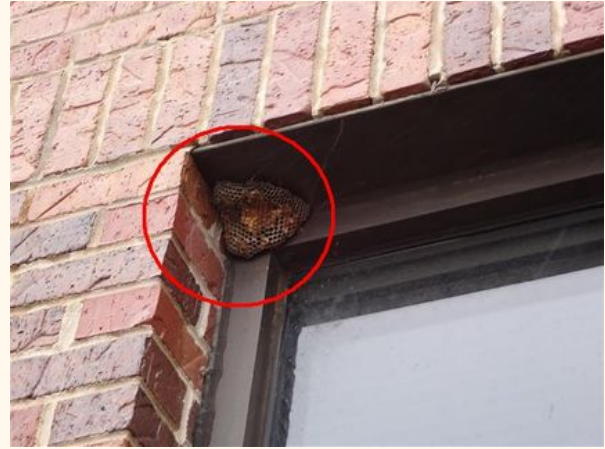
🔧 (IGPC-13) Repair: Nests for flying stinging pests were noted in several locations around the structure and in order to discourage further nest building, extreme care should be taken to remove all old and active nests.

Numerous Nests Noted on Exterior of Structure

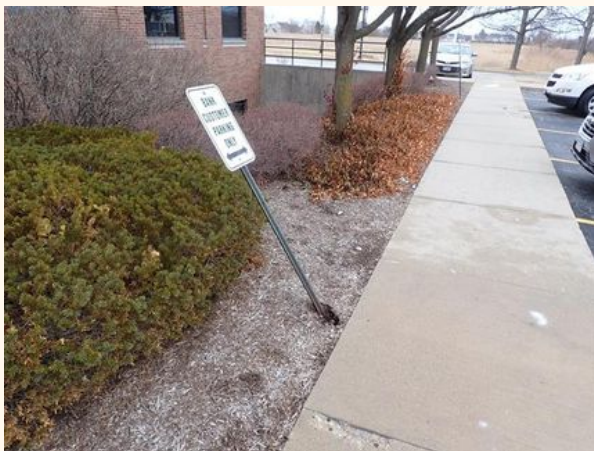
🔧 (IGPC-14) Repair: Several of the exterior signs had been displaced and may need to be re-installed if their use is still desired.

Bent Signs on Property

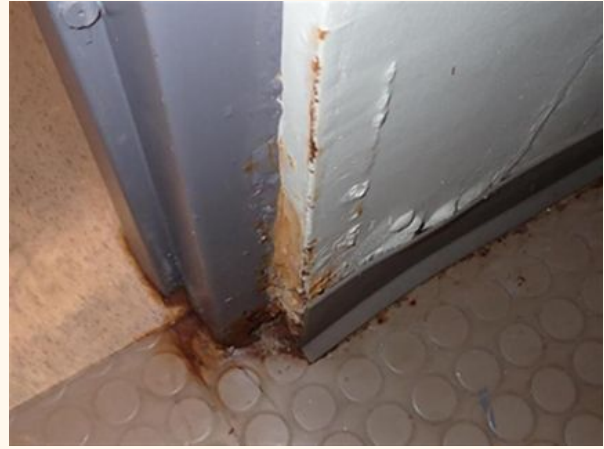
Moisture Stains and Damage by Lower Level Doors

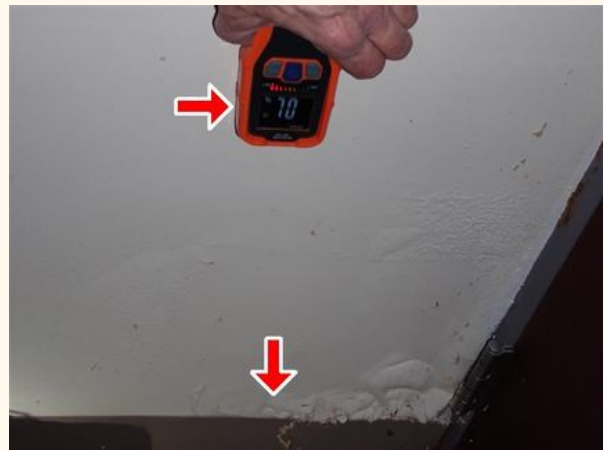
Moisture Stains and Damage on Stairwell Walls

Elevated Humidity Measured Well Above Floor

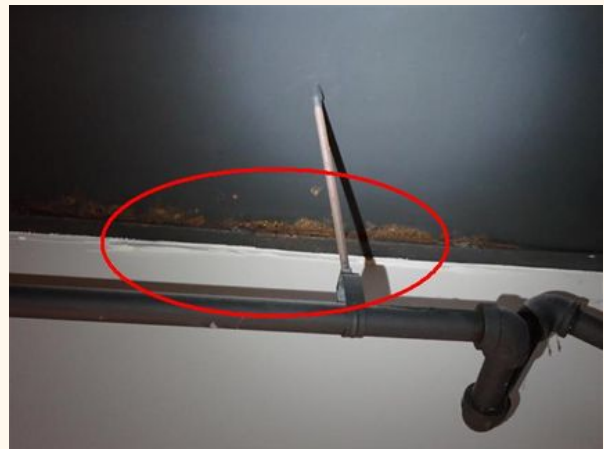
Elevated Humidity Measured in Areas with No Damage

Corrosion on First Floor Stair Landing in NE Corner Stairwell

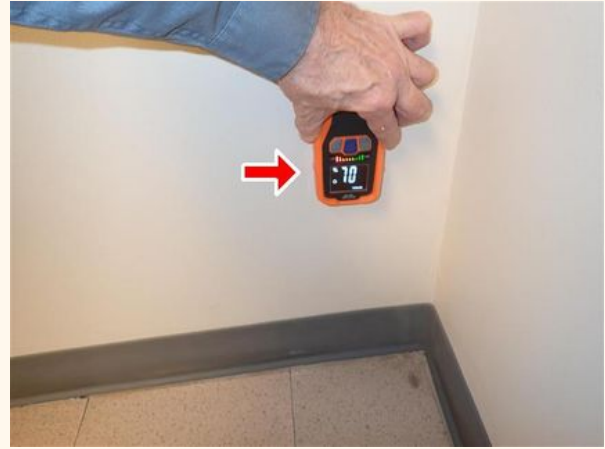
Moisture Related Damage by Elevator

Elevated Humidity in Wall Areas by Elevator

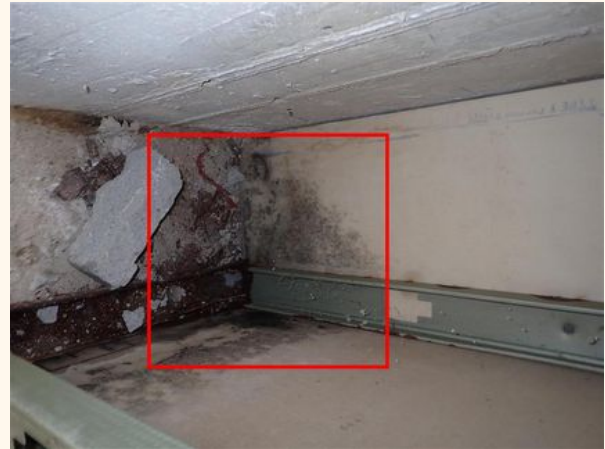
Corrosion on Framing by Elevator

Mold-like Substance Noted in Wall Areas

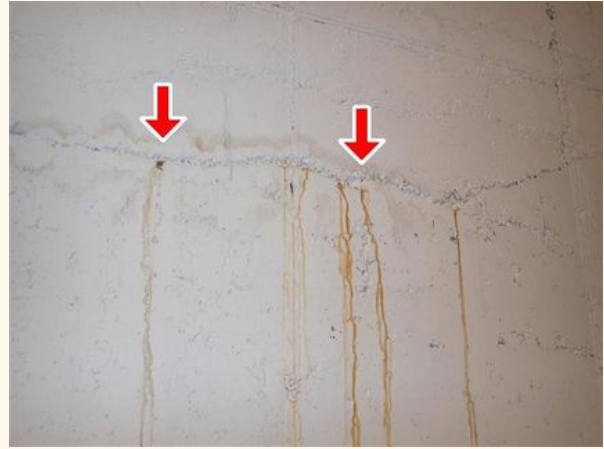
Bank Vault

🔧 (ISFABE-2) Repair: Moisture related staining was observed on the interior of the bank vault and seepage may be occurring along what appears to be a cold joint in the foundation and also through honeycombing in the concrete. Since this is a bank vault, there may have been more reinforcement than is installed in a normal foundation which can make it difficult to consolidate the concrete during pouring resulting in a porous wall. Also, if the concrete was not delivered and poured in a timely fashion, the newly placed concrete does not bond with the concrete beneath. The plans for the building can be reviewed to confirm the presence of the additional reinforcement and given the lack of inward movement on the wall it is doubtful that there are structural concerns, however, the leakage through the concrete is difficult to eliminate and typically requires the installation of an exterior membrane on the foundation wall and evaluation and repair by a qualified foundation repair contractor is recommended.

Leakage Along Cold Joint

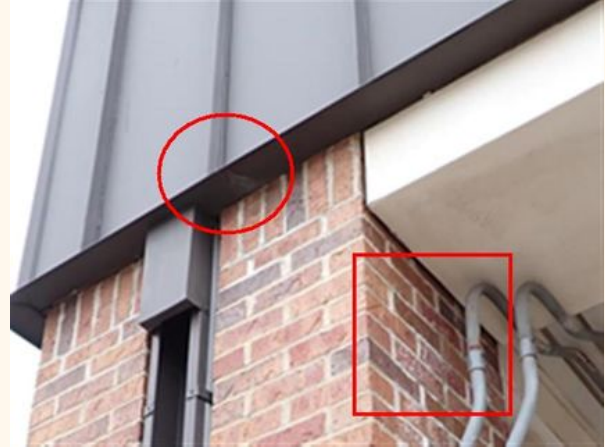
Efflorescent Stains on Column

Moisture Stains on Joint

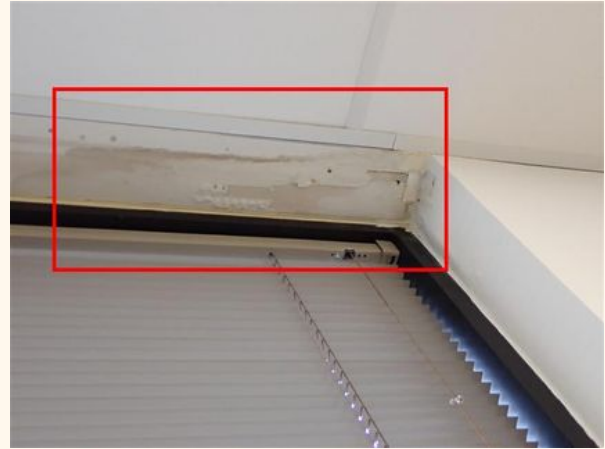
No Drip Edge Observed Above Windows

Moisture Stains and Damage Above Windows Noted

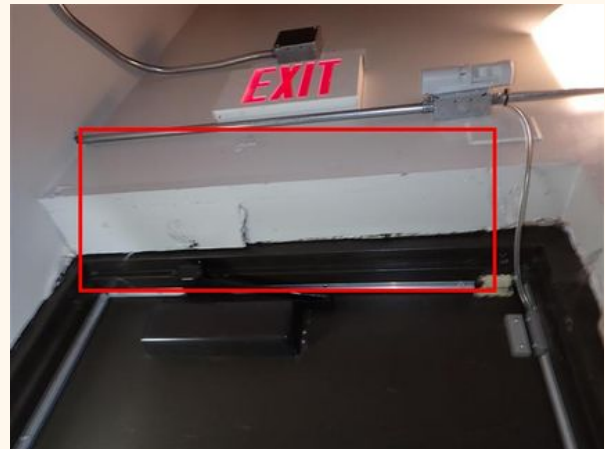
Potential Repaired Window Areas

Damage Noted Above Rear Entry Door

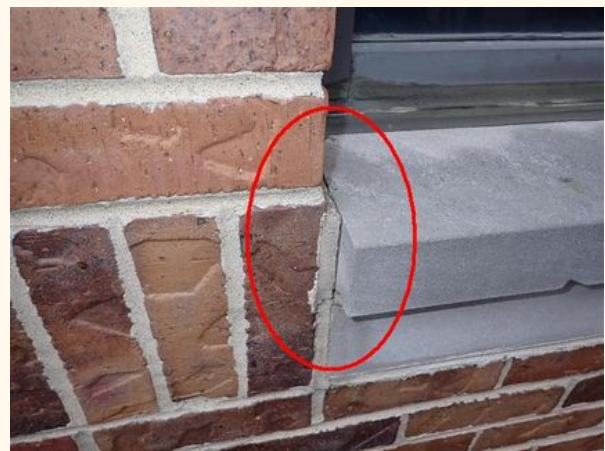
Mortar Joints in Corners of Stone Sills

Hairline Cracking Observed in Mortar Joints

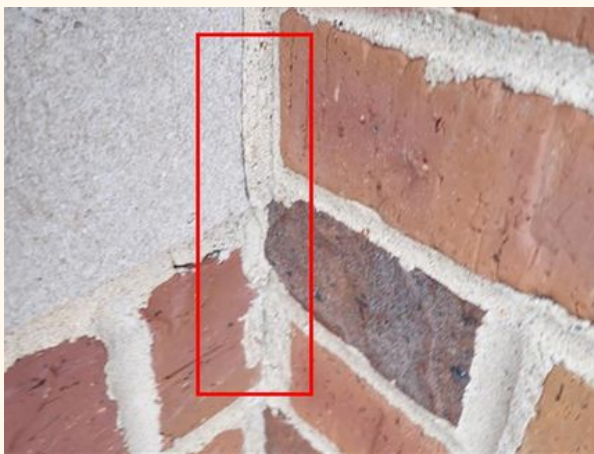
🔧 (ISFABE-9) Repair: Cracking was noted in the masonry joints between dissimilar materials and corner joints on the structure. All dissimilar elements on the exterior walls of the structure such as: brick-to-stone; brick-to-concrete block; concrete block-to-glass block, all interior corners and all construction joints should be joined one to the other and sealed against moisture through the use of backer rod and urethane caulk or its equivalent. These elements have either differing coefficients of expansion and contraction in relation to temperature and moisture or are subject to movement which can lead to cracking of the cladding material and/or of the mortar joints. In order to reduce the potential for moisture related damage, the existing cement mortar joints should be ground out and replaced with the appropriate backer rod and ASTM approved caulking by a qualified masonry repair contractor.

Hairline Cracks in Corner Masonry

This procedure is in keeping with the standards set forth by the Brick Industry Association. Further information is available at the following link: [Accommodating Expansion of Brickwork](#)

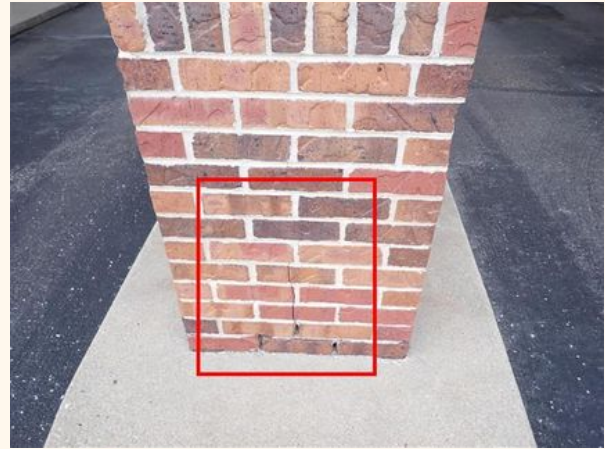
🔧 (ISFABE-10) Repair: The exterior masonry walls are in overall good condition, however, minor areas of deterioration and damage were noted. In order to reduce the potential for damaging and mold causing moisture to enter the home, the exterior walls should be evaluated and repaired by a qualified masonry restoration contractor.

Cracks Below Capping on Roof

Cracks at Bottom of Drive-thru Pillar

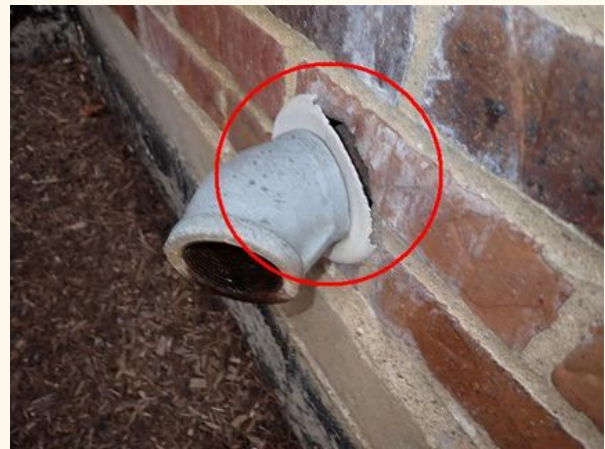
🔧 (ISFABE-11) Repair: All exterior wall penetrations such as; piping, conduit, vent caps, etc. should be sealed against moisture intrusion, drafts, and energy losses through the use of the appropriate caulking methods and materials.

Unsealed Receptacles

Unsealed Wall Penetration by Sprinkler Drain

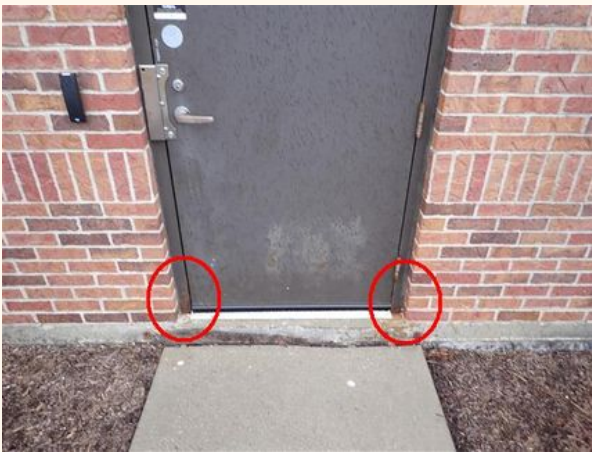
🔧 (ISFABE-13) Repair: Corrosion was noted around the lower portion of the rear exterior doorframe and moisture related damage and elevated humidity levels were noted in the walls adjacent to the door. It appears that the weatherstripping is missing in areas around the perimeter of the door which allows moisture to enter the gaps between the door and the doorframe. In order to reduce the potential for moisture related damage, it is recommended that a qualified handyman install appropriate weatherstripping around the perimeter of the door and the doorframe be repaired or replaced as needed.

Corrosion on Bottom of Doorframe

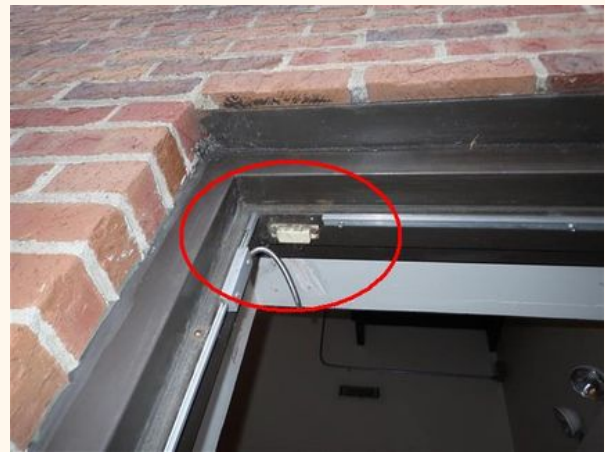
Gap in Weatherstripping Around Rear Entrance Door

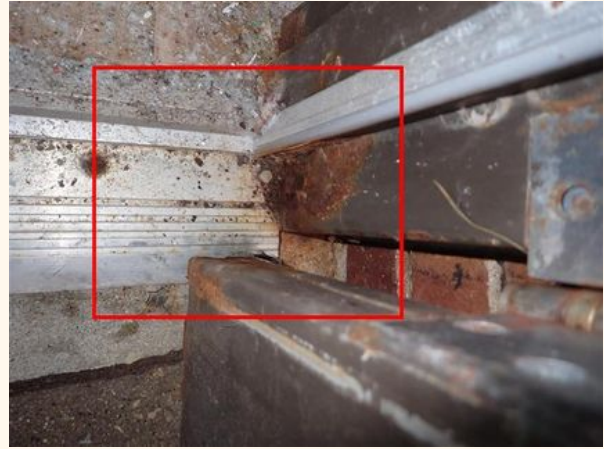
Corroded Doorframe on Rear Entry

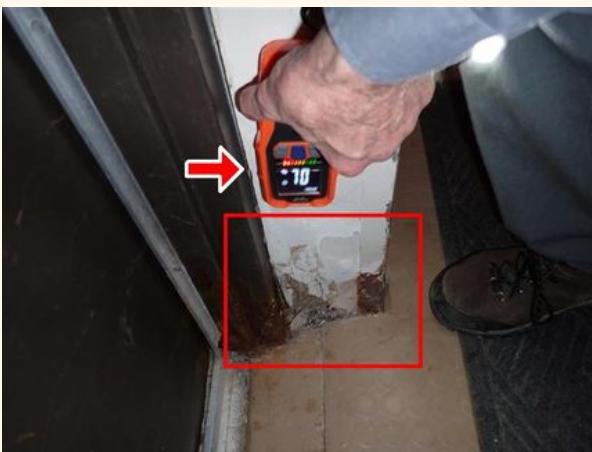
Damaged Wall Finishes and Elevated Humidity Around Rear Entry Door

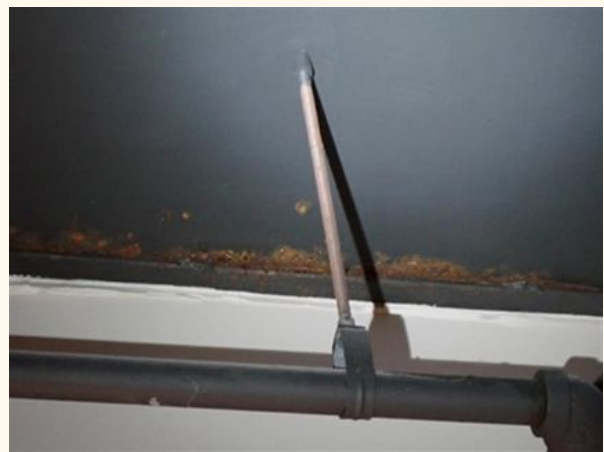
Corrosion in Metal Landing by Door

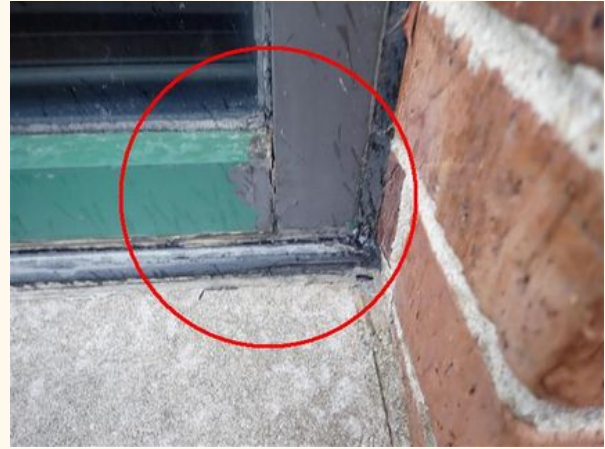
🔧 (ISFABE-14) Repair: Gaps and openings were noted in the exterior corners of the aluminum window installations. Potential moisture related damage was observed on the interior of the windows and In order to reduce the potential for moisture related damage, it is recommended that a qualified window installation contractor evaluate and repair the windows as needed.

Unsealed Corners on Windows

Cracks and Gaps in Window Corners

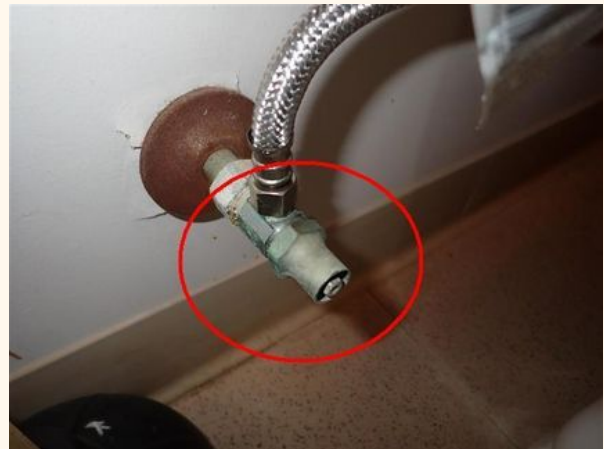
Gate Valves on Toilet Supplies

Missing Shut-off on Toilet Supply

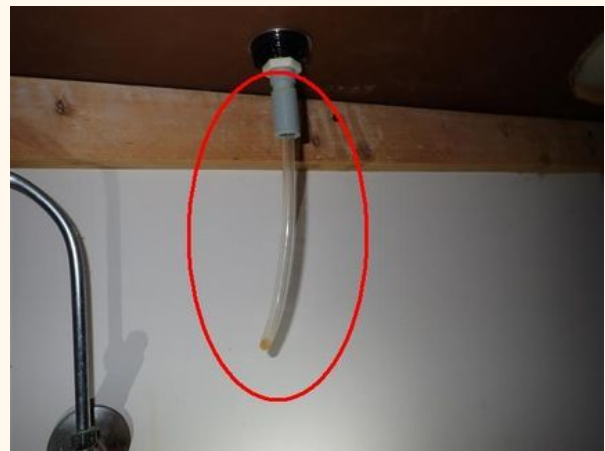
Non-functional Soap Dispensers

Missing Containers on Dispensers

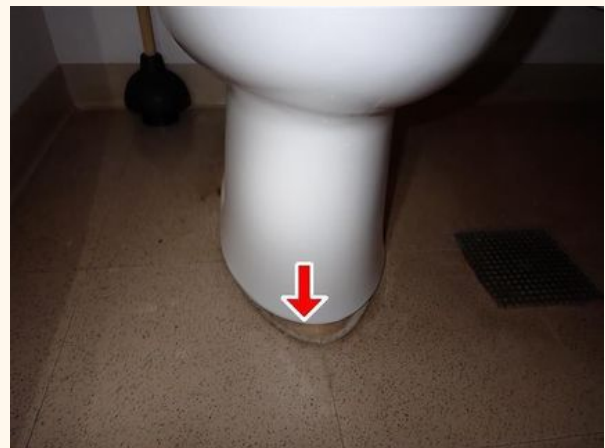
Loose Toilets in Nearly Every Bathroom

Unsealed Bases on Toilets

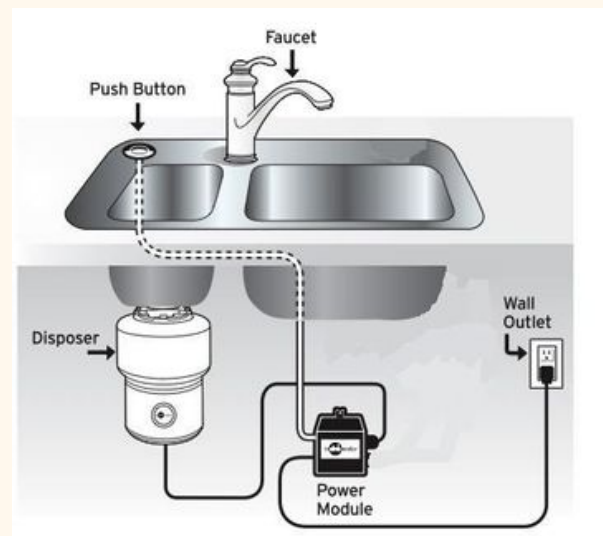
🔧 (IMAES-12) Repair: The switch for the food waste disposer is located beneath the kitchen sink. In order to reduce the potential for electric shock when using the disposal with wet hands and for the sake of convenience, the switch for the food waste disposer should be changed to an air activated switch located on the countertop near the sink housing.

Switch for Disposer in Upper Level Kitchen

Disposer Air Switch

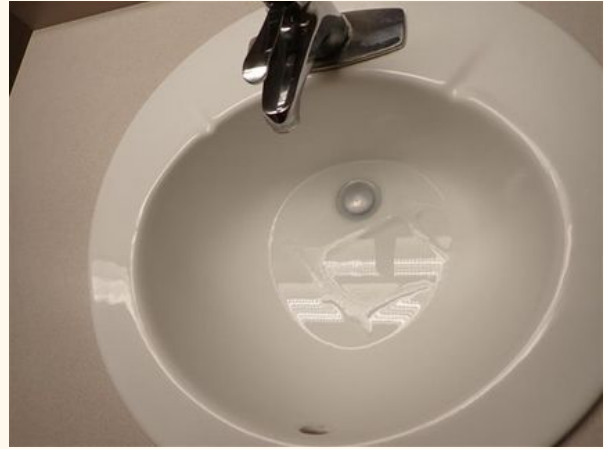
🔧 (IMAES-13) Repair: Standing water was observed in one of the sinks in the ladies restroom in the upper level. In order to be able to use the sink, repair by a qualified plumber is recommended. Also, the sink in the lower level breakroom was slow to drain and it appears the grate was clogged with food particles and just needs to be cleaned to drain properly.

Food Waste Clogging Drain

Standing Water in Sink

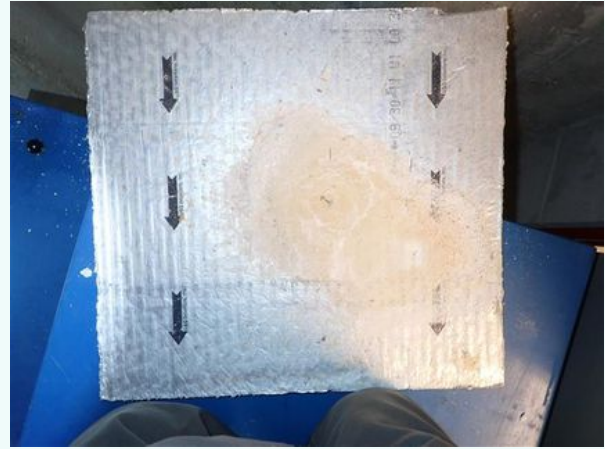
Leakage Stains on Pipe in Ceiling of Elevator Mechanical Closet

Stains on Panel Below Piping

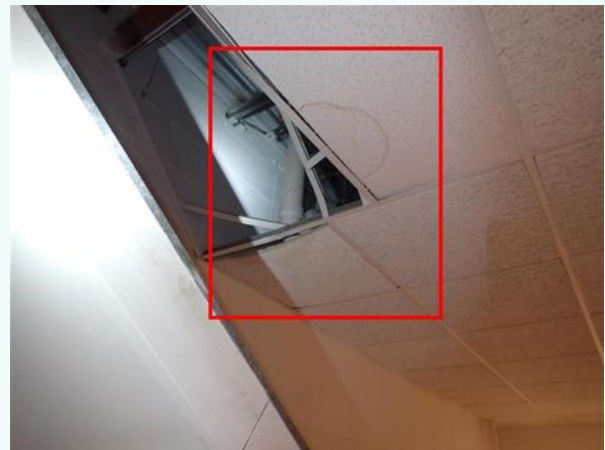
No Moisture by Wall Stain Below Pipe

Stains on Ceiling Tile in Former Mail Room

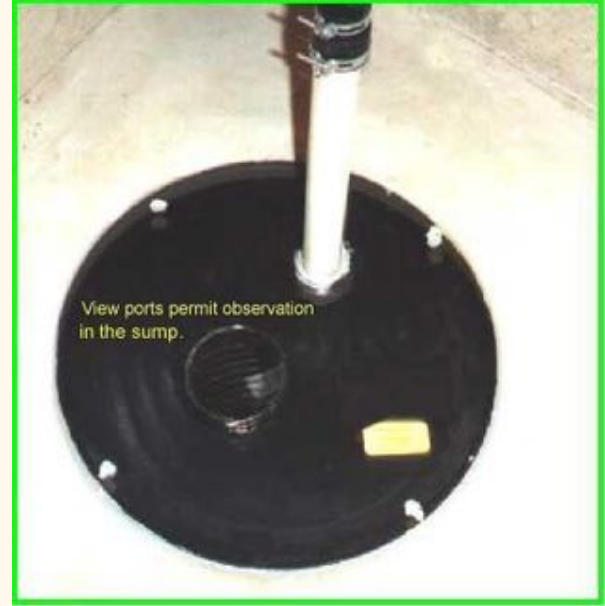
Unsealed Sump Pit

Sump Cover

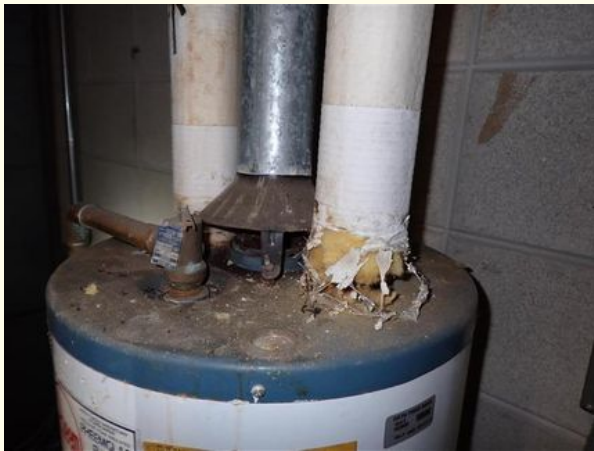
Corrosion and Staining on Water Heater

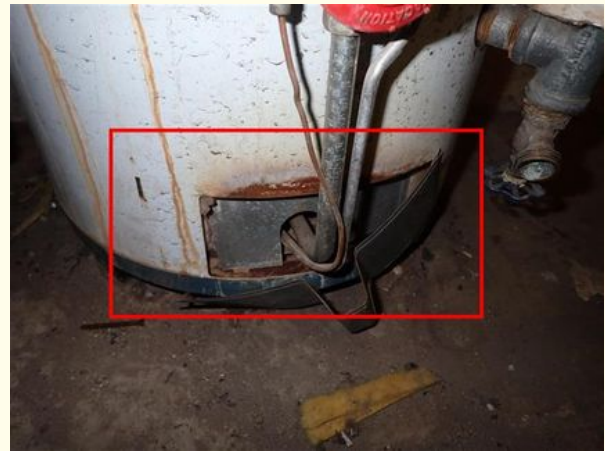
Displaced Cover on Burner and Corrosion on Unit

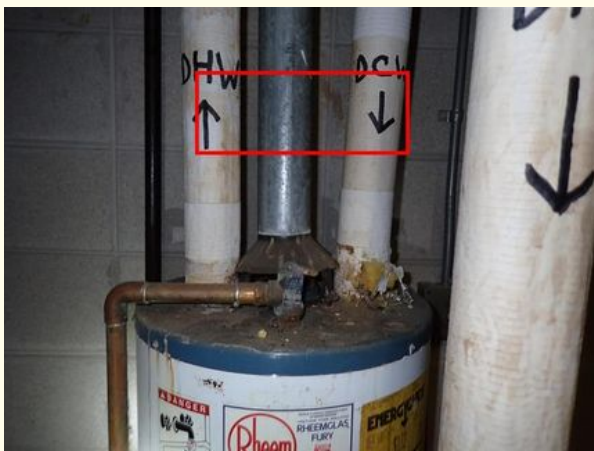
Expansion Tank Needed on Water Heater

NOTE: When the water heater is replaced consideration should be given to installing an expansion tank. This feature can be critical for absorbing the pressure from water that expands as it is heated thereby prolonging the life by reducing the stress on the water heater and other plumbing components.

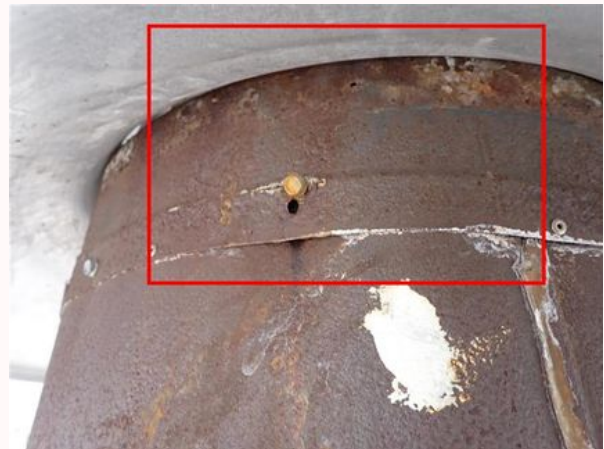
⚠️ **IMAES-19 IV MECHANICAL AND ELECTRICAL SYSTEMS:** Corrosion and moisture related staining was noted on the vent pipe for the boilers both on the roof and in the mechanical closet and was excessively present on one of the two boilers. The massive boilers in the basement appear to have insufficient access to combustion/dilution air which can reduce the ability for the boilers to vent properly resulting in the formation of condensation in the vent piping. These boilers were installed in 2011 which suggests that the existing boilers were only in service for 21 years. Cast iron boilers can last for more than 35 years if maintained properly and in order to reduce the risk of equipment damage, inefficient combustion and infiltration of carbon monoxide into the structure, a controlled intake ventilation damper system that draws intake air from the outside of the structure should be installed by a qualified HVAC or mechanical contractor.

Moisture Stains Around Boiler Vent Pipe

Corrosion and Open Holes on Vent Pipe

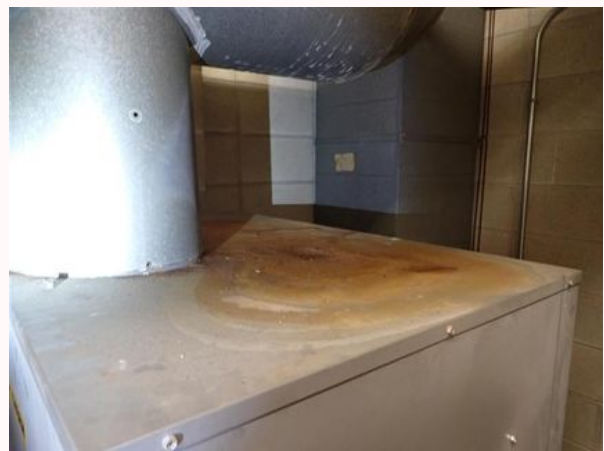
Corrosion on Boiler

Staining and Corrosion on Top of Boiler

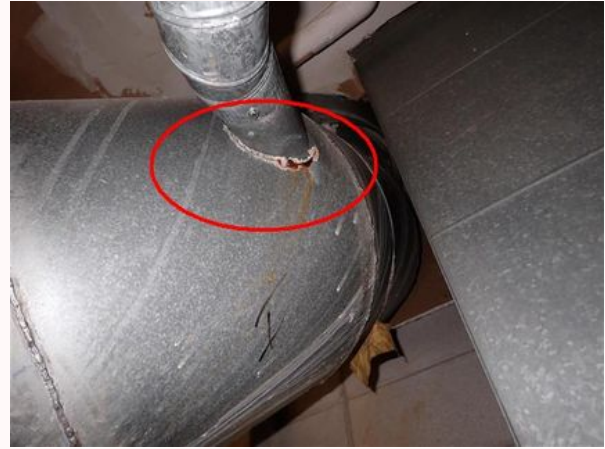
Moisture Stains and Corrosion on Vent Pipe

Corrosion and Staining by Water Heater Vent

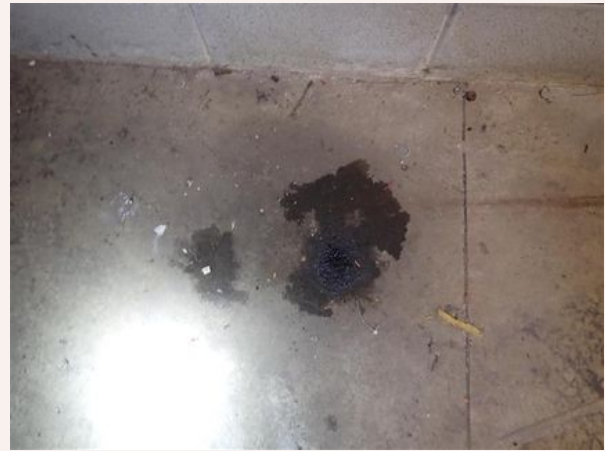
✂️ (IMAES-20) **Recommended Maintenance:** The circulating pump for the hot water heating system was covered with oil at the time of the inspection and oil was observed on the floor below the unit. It appears that the unit is being oiled too frequently which can reduce the performance of the pump and possibly result in binding of the unit. In order to reduce the potential for pre-mature failure of the pump, the oiling schedule should be adjusted and comply with the manufacturers specifications.

Excessive Oil on Circulating Pump

Oil on Floor Below Pump

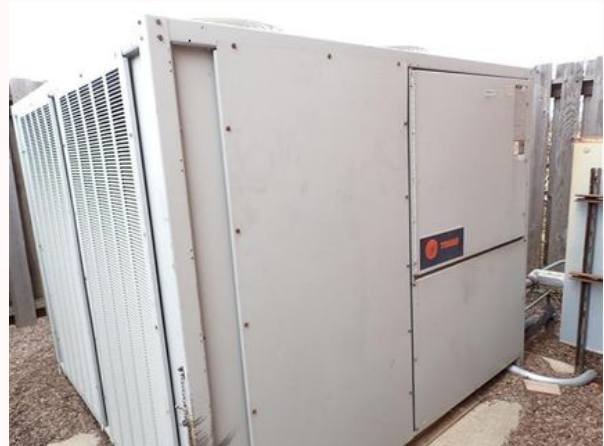
⚠️ **IMAES-21 IV MECHANICAL AND ELECTRICAL SYSTEMS:** **The A/C condenser is well beyond the end of the expected service life and although the system was not tested at the time of the inspection, cooling levels may be inadequate in the near future. The R-22 refrigerant that is used in the unit is being phased out** and no new or imported R-22 is allowed in the U.S. and technicians will only be able to use recycled, reclaimed, or previously produced R-22 to service equipment. Therefore it will become more expensive to service the unit in the future. The cost to retrofit the HVAC system to use the new R-410 A replacement refrigerant is expensive and involves replacing the evaporator coils in the air handling unit.

R-22 Refrigerant Used in AC Condenser

Large Older Condensing Unit

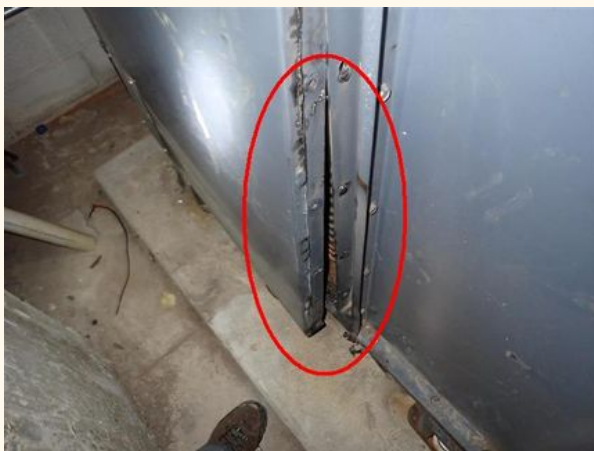
🔧 (IMAES-22) Repair: An open gap in the casing was observed on one of the air handlers in the mechanical room and significant air leakage was occurring at the time of the inspection. A comprehensive evaluation of the HVAC system was not a part of this commercial inspection and in order to ensure the systems are operating properly, it is highly recommended that a thorough evaluation of the systems be conducted by a qualified HVAC service technician.

Open Gap on Air Handler

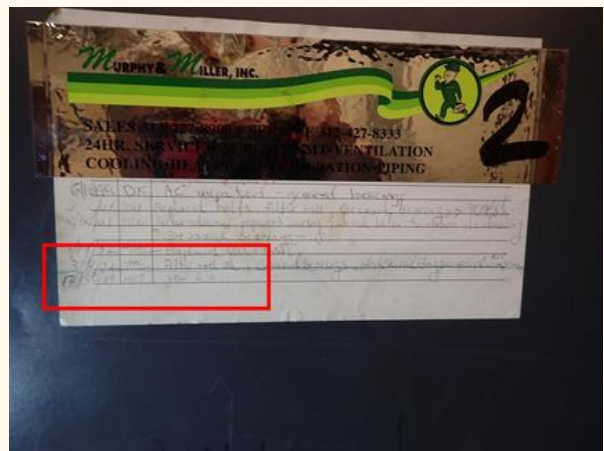
NOTE: The air handlers appear to be receiving fairly regular servicing, however, some older service dates were observed on some tags. Also, the schedules for the filter replacements should be determined.

Belts Replaced in 2004?

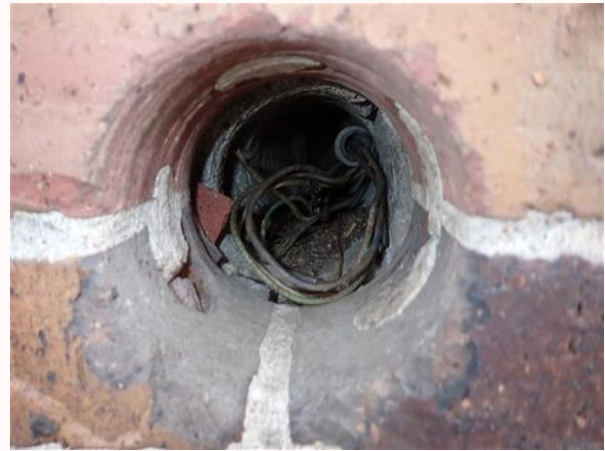
⚠️ **IMAES-28 IV MECHANICAL AND ELECTRICAL SYSTEMS:** Exposed wiring was observed on the north side of the masonry sign in front of the structure. In order to reduce the risk for electrical shock from inadvertent contact with exposed current carrying equipment and in order to contain molten copper created by high temperature arcing and sparking of energized wiring, it is recommended that all electrical connections be concealed inside covered metal junction boxes by a qualified electrician.

Open Hole on Sign

Exposed Wiring in Sign

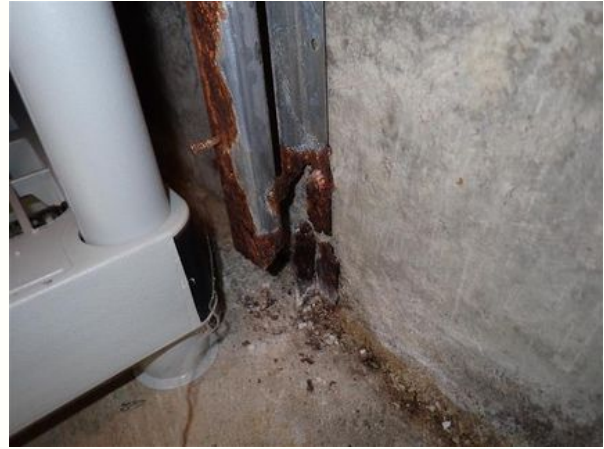
✦ (IMAES-29) **Note:** Moisture related staining and damage was noted in a document storage room in the lower level in the southeast corner of the building. The lower 2 feet of drywall in the room has been removed and corrosion was observed on some of the steel wall framing in the room. It appears that moisture had entered the room via a conduit from the external electrical transformer and **according to an answer in the questionnaire that was sent to the current owner, the flooding occurred as a result of localized flooding from a sump pump back-up.** In order to reduce the potential for moisture related damage and to prevent colder external air from entering the building and condensing on warmer interior piping, the feeder conduits from the transformer should be sealed by a qualified electrician.

Transformer on East Side of Structure

Corroded Framing

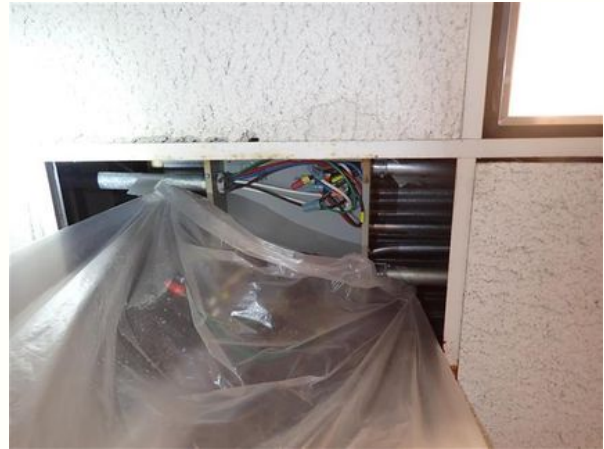
Drywall Removed

Leakage Stains on Junction Box in Ceiling

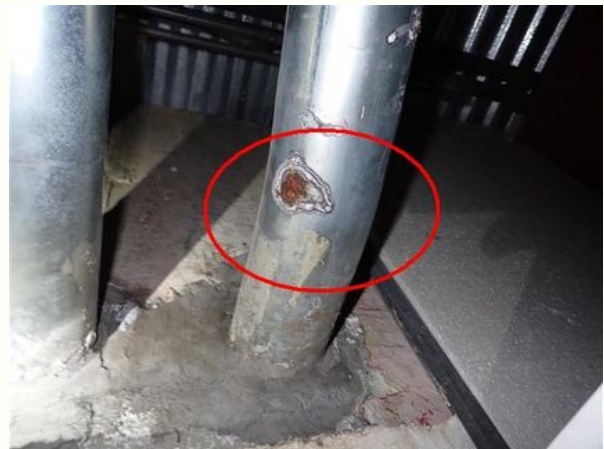
Leakage Stains on Walls

Corrosion on Feeder Conduit

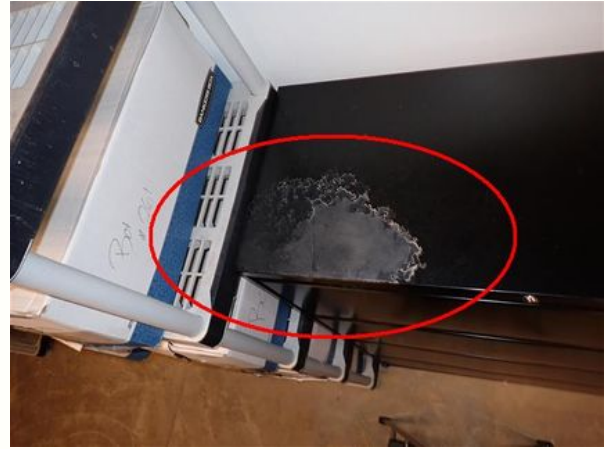
Corrosion on Ceiling Grid

Moisture Stains on Cabinet Below

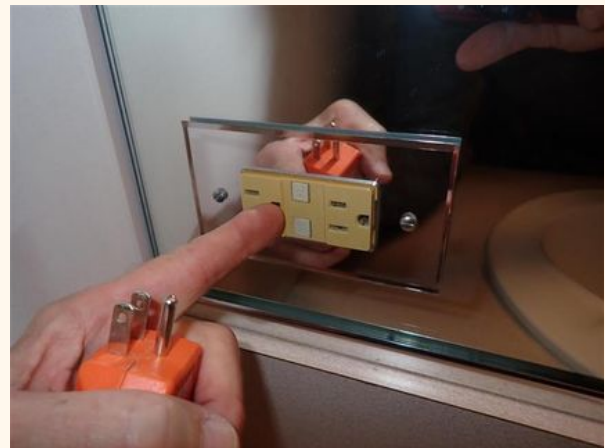
Non-GFCI Receptacles on Exterior of Structure

Non-functional GFCI Receptacle in Bathroom

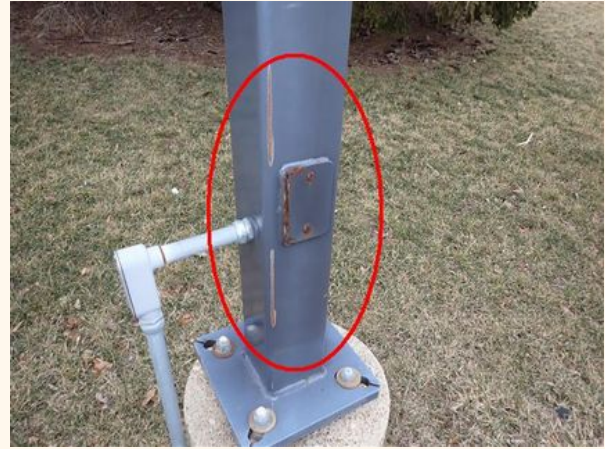
Corrosion on Light Pole Base

Corrosion on Light Pole

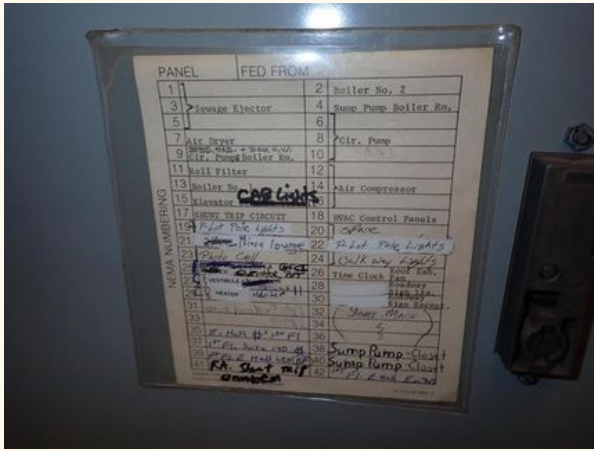
⚠ (IMAES-34) Repair: There may be missing and/or incomplete circuit directory for the electrical service panel/s. In order to allow for safe and efficient electrical circuit interruption when required for maintenance, repairs, or in emergencies, a complete and accurate electrical circuit directory should be provided to the buyer before closing.

Numerous Changes Made on Some Directories

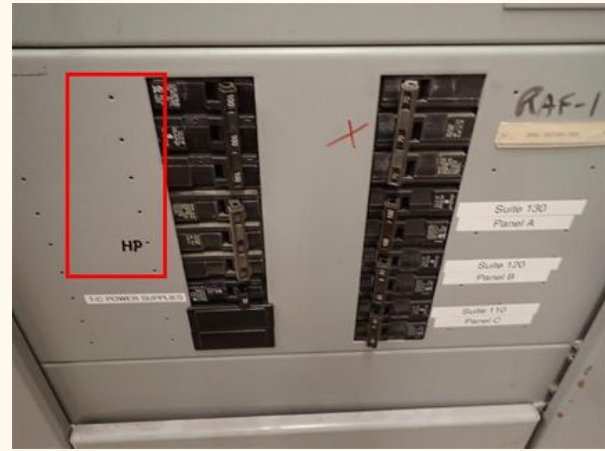
Unlabeled Circuits on Main Shut-off

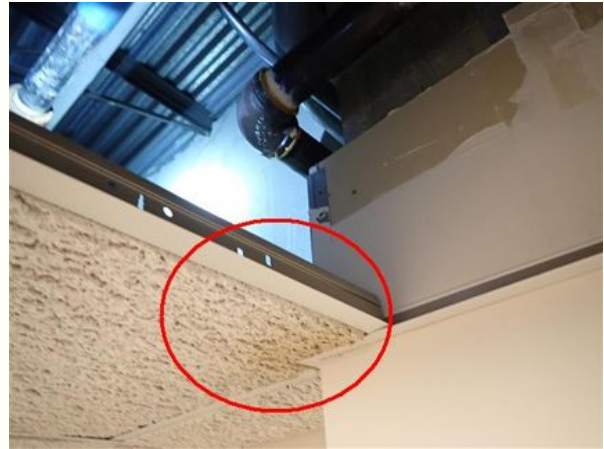
Stained Ceiling Tile by Elevator

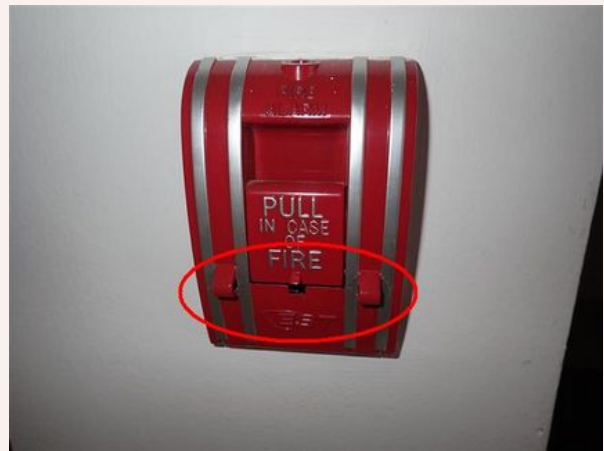
Missing Glass Indicator on Alarm Pull

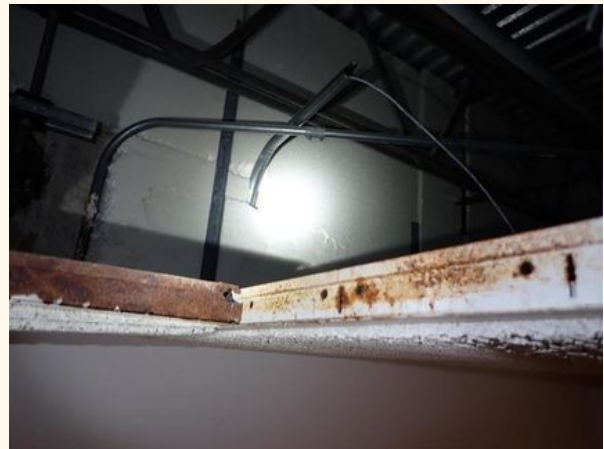
Walls Removed in Storage Area

Damaged Ceiling Tile System

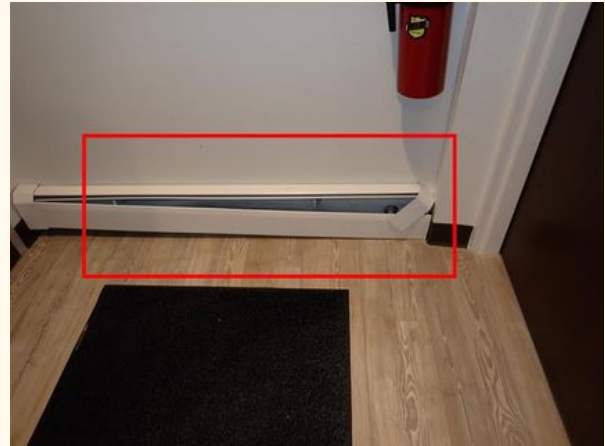
Stains and Warped Tile in Bathroom Tiles Below Urinal

Damaged Radiator Cover

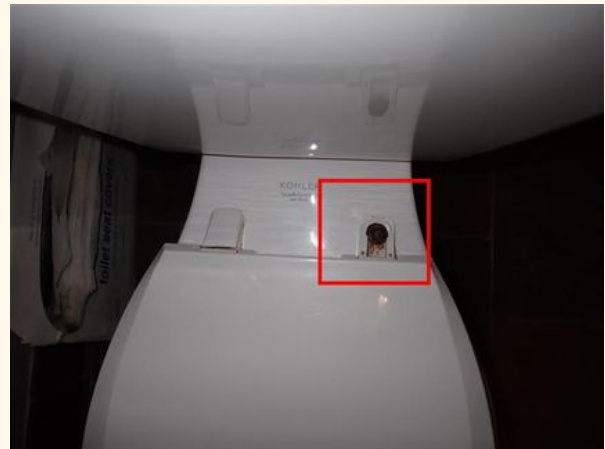
Stains on Window Ledges

Missing Cap on Toilet Seat

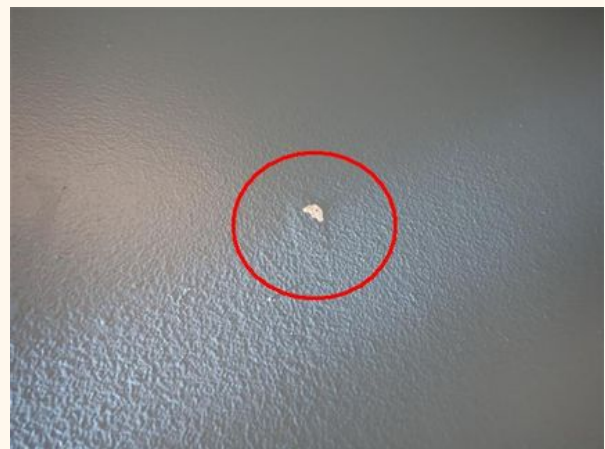
Water Stains on Window Sills from Plants

Paint Missing on Walls

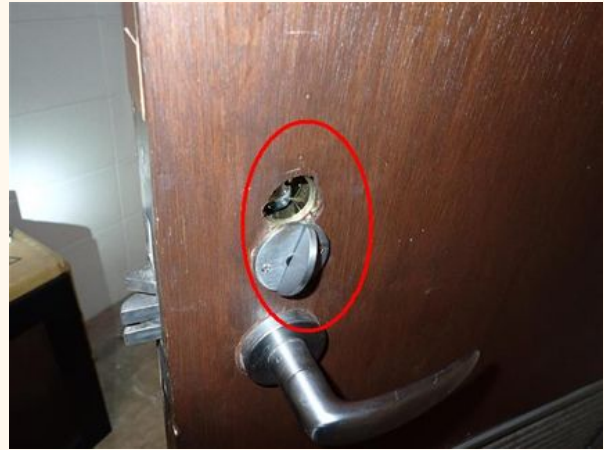
Loose Lock Mechanism on Basement Closet

Hole by Lock Mechanism
