This report is prepared exclusively for **Large Commercial Office Building**
Inspected On: **2022-11-08**

This was an inspection of a large multi-story office building. The structure was built approximately 12 years ago and there were several ongoing concerns, mostly related to moisture that were damaging portions of the structure. Please read the report carefully in order to gain an understanding of the concerns regarding the property.

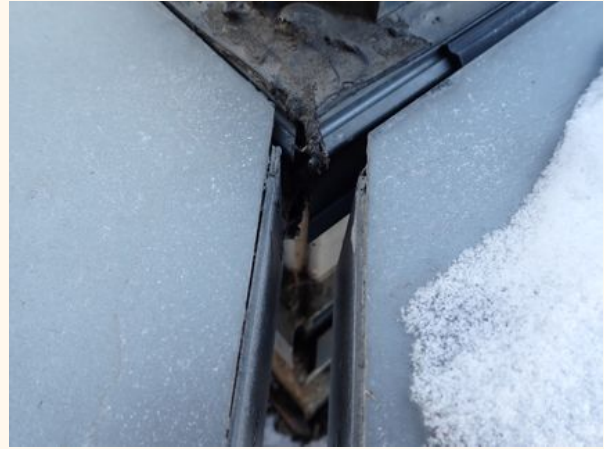
Possible Gaps Noted in Corner Joints

Multiple Layers of Materials in Difficult to Seal Corner Locations

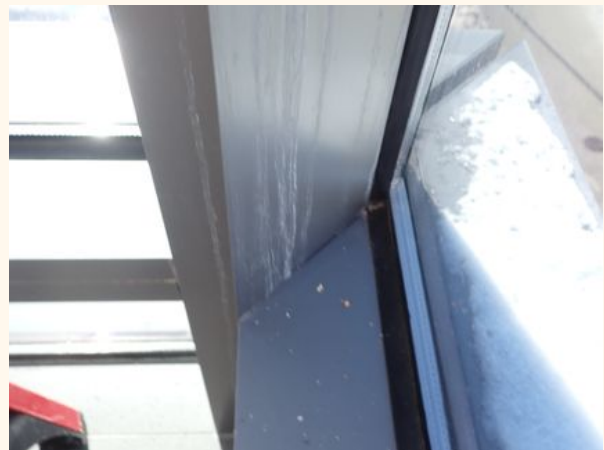
Potential Moisture Related Staining on Eave Area by Corner Joint

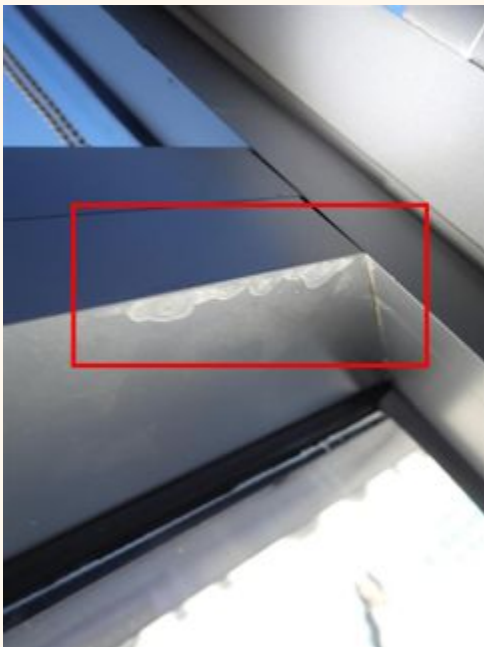
Heavy Vertical Staining on Corner Trim Areas

Moisture Stains on Interior Corners

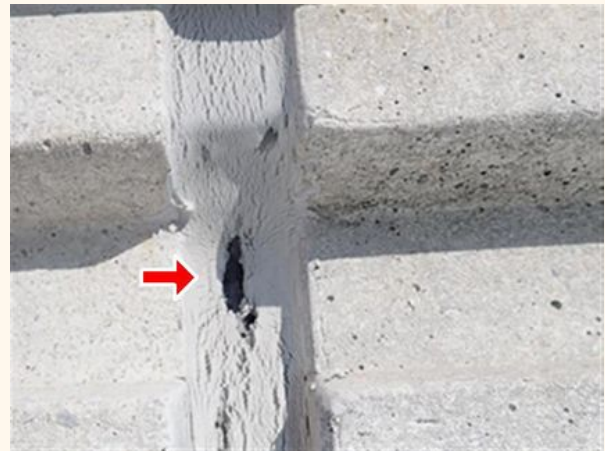
🔧 (EWGCE-2) Repair: The existing caulking around the perimeter of the structure is old, cracked, deteriorated and/or missing. Exterior sealant performance is directly related to the joint preparation and application. For increased service life, performance and aesthetics, the exterior of the structure should be carefully examined and old deteriorated caulking should be removed and the exterior of the structure caulked via appropriate means and materials. Proper joint preparation and the use of compliant exterior rated sealants of good quality is recommended.

Deteriorated Caulk Between Pre-cast Cladding Panels

Close-up of Openings Noted in Caulk Joints

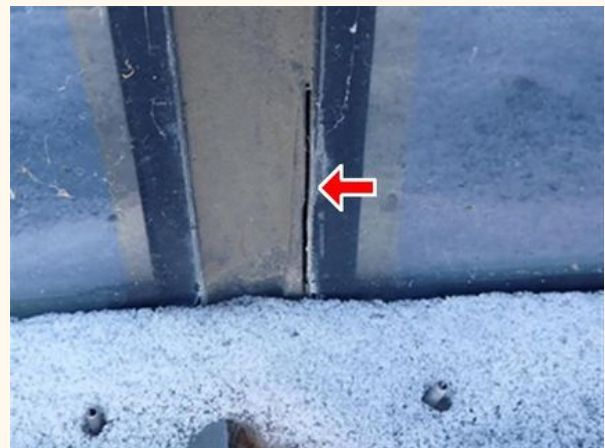
Gaps in Caulking Noted Around Windows

Gaps Noted in Caulking Around Windows

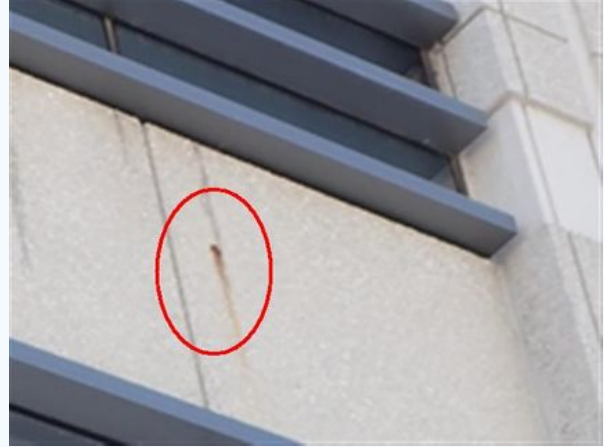
🔍 (EWGCE-3) Due Diligence: Corrosion stains were noted on several of the pre-cast concrete cladding panels on the East façade. In order to reduce the potential for further deterioration

Corrosion Noted on Pre-cast Panels

Corrosion Noted on Panels

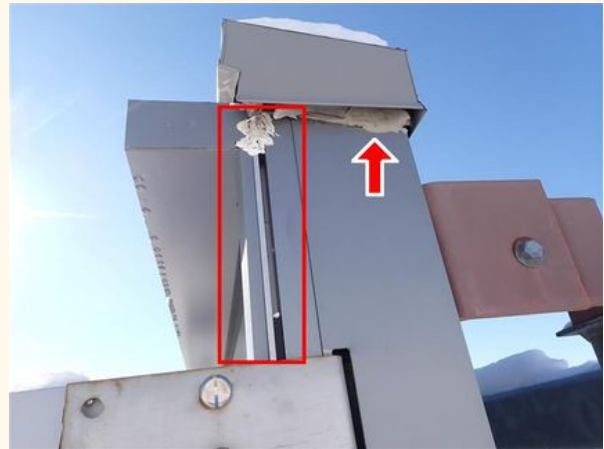
🔧 (EWGCE-4) Repair: There are decorative features on the building that extend to the rooftop. Deteriorated elements were noted on these features and for proper appearance the features should be evaluated and repaired and/or refinished as needed.

Loose Rubber Gasket

Missing Gasket Area and Sloppy Caulk on Cap

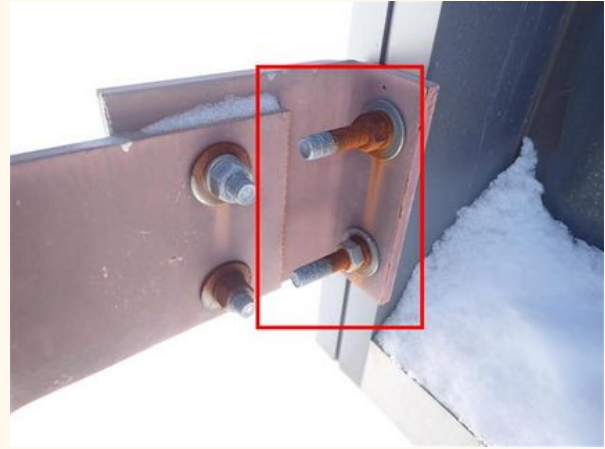
Peeling Coating on Connecting Brackets

Corroding Connecting Bolts

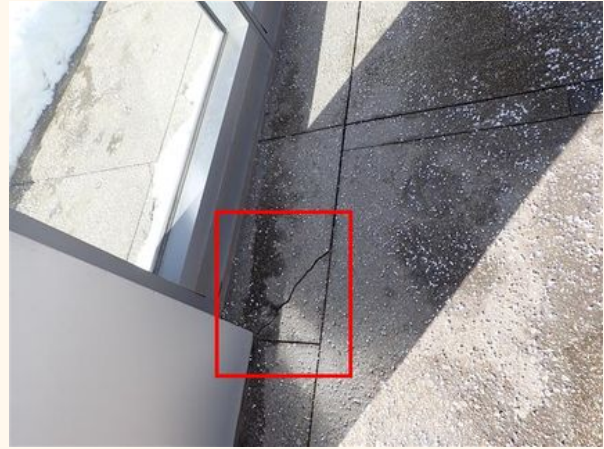
🔧 **EWGCE-6 EXTERIOR WALLS< GROUNDS, CHIMNEYS. ETC:** The exterior concrete walks have cracks which can allow moisture penetration that creates the potential for further damage from freeze/thaw cycles. In order to reduce the potential for moisture related damage, the cracks should be sealed by a qualified concrete repair contractor.

Cracks Noted in Exterior Walks

Cracked Walks Noted

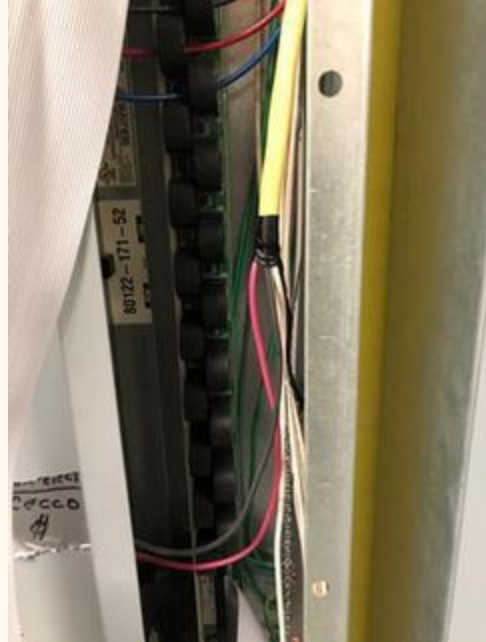
Uncovered Junction Boxes in Telecom Electric Room

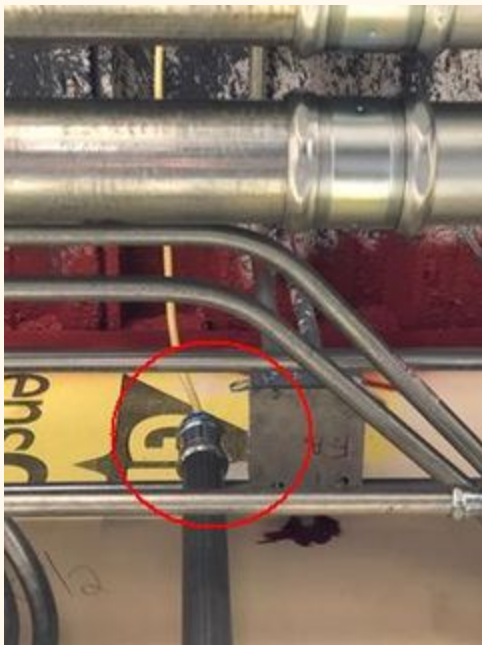
Romex Noted in Panel 3lp-1

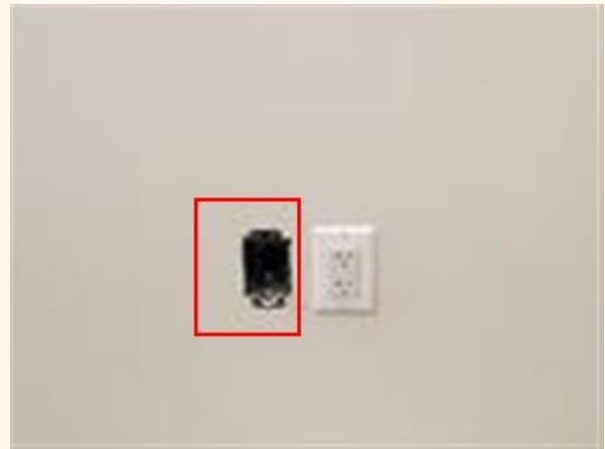
⚠️ (ESGDAF-2) Repair: Uncovered, ungrounded, inoperative, loose and/or mis-wired electrical receptacles were noted in various areas of the structure. All of these conditions represent significant electrical safety defects. All of the electrical receptacles in the building should be evaluated and repaired or replaced as necessary by a licensed and competent electrical contractor.

Receptacles Missing Covers

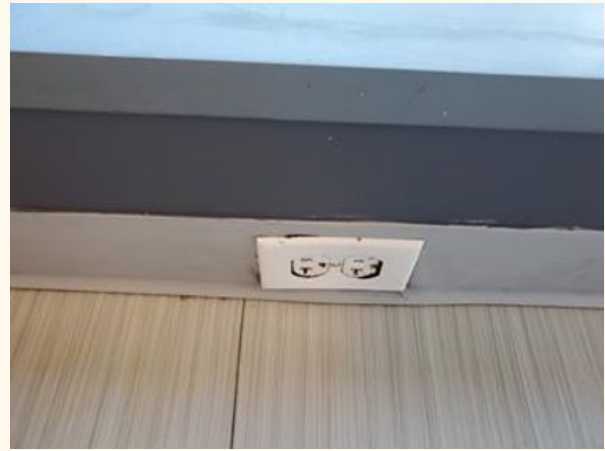
Loose Covers on Receptacles

Loose Receptacle with Damaged Cover

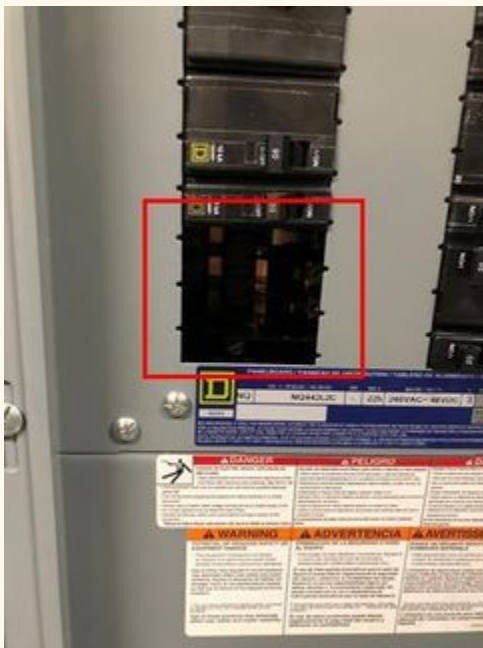
⚠️ (ESGCDAF-3) Repair: The open twist-outs at the electrical service panel creates a risk for electrical shock from potential contact with energized equipment. Repair by a qualified electrician is recommended.

Open Twist-outs on Panel 3 rp-1

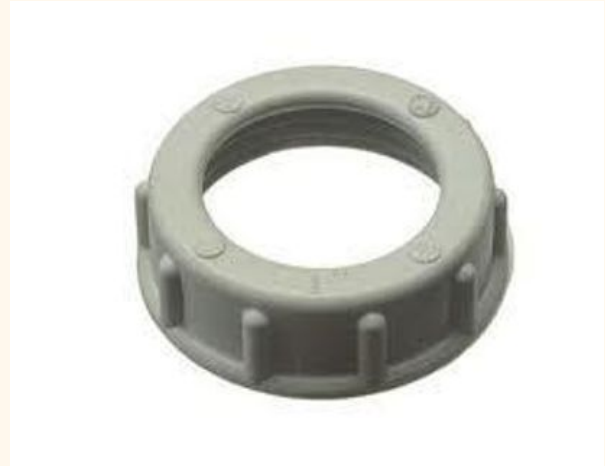
⚠️ (ESGCDAF-4) Repair: Larger electrical conductors are required to be protected at conduit terminations with a non-conductive bushing in order to reduce the risk for arcing/sparking, shock, fire, etc. These bushings are missing in the main distribution panel and it is strongly recommended that the electrical panel(s) be evaluated and repaired as needed by a qualified electrician.

Non-conductive Bushing Missing on Feeder Conduit in Telecom Electrical Room

Non-conductive Bushing

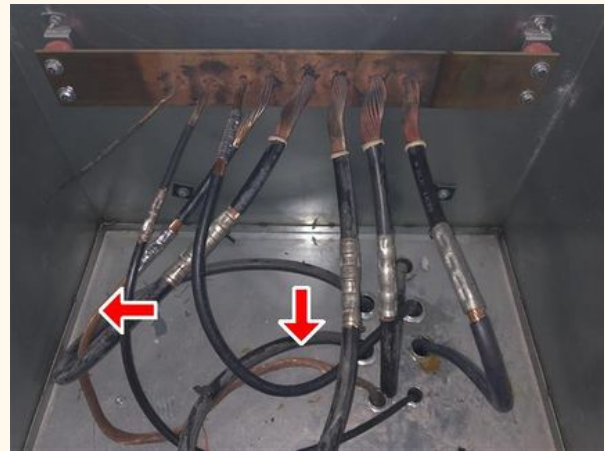
🔧 (ESGCDAF-5) Repair: The grounding connection to the water supply does not have a certification tag or jumper wire. Also, no driven ground rods were located and there was a bare conductor on the bus bar that did not go to earth or grounding. In order to ensure proper grounding of the building it is recommended that the grounding system be evaluated and repaired as needed by a qualified electrician.

Missing Tag and Jumper Wire on Water Service Ground Connection

Bare Conductor Connected to Bus

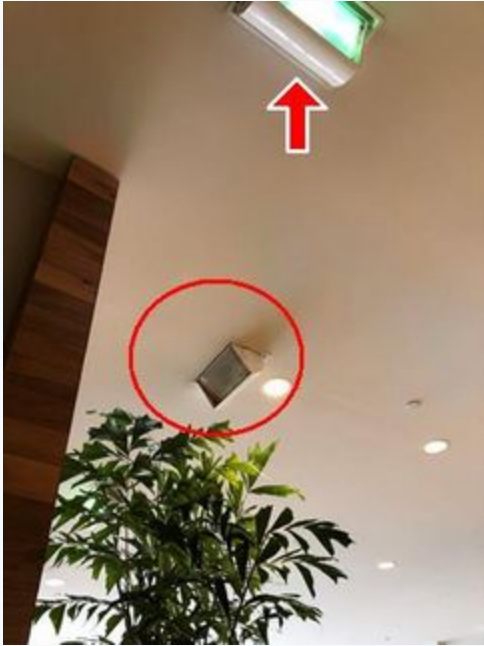
🔍 (ESGCDAF-6) Due Diligence: There were numerous lighting outages throughout the structure. While existing building maintenance has been keeping up with some bulb replacement and converting many bulbs to LED's, there are numerous specialty fixtures installed throughout the structure for the various build-out spaces. The buyer will need to determine which fixtures will remain in use and in the future will need to maintain an active stock of replacement bulbs for those fixtures.

Flickering Exit Signs and Non-functional Halogen Fixtures

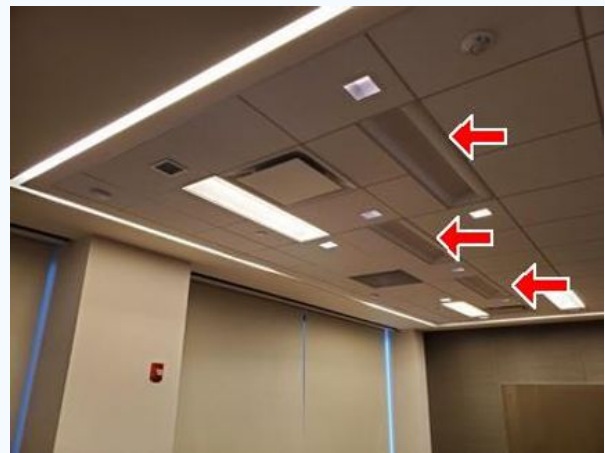
Numerous Ceiling Fixtures

Non-functional Recessed Lighting

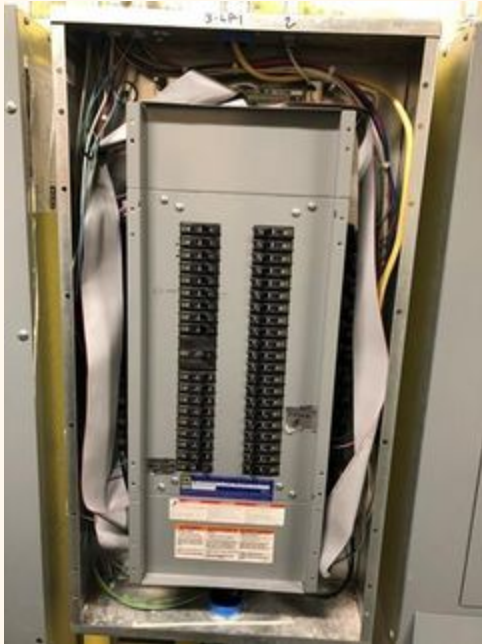
🔧 (ESGCDAF-7) Repair: In order to allow for safe and efficient electrical circuit interruption when required for maintenance, repairs, or in emergencies, a complete and accurate electrical circuit directory should be provided to the buyer before closing.

Unlabeled Circuits in Telecom Electric Room

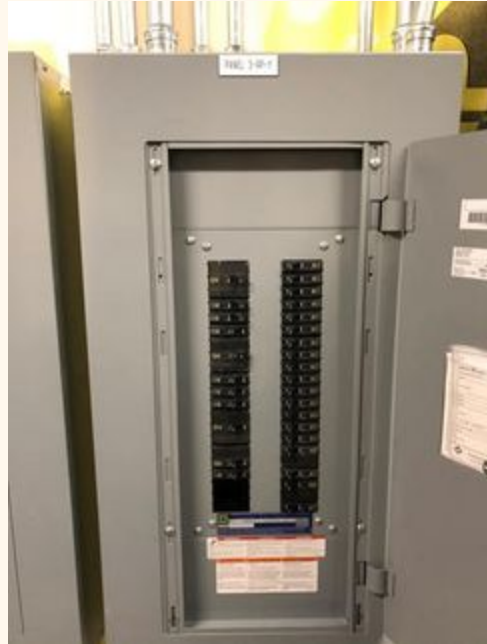
Unlabeled Circuits in Panel 3lp-1

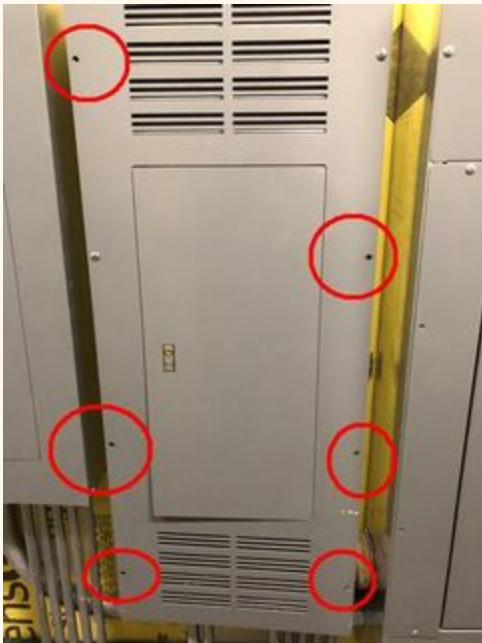
🔧 (ESGDAF-8) Repair: In order to reduce the potential for inadvertent contact with energized electrical equipment it is recommended that the missing electrical panel cover screw(s) be replaced.

Missing Screws on Panel 2-rr-1

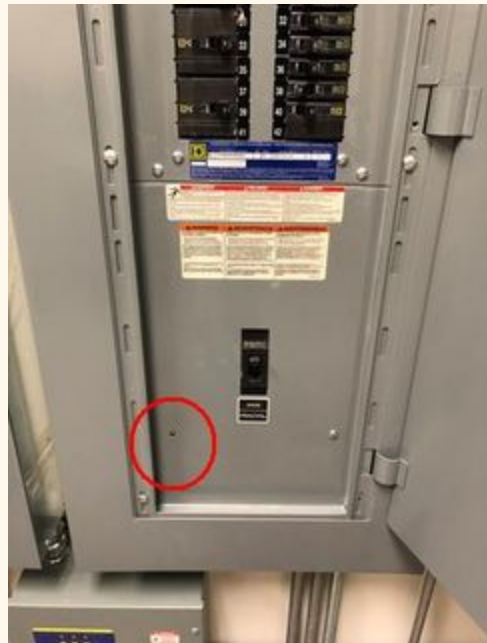
Missing Screws on Panel Cover in Electrical Room 110

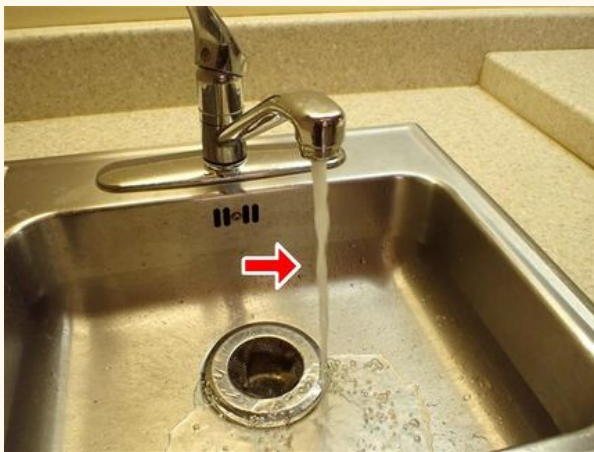
🔧 (PSDFAV-1) Repair: The building is essentially un-occupied and while the lavatories in the building were all still functional with the exception of self flushing devices that required battery replacement, the water in many of the internal kitchen sinks was turned off along with water heaters for those sinks and so functionality could not be tested. Incipient leakage stains and active leakage were noted on drain pipes for some fixtures and if use of any of the "kitchen" plumbing fixtures is desired, the water heaters will need to be turned on and the faucets and drains should be monitored when first used and repair by a qualified plumber may be needed.

Residual Flow in Some Fixtures

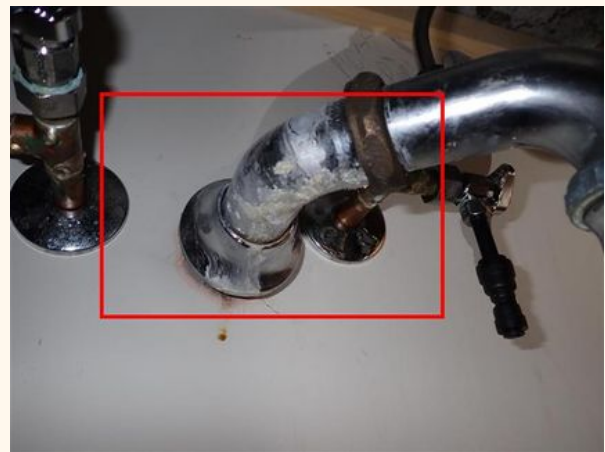
Incipient Leakage Stains on Sink Drain Piping

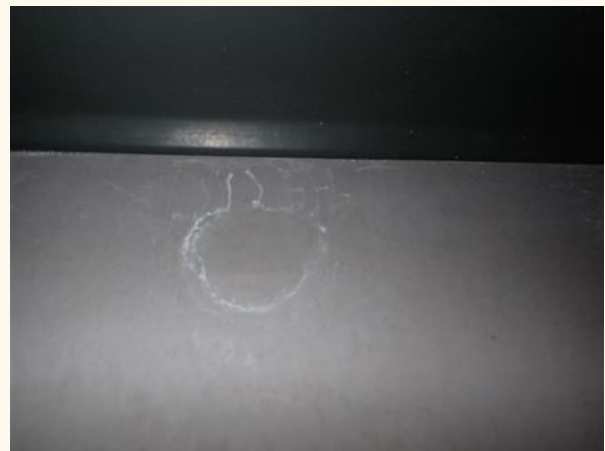
Active Leakage From Abandoned Valve

Moisture and Staining on Floor Below Connection

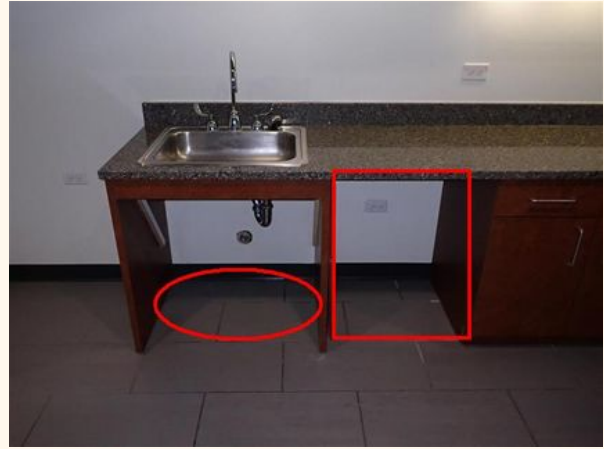
Leakage Noted From Improperly Abandoned Dishwasher Drain

Removed Dishwasher Space and Moisture and Staining Below Sink

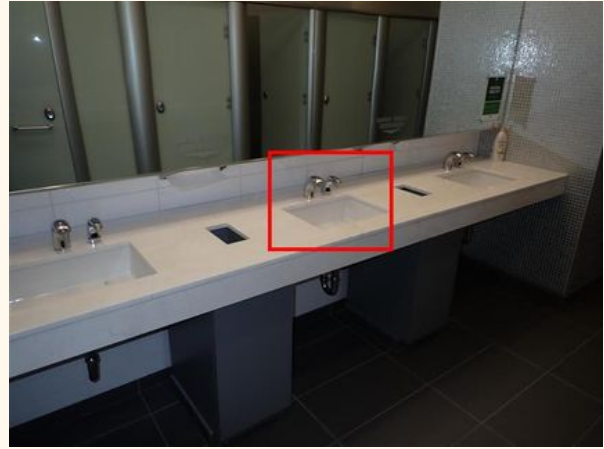
🔧 (PSDFAV-2) Repair: The subject building currently has limited use and while the automatic non-touch fixtures are being maintained, non-responsive fixtures were noted and most likely battery replacements are needed. As a part of occupancy of the building, all plumbing fixtures should be tested and serviced as needed.

*Non-functional Self Flushing Mechanisms
Noted*

Non-responsive Sink in Upper Level Bathroom

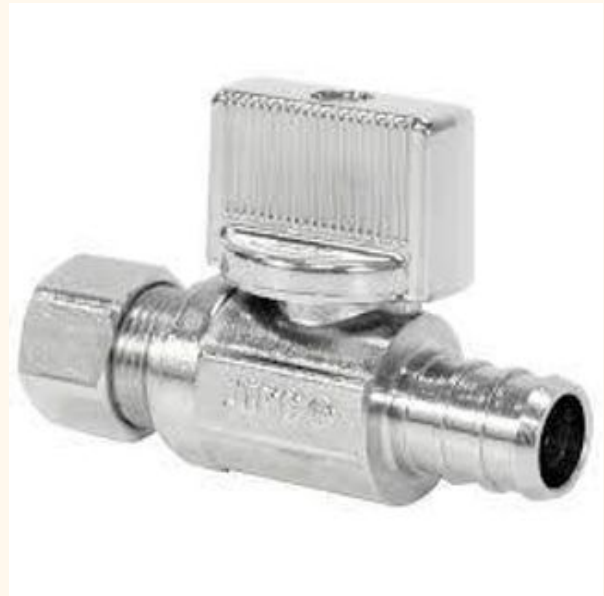
Unreliable Saddle Valve for Filter Water Supply

Quarter Turn Fixture Valve

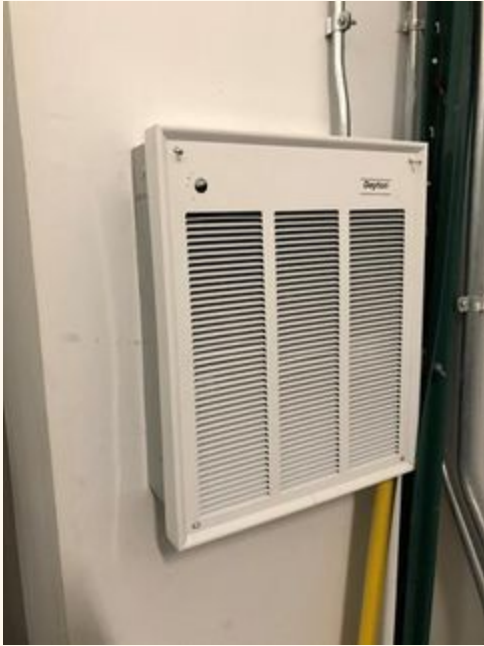
🔧 (HACVAGAS-5) Repair: Loose covers were noted on some of the small electrical door heaters. In order to reduce the potential for injury and damage, it is recommended that the covers be secured.

Loose Covers Noted on Heaters

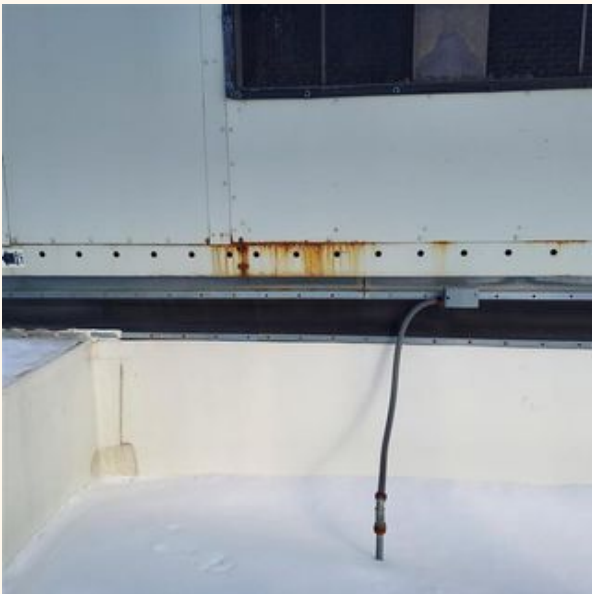
🔧 (HACVAGAS-6) Repair: Rust, corrosion and deterioration was noted on the rooftop evaporative condensing sections on both HVAC systems. This condition is an indication of a leak in the evaporative section. In order to prevent further ongoing deterioration to the unit prior to seasonal start-up, it is strongly recommend that a qualified mechanical contractor be retained for appropriate corrective measures.

Rust and Corrosion on Evaporative Condensing Section (West unit)

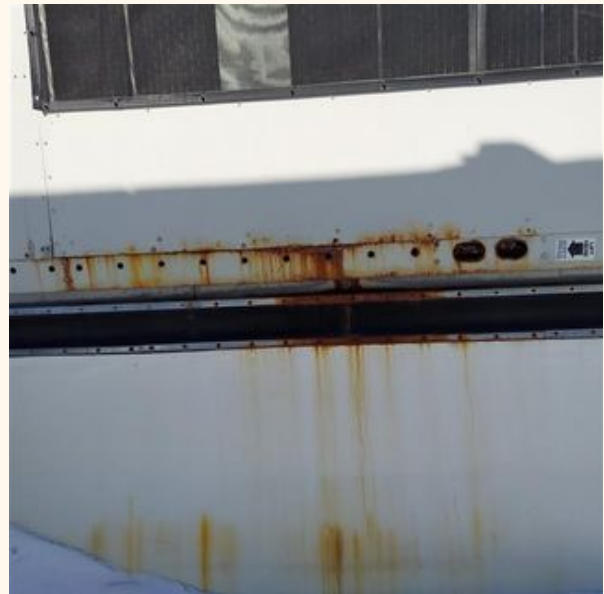
Rust and Corrosion on Evaporative Condensing Section (East unit)

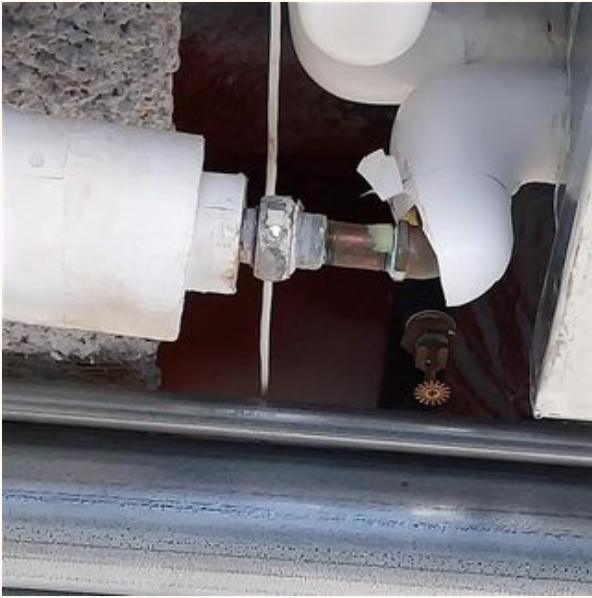
🔧 (HACVAGAS-7) Repair: Area's of missing pipe insulation were noted on the third floor chilled water supply and return piping. In order to reduce the potential for condensation and loss of chilled water temperature, the pipe insulation should be repaired or replaced.

Missing Pipe Insulation.

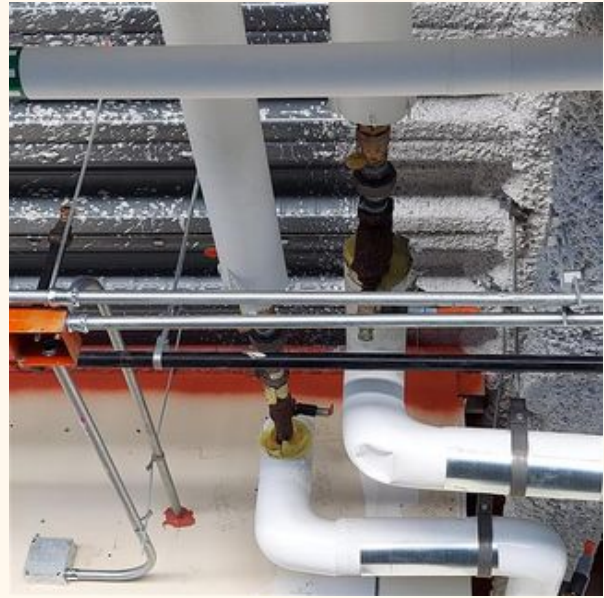
Missing Pipe Insulation.

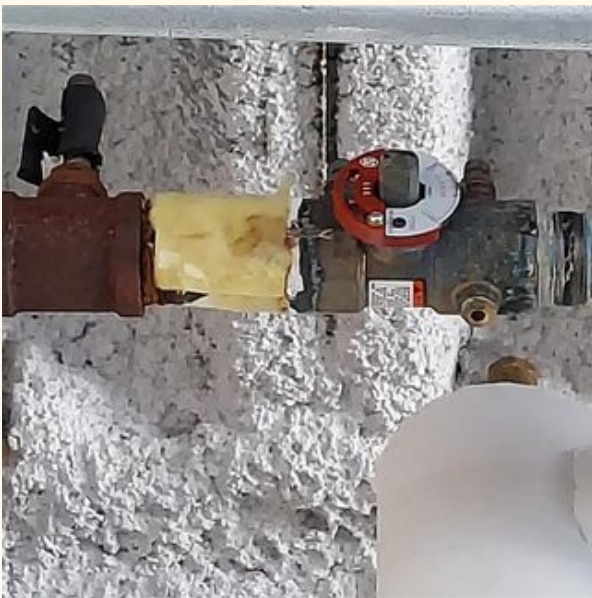
Missing Pipe Insulation.

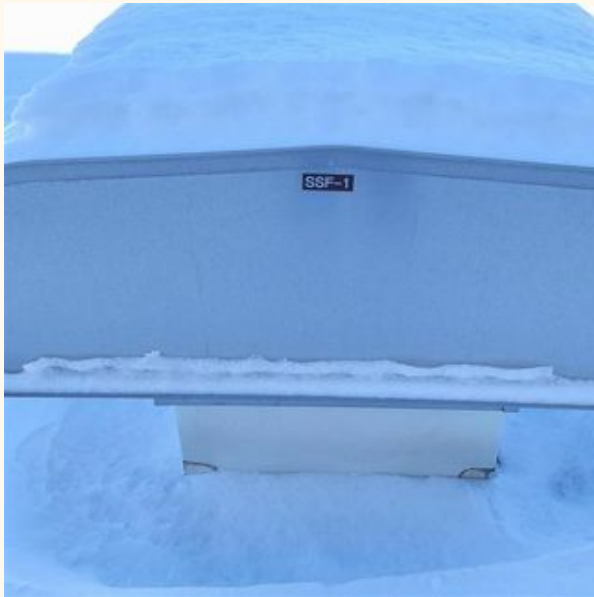
🔧 (HACVAGAS-8) Repair: The two stairwell pressurization fans were not operated at time of inspection, inspection of this equipment is beyond the scope of a commercial building inspection. A qualified specialty contractor services should be engaged to evaluate, operate and insure these critical life safety units perform as intended.

Stairwell Pressurization Fan

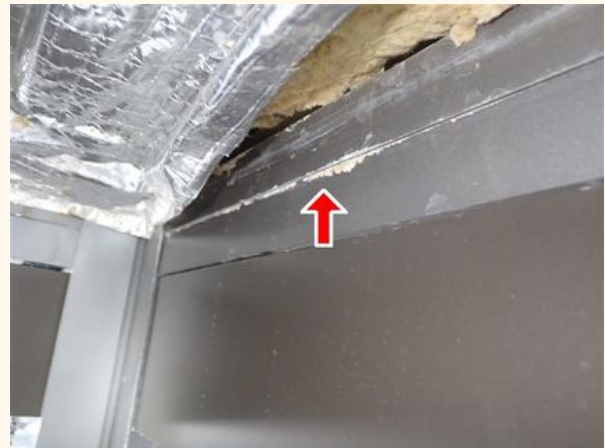
Loose Insulation Above Window

Incipient Leakage Stains Below Insulation

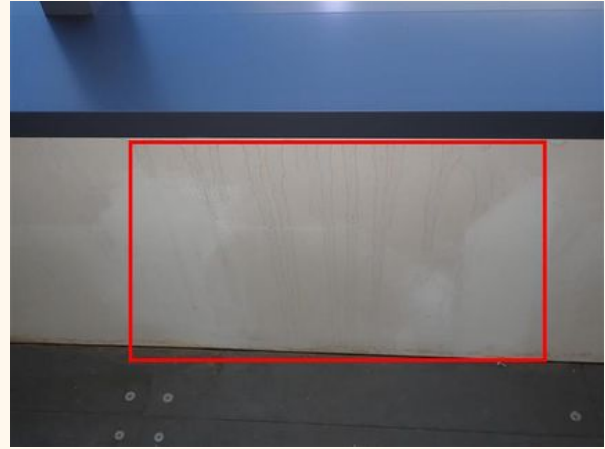
Potential Interior Leakage on Window Dividers

Moisture Stains on Wall Areas Below Windows

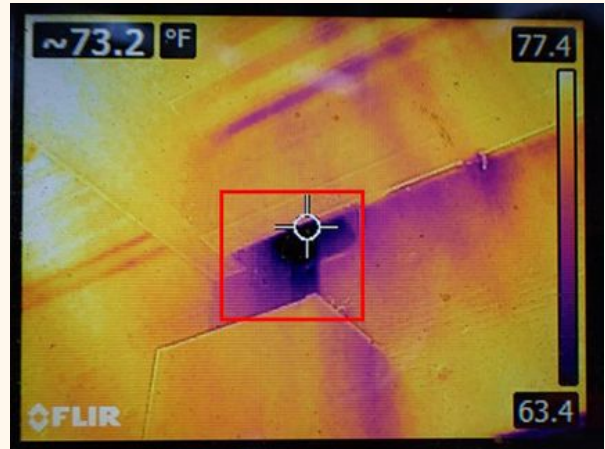
🔍 (IVAE-2) Repair: An infra-red examination of open ceiling areas on the fourth floor revealed a potential lack of insulation around the column to roof connections. In order to reduce the potential for moisture related damage related to condensation, these areas should be evaluated by a qualified insulation specialist in order to see if they can be insulated with closed cell spray foam insulation.

Column to Beam Connection on Fourth Floor

Temperature Differential Noted at Connections

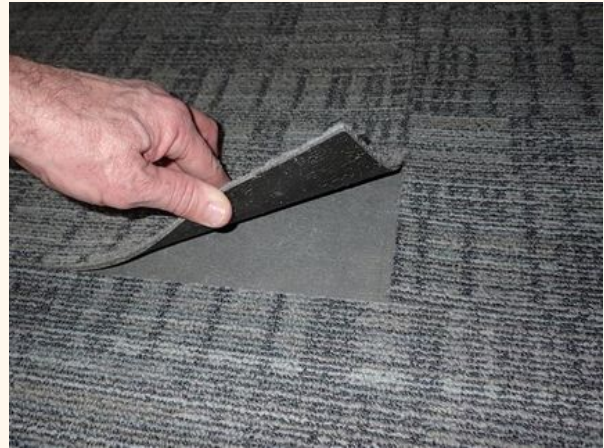
Loose Ceiling Tile Grid Members

Loose Carpet Squares that Present Trip Hazards

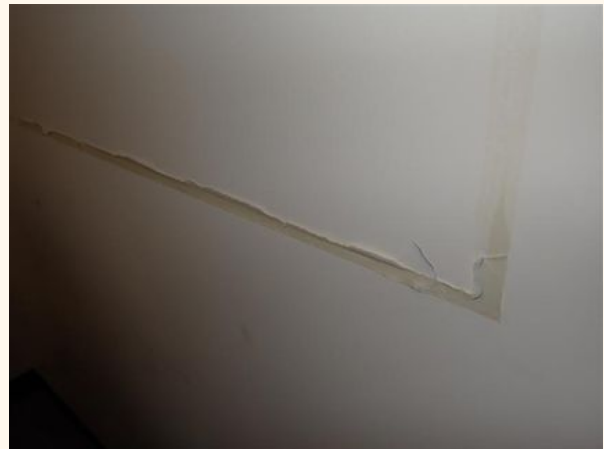
Loose But Intentionally Removable Carpet Squares

Damaged Wall Finishes Noted

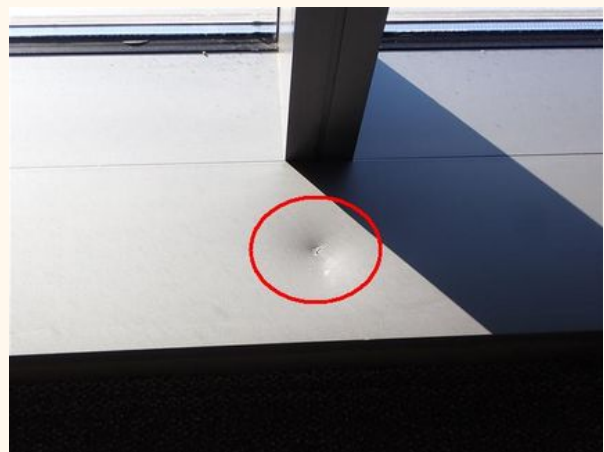
Numerous Wall Mounts Noted

Damaged Interior Metal Fenestrations

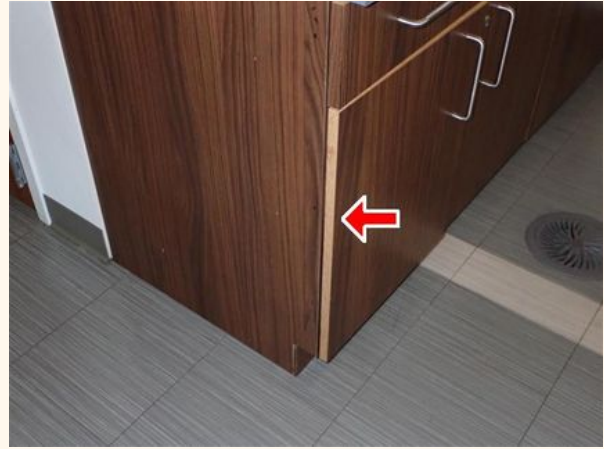
Water Supplies for Coffee Makers, Etc.

Missing Edges on Cabinets

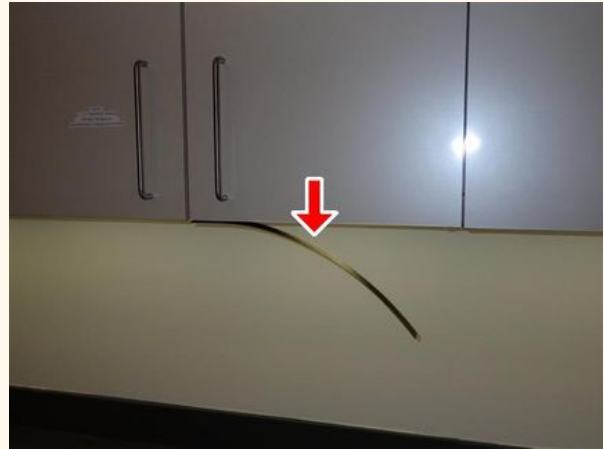
Loose Exit Sign

Delaminating Cabinet Finishes

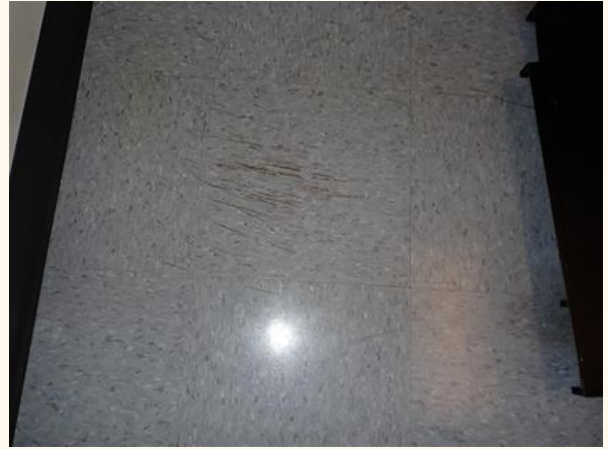
Damaged Wall Finishes

Damaged Floor Finishes

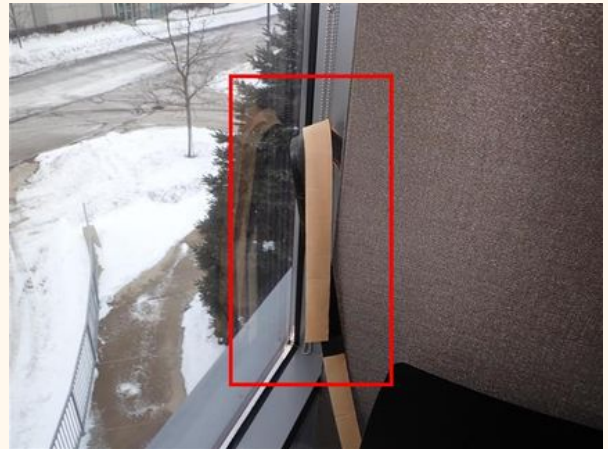
Loose Window Trim

Loose Material on Workspace Enclosure

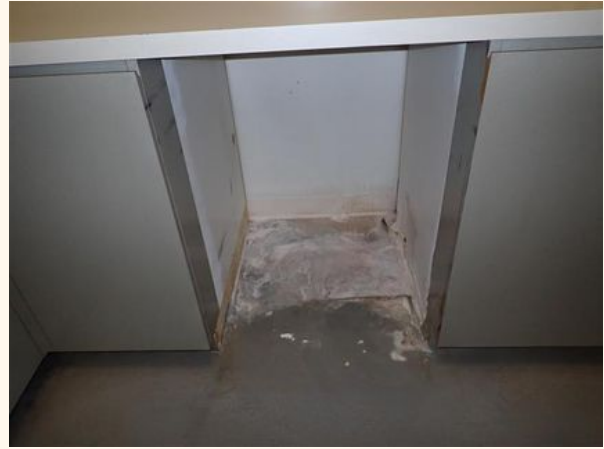
Separated Window Trim

Damaged Finishes Adjacent to Removed Dishwasher

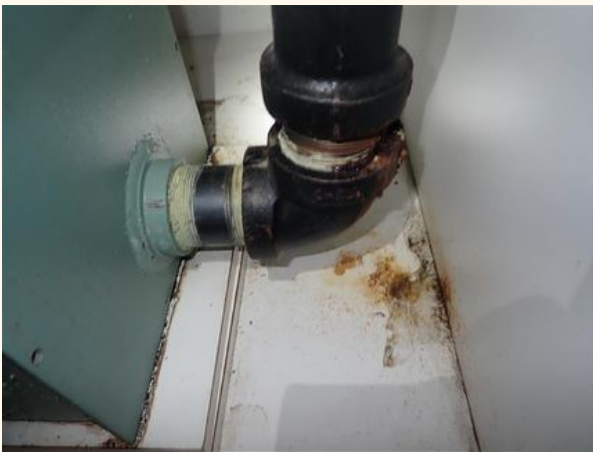
Leaking Grease Trap Below Sink

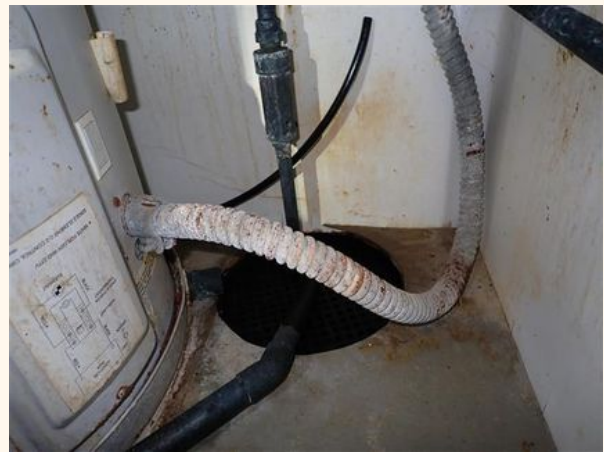
Corrosion and Leakage Stains Around Water Heater in One Kitchen

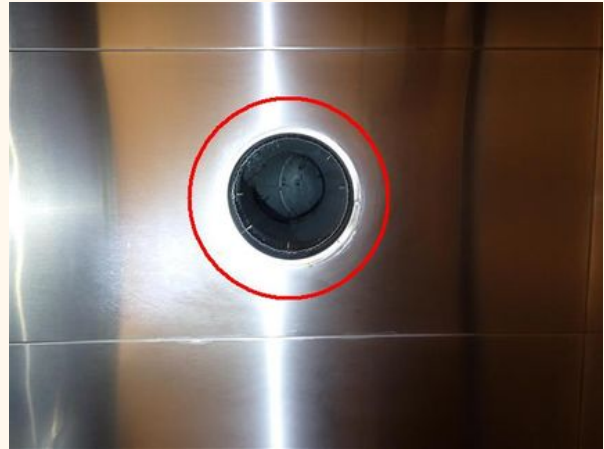
Corrosion Noted on Interior of Fridge

Vent Pipe Open to the Exterior - Cold Air Noted

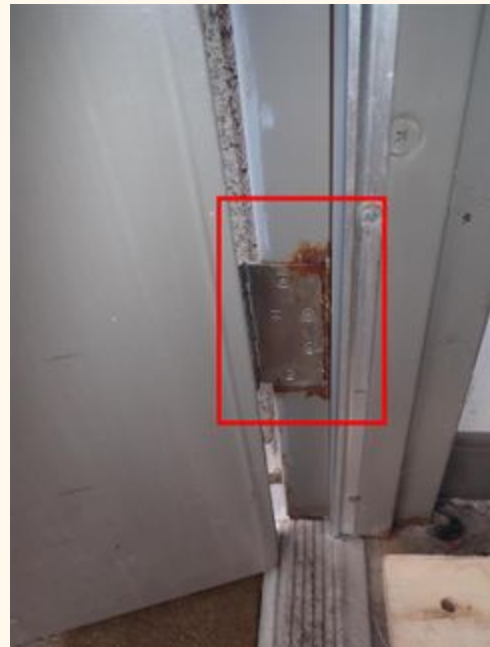
Corrosion and Deterioration Around Door Seals

Corroded Hinges

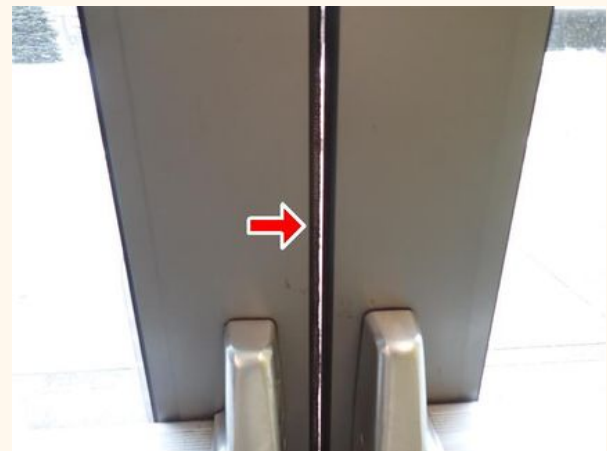
Deteriorated Threshold

Gaps Noted Between Doors

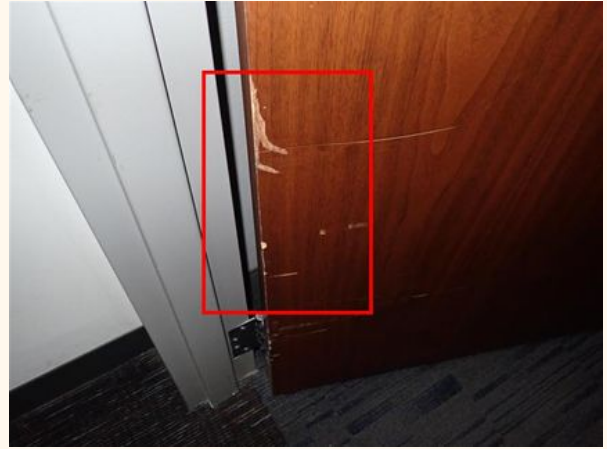
🔧 (WDS-3) Repair: Several of the doors in the structure failed to close or latch properly and some were damaged. If use of any of these doors is desired, for proper operation and appearance, it is recommended that any non-functional or damaged doors be repaired, adjusted or replaced by a qualified carpenter or door installation contractor.

Non-latching Door in Fourth Floor Office

Damaged Doors

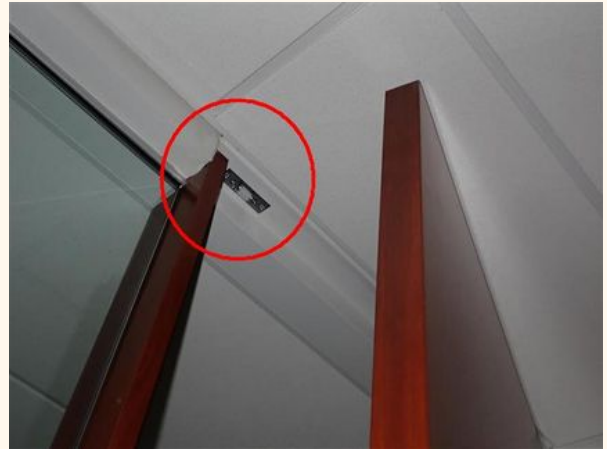
Damaged Door

Several Non-latching Roller Top Doors Noted

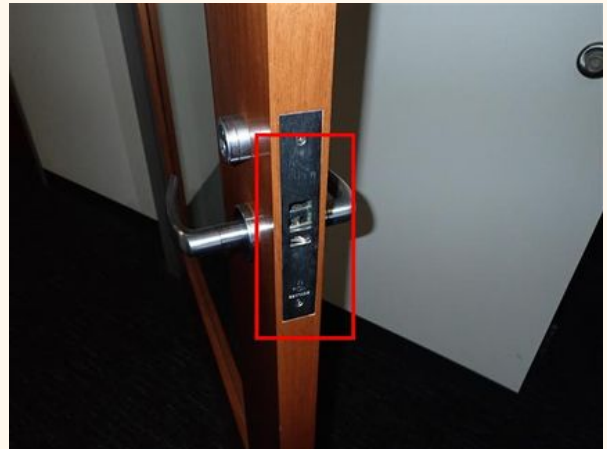
Peeling Veneer on Several Doors Noted

Non-operational Catch on Door

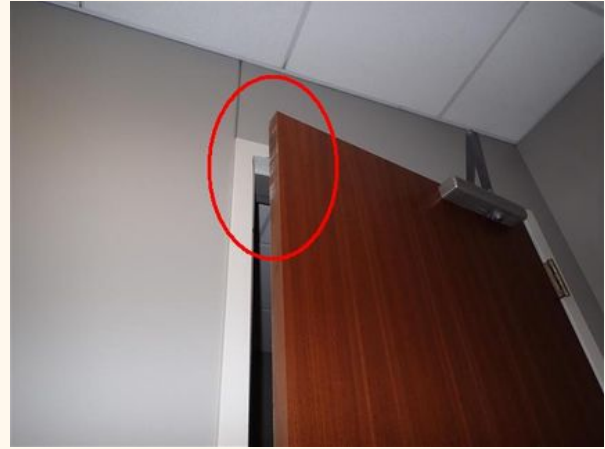
Missing Hardware on Doors

Doors Rubbing on Doorframes

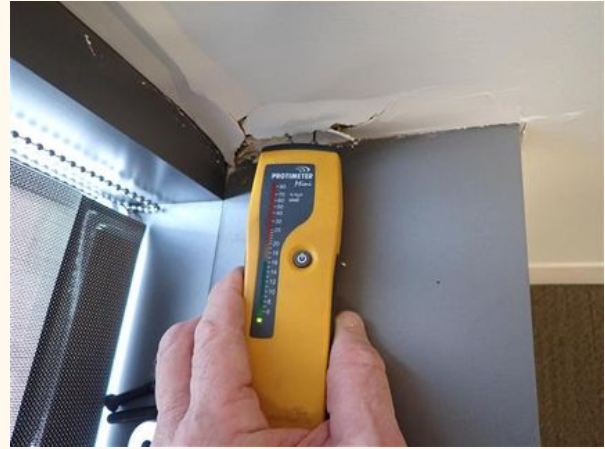
Potential Moisture Related Damage Noted on Numerous Wall Surfaces

No Active Moisture in Badly Damaged Area

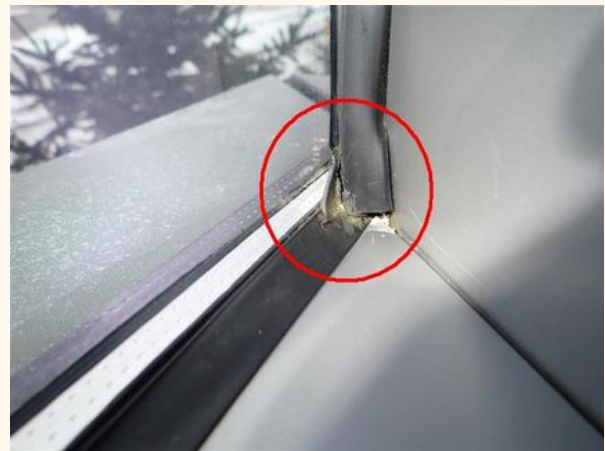
🔧 (WDS-5) Repair: Some irregularities with regards to sealant installation was noted on several windows. No apparent signs of leakage were noted on these windows, however, they should be monitored and if leakage is noted in the future, repair by a qualified curtain-wall contractor is recommended.

Irregular Sealant Installation

Potentially Improper Corner Seal - Staining or Dirt in Corner?

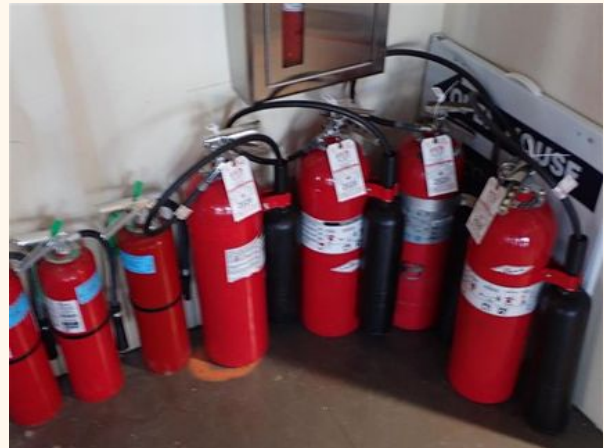
🔧 (O-2) Repair: There were numerous fire extinguishers noted throughout the building. Many of the extinguishers appear to have been regularly maintained, however, some expired extinguishers were noted. All equipment that is part of the sale of the property that is required for use in the structure should be evaluated and serviced as needed for re-certification.

Expired Extinguishers

Loose Extinguishers

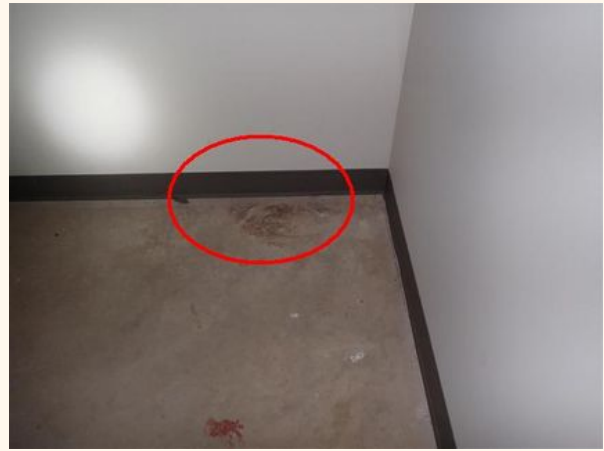
Incipient Leakage Noted on Some Fittings

Staining on Floor Below Leakage Stains
