This report is prepared exclusively for **Any Client**  
Inspected On: **2022-12-06**

This inspection was a Property Condition Assessment of a 15 year old 40 unit condominium building. There have been a number of problems occurring since the building was built and there have been significant expenditures to rectify some of the problems. The building is at a critical juncture as the reserve funds are low and there are still a number of concerning issues to address. This PCA will be used to drive a Reserve Study that will look at upcoming expenditure needs and the need to adjust the monthly assessment to cover the needed upcoming improvements.

# The Scope and Purpose of a Property Condition Assessment

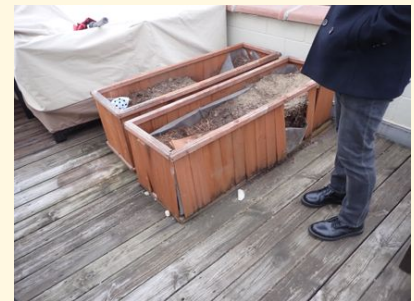
*Carpeting Trapping Moisture and Damaging Deck*

🔧 **EWGCE-1 EXTERIOR WALLS< GROUNDS, CHIMNEYS. ETC:** The existing wooden roof deck is weathered and deteriorating. In many cases there are rugs or other objects on the roof that are trapping moisture against the deck and deteriorating the existing deck boards. There are also planters that are deteriorating and the dirt from the planters is spilling onto the deck boards and getting into the roof deck and drainage piping. **Since the deck needs to be removed to replace the roof, it is vitally important that the deck and roof membrane be on the same replacement cycle.** In order to extend the service life of the deck materials, all materials that trap moisture should be removed from the deck and be banned from future use. If planters are desired, they should be appropriately designed and installed in a manner that does not affect deck surfaces, like wall mounted planters. Once the deck is clear the exterior wooden deck surfaces should be professionally cleaned and sealed against weather. Any deteriorated boards should be replaced prior to the sealing.

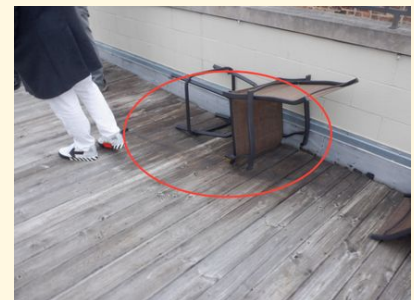
*Sagging and Unstable Deck Area*

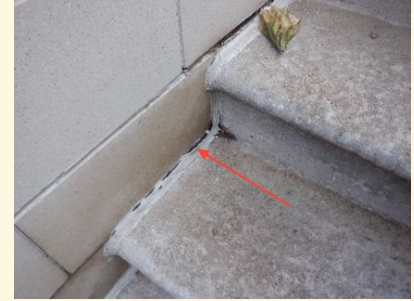
*Cracked and Deteriorated Caulk on Edges of Stairs*

🔧 **EWGCE-2 EXTERIOR WALLS< GROUNDS, CHIMNEYS. ETC:** The existing caulking around the perimeter of the structure is missing, cracked and sloppy and/or improper. Exterior sealant performance is **directly related to the joint preparation and application.** For increased service life, performance and aesthetics, the exterior of the structure should be carefully examined and old deteriorated and/or improper caulking should be removed and the exterior of the structure caulked via appropriate means and materials. Proper joint preparation and the use of compliant exterior rated sealants of good quality is recommended .

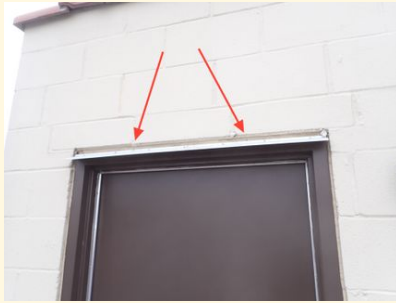
*Sealed Lintels*

**🔧 (EWGCE-4) Repair:** Some of the exterior window lintels have been sealed and can no longer drain moisture which increases the potential for corrosion of the lintels. Over time the corroding steel will expand which can damage the adjacent masonry walls and allow moisture to penetrate to the interior of the living space. In some cases inappropriate or improper weep ropes have been installed, if these are to be utilized they should be proper weep tubes that extend back into the wall cavity. In order to reduce the potential for moisture related damage, the lintel drainage space should be repaired by a qualified masonry restoration contractor.

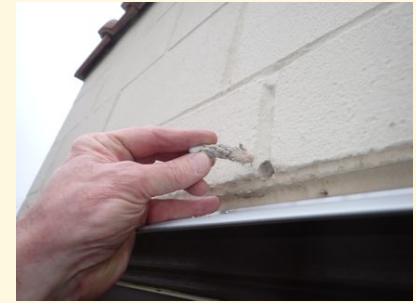
*Loose and Improper Weep Ropes*

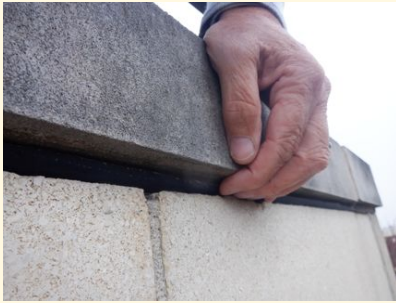
*Thin Membrane Flashing and Open Gaps on Edges of Caps*

**🔧 (EWGCE-5) Repair:** The stone capping above the parapet walls and its ancillary flashing are improperly configured and present a significant risk for moisture penetration, moisture saturation and damage to the adjacent brick masonry. It appears that the capstones have been removed and replaced, with flashing, however, the workmanship and materials varies on portions of the roof. In some cases proper stainless steel drip edge has been utilized, however in other areas, poor quality thin membrane was used and there is no drip edge and there is deteriorated mortar and openings below the cap that can allow the entry of moisture. Ideally, parapet wall capstones should be sloped inward toward the roof surface so that runoff is properly channeled to the roof drains and should have sufficient overhang and drip grooves so that the amount of moisture running onto the exterior masonry walls is limited. Stainless steel drip edge and thick elastomeric flashing are vastly superior to the thin vinyl flashing that is typically used. It is recommended that the existing stone capping without the drip edges be removed; stainless steel drip edge be set into a thick bed of high-quality caulking along both the inner and outer top masonry courses; that heavy, self-adhesive, elastomeric flashing be installed as a waterproof bridge across the entire depth of the masonry wall; that the existing stone capping or new stone capping be set into place and secured with stainless steel pins; and that properly configured caulked joints be used at the butt joints of the stone capping slabs.

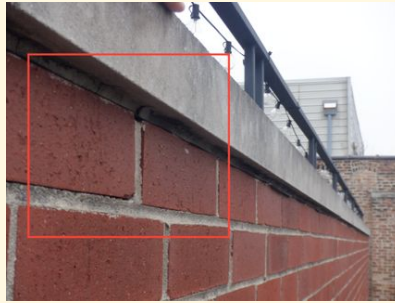
*Cracked Mortar Joints Below Cap*

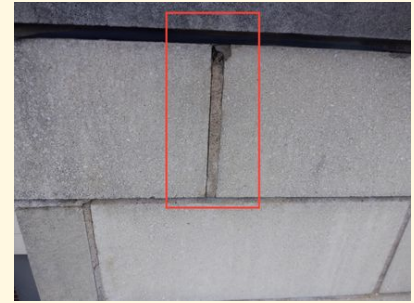
*Cracks in Joints Below Cap*

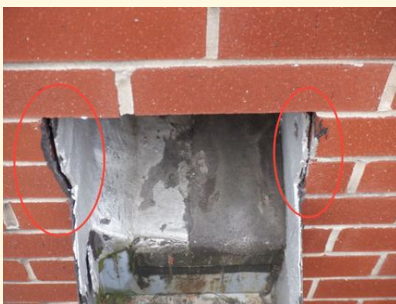
*Open Gaps Between Scuppers and Masonry Openings*

**🔧 (EWGCE-6) Repair:** The through-wall drainage scupper details are improperly configured and are prone to allowing moisture penetration and damage to take place. The installations conform with neither the National Roofing Contractors Association (NRCA) standards nor those of the Sheet-Metal and Air-Conditioning Contractors National Association (SMACNA). In order to reduce the risk for moisture penetration, saturation and freeze/thaw damage, it is strongly recommended that the through-wall scupper openings be repaired by a qualified sheet-metal contractor. Also, debris was found in several of the scuppers that could reduce or block flow. In order to reduce the potential for moisture related damage It is recommended that debris screens be added to the scuppers and they be checked and cleaned regularly

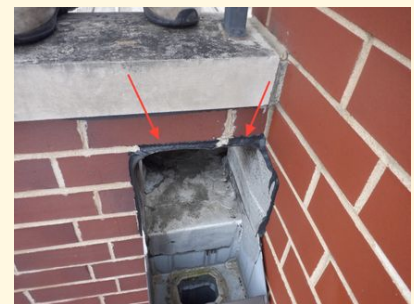
*Caulked Edges Prone to Failure*

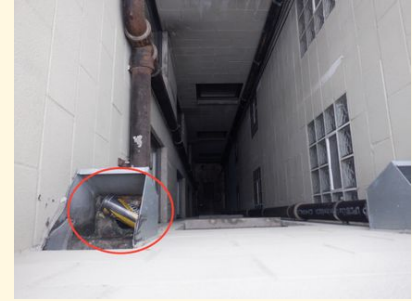
*Debris Noted in Scupper*

Also, debris was found in several of the scuppers that could reduce or block flow. In order to reduce the potential for moisture related damage it is recommended that debris screens be added to the scuppers and they be checked and cleaned regularly

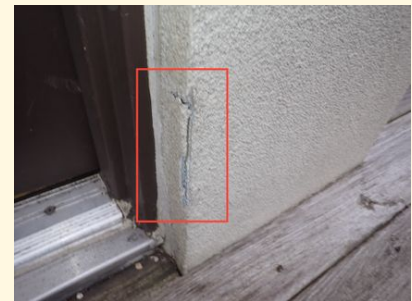
*Damaged EIFS*

**🔧 (EWGCE-7) Repair:** This structure has an exterior cladding of EIFS (Exterior Insulation and Finishing Systems) and cracks were observed in the exterior walls. This wall cladding system may allow unseen moisture penetration, rot and damage to occur and progress to critical levels before being noticed. No representation is made in this report regarding the suitability or performance of this product. Obvious defects will be noted but a final determination on the existing condition of the EIFS system should be made by a licensed and competent contractor specializing in the review and repair of these systems.

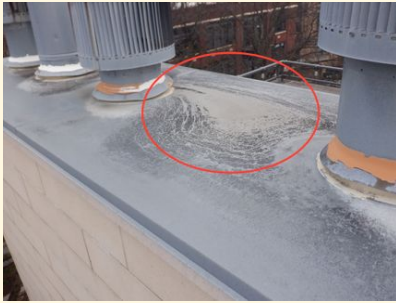
*Water Ponding on Caps*

**🔧 (EWGCE-8) Repair:** The galvanized steel chimney crowns/caps are not properly configured to shed moisture, as a result, the sheet metal crowns are at risk for allowing moisture into the chimney chase and to premature corrosion and failure of the cap. It is strongly recommended that the sheet metal crown be replaced by a qualified sheet-metal specialty contractor.

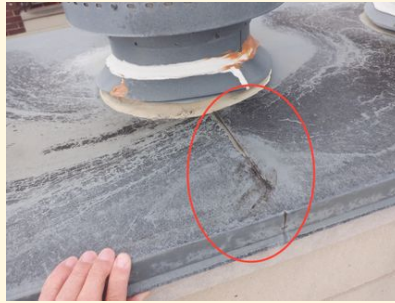
*Open Seam Joints Prone to Leakage*

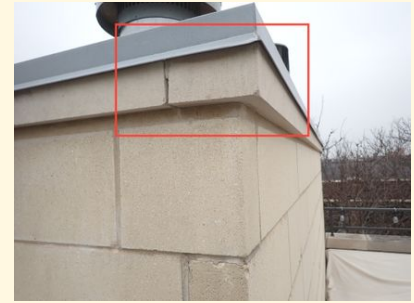
*Cracked and Damaged Masonry Below Metal Caps*

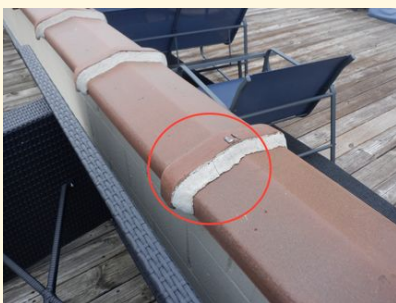
*Cracked and Open Joints on Clay Tile Cap*

**🔧 (EWGCE-9) Repair:** The butt joints between the individual sections of clay tile coping have been sealed with cement mortar. The mortar is cracking and the joints are open which creates a risk for moisture saturation/damage to the masonry walls below. The coping tiles serve to protect the underlying brick masonry walls from wetting/drying and freezing/thawing damage and should be neatly joined and properly sealed in order to perform this function. In order to reduce the potential for moisture related damage, the coping tiles should be repaired or replaced as needed by a qualified masonry or roofing contractor. Ideally it is recommended that the individual clay tiles be removed and reinstalled using backer rod and polyurethane caulk to seal the joints, however, this may be cost prohibitive at this point and it may be possible to smear the cap joints with tar until such time when they can be properly sealed or replaced with a neatly cut and properly sealed kyner coping cap.

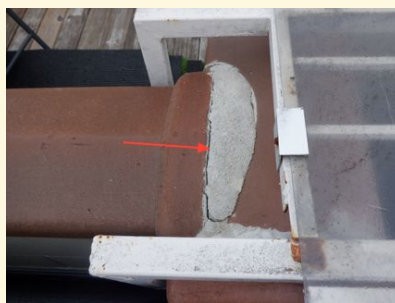
*Close-up of Large Cracks in Clay Tile Joints*

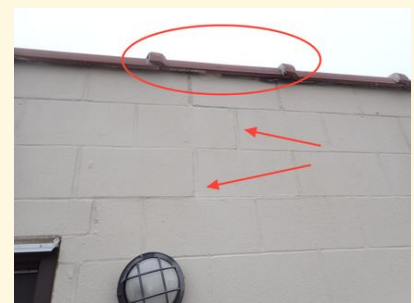
*Cracks in Masonry Below Cracked and Open Cap Joints*

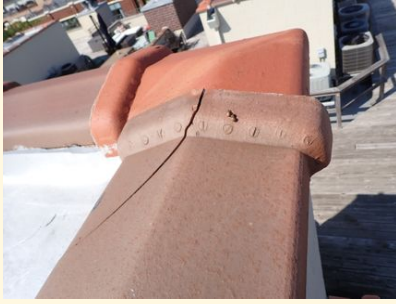
*Damaged Clay Tile Cap*

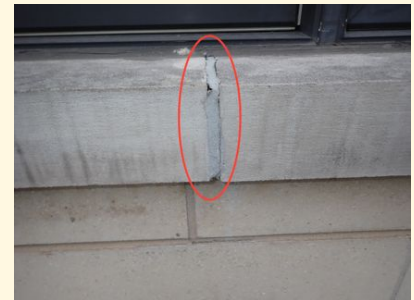
*Gaps and Openings in Caulk Smear*

**EWGCE-10 EXTERIOR WALLS< GROUNDS, CHIMNEYS. ETC:** Caulk appears to have been smeared over the joints between the stone copings and/or sills and cracks were noted on the sides of the caulked joints. All of the exterior caulk joints should be configured and applied according to appropriate standards. A thin smear of caulk over a brittle substrate such as cement mortar, does not constitute an appropriate caulk or sealant joint. In order to reduce the risk for moisture penetration, drafts and energy losses, it is recommended that all of the exterior caulking on the building be evaluated and repaired or replaced as needed by a qualified handyman or masonry restoration contractor.

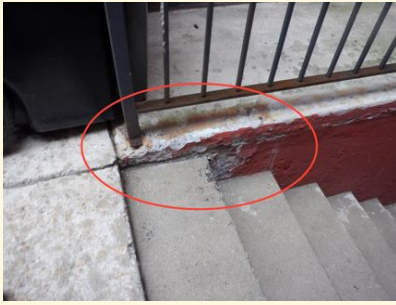
*Deteriorated Concrete on Wall*

**🔧 (EWGCE-11) Repair:** Spalling and deteriorated concrete were observed on the sides of several of the retaining walls which can allow moisture to enter the wall resulting in further corrosion of the reinforcing steel which can deteriorate the wall further. In order to reduce the potential for moisture related damage It is recommended that a qualified concrete repair contractor evaluate and

repair the wall as needed.

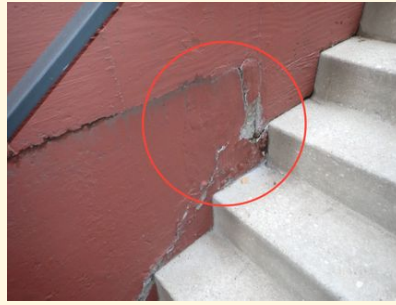
*Deteriorated Concrete on Retaining Wall*

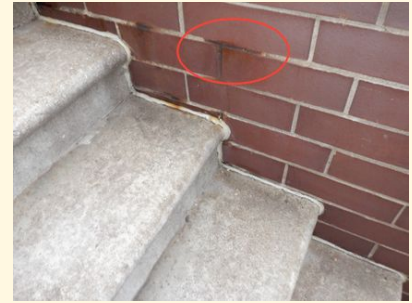
Corrosion was noted in mid wall areas in at least one of the front stairway walls. Based on the thickness of the walls and presence of brick on both faces, the walls do not appear to have a concrete core so the source of the corrosion is most likely an improper tie used on the masonry Courses. In order to reduce the potential for further corrosion, it may be necessary to remove the affected bricks and restore the affected areas.

*Corrosion on Stairwell Walls*

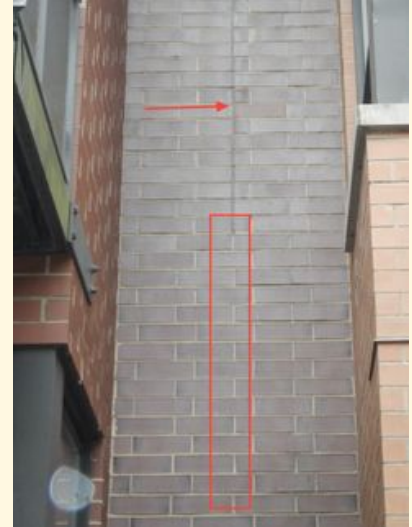
The movement joints on the long walls of this structure are incomplete. In order to reduce the risk for random cracking from the motion inherent in masonry walls that are 40' or longer, movement joints are recommended by masonry industry associations. These joints can be retro-fitted by a qualified masonry contractor and in order to determine if this building would benefit from the installation of movement joints, further review of the exterior masonry walls is recommended.

*Movement Joint (Arrow) and Incomplete Joint*

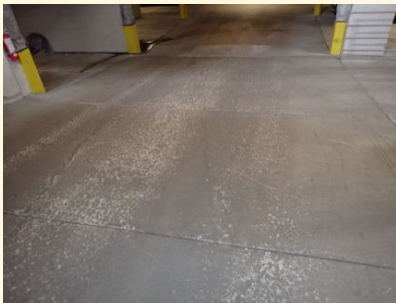
*Spalled Driveway Surface*

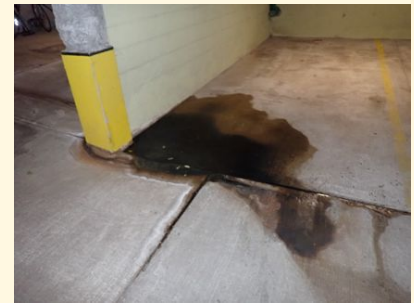
*Standing Water in Garage*

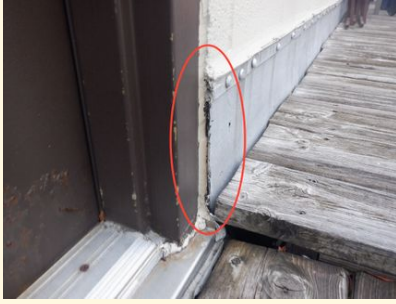
*Missing Termination Bar Flashing*

**🔧 (RCFRD-1) Repair:** Termination bar flashing should be installed at all areas where the modified bitumen roof covering is terminated. Failure to install the appropriate flashing at these areas can result in delamination, breaching, moisture intrusion and extensive damage. Evaluation and repair of the roof covering by a licensed and competent roofing contractor is recommended.

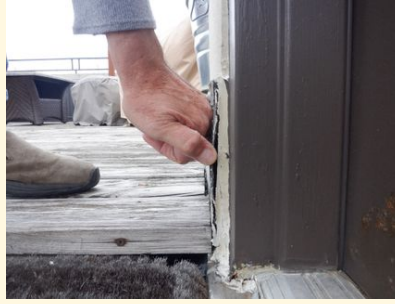
*Unsealed Edges on Vertical Roof Edges*

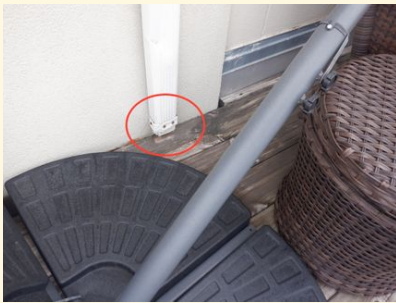
*Downspout Discharging onto Roof Deck*

**⚠️ (RCRFRD-2) Repair:** Many of the downspouts on the roof discharge onto the roof deck. While the deck does have exterior exposure, the concentrated runoff from the downspouts may accelerate deck board deterioration and should most likely discharge directly onto the roof membrane and repair by a qualified gutter installation contractor is recommended.

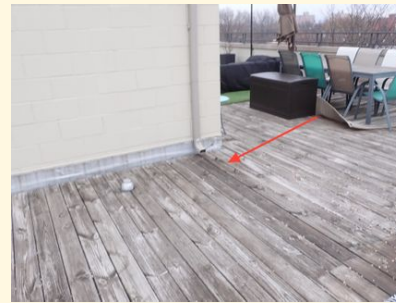
*Damaged Noted by Downspout Discharge*

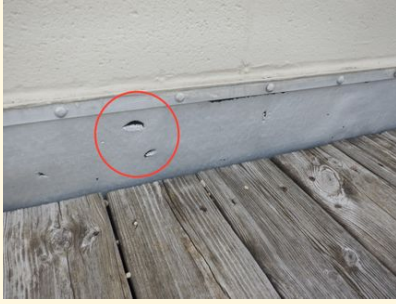
*Damaged Roofing*

**⚠️ (RCRFRD-3) Repair:** Exposed areas of roof membrane are being damaged by furniture or other objects and the gashes may allow for the entry of moisture. Any areas that are open should be repaired by a qualified roofing contractor and in order to reduce the potential for future moisture related damage, protective material should be installed wherever exposed roofing is adjacent to deck areas

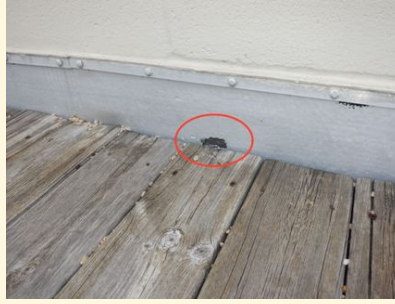
*Damaged Roofing*

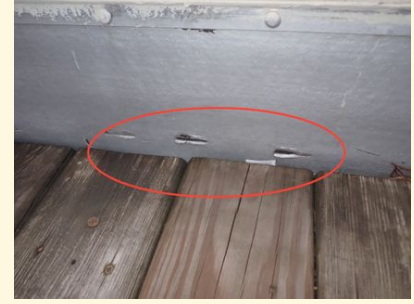
*Damaged Roofing*

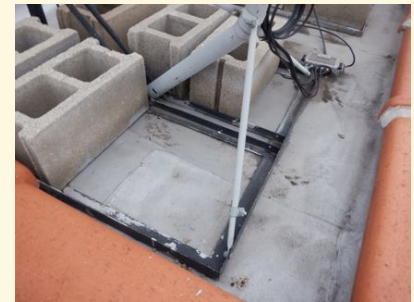
There are several satellite dishes on various roofs on the structure. The metal frame that the satellite dish is anchored to is weighted with concrete block and has sharp corners that can cut into and damage the roof surface which creates the potential for moisture intrusion. In order to reduce the potential for damaging moisture to enter the structure, it is recommended that protective pads be placed beneath the satellite dish framework.

*Metal Frames on Roofs*

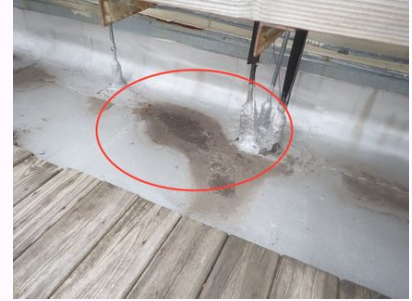
Ponded areas were noted on the low slope roof. Ponding accelerates the rate of roof wear/deterioration and increases the risk for leaking. When a new roof covering is installed, plans should be made to re-pitch the roof using tapered roof insulation.

*Ponding Areas on Roof*

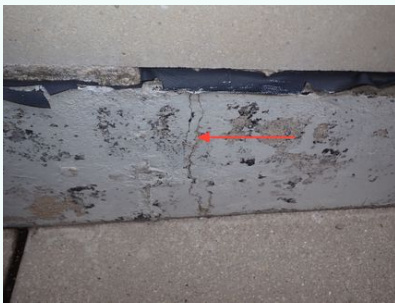
👁️ **(SAF-1) Monitor:** At least one foundation wall crack was noted on the east side on the exterior of the foundation and there was cracking in the masonry adjacent to the crack. It's possible that there was some minor settlement along this wall and the cracks in the masonry should be monitored to see if they are getting wider. Widening cracks would be a sign of continuing foundation settlement and if additional movement is noted the foundation should be evaluate and repaired by a qualified foundation repair contractor.

*Foundation Crack*

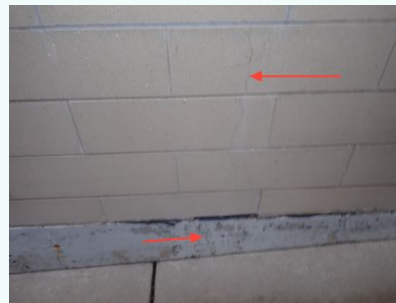
*Cracking in Masonry by Crack*

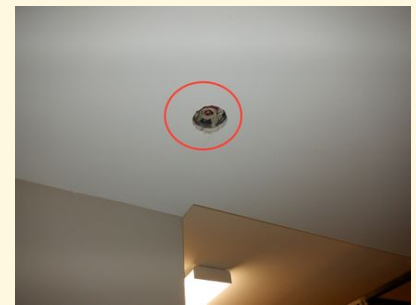
Exposed wires were observed in at least one location in the structure. In order to reduce the risk for electrical shock from inadvertent contact with exposed current carrying equipment and in order to contain molten copper created by high temperature arcing and sparking of energized wiring, it is recommended that all electrical connections be concealed inside covered metal junction boxes by a qualified electrician.

*Open Junction Box in Basement Ceiling*

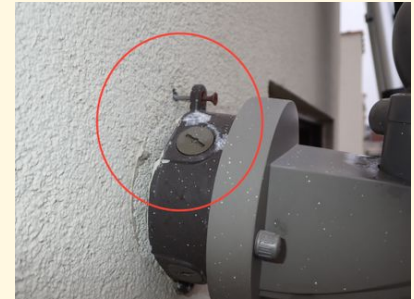
At least one of the exterior light fixtures are loose. Loose electrical fixtures can result in arcing/sparking during use and present an increased risk of fire. Any loose electrical fixture on the structure should be evaluated and repaired as needed by a licensed electrician.

*Loose Light on Rooftop Deck*

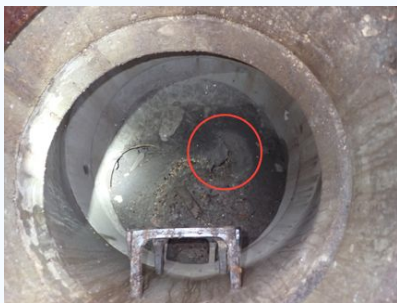
*Drainage Location in Manhole*

🔍 (PSDFAV-1) **Due Diligence: A video camera sewer scope is recommended.** An evaluation of the sewer line below the ground was attempted at two locations in the parking garage. One was near the NW corner of the garage and the other was by parking space G41. The pipe near the NW corner went underwater at about 12 feet and the camera was pushed to 40 feet before it wouldn't go further and was under water continuously. The pipe near space G41 hit an obstruction at about 9 feet and the camera could not be pushed further. Both pipes were full of sludge which made televising more challenging and blockage may be responsible for the back-up in the one pipe. It should be noted that there are numerous rooftop planters and significant quantities of debris were noted beneath the rooftop deck and much of the debris and dirt could be flowing into the sewers via the rooftop drainage scuppers and has the potential to be the source of the blockage. There are two sanitary manholes on the north side of the structure, one had a significant quantity of sludge that should most likely be removed. The other was full of debris, however, it was clear that drainage was occurring in the bottom of the structure. Also, it appears that leakage has been occurring by one of the clean-out covers in the garage. In order to provide proper sanitary drainage for the structure and to ensure the condition of the drainage pipes, the manholes should be cleaned out by a qualified sewer cleaning company. Also, any accessible sanitary/drain pipes should be flushed and televised by a qualified sewer cleaning company.

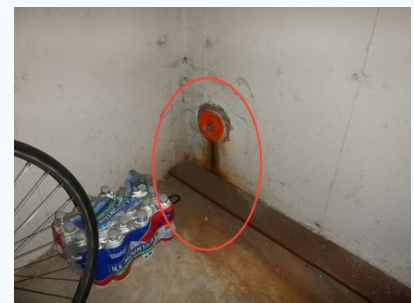
*Potential Leakage at Televising Location*

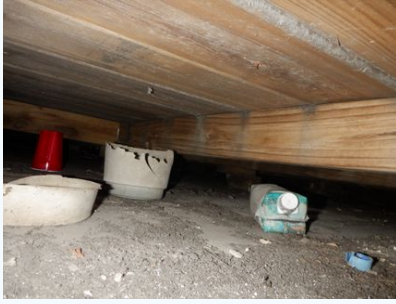
*Dirt and Debris Noted Beneath Rooftop Decks*

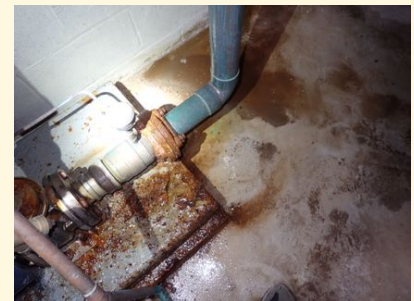
*Excessive Condensation in Mechanical Room*

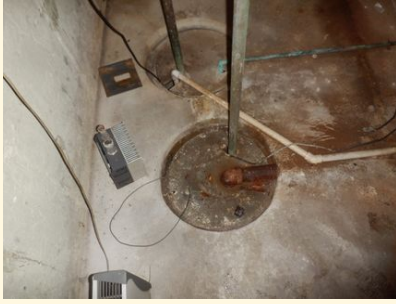
*Unsealed Sump Pits*

**FINAL NOTE:** One of the sump pumps was unplugged and obviously not operational at the time of the inspection. It is unknown if there is insufficient flow to require a sump pump or if the pump is broken. For proper removal of excess water from the foundation, the need for two pumps should be evaluated and adjusted if needed.

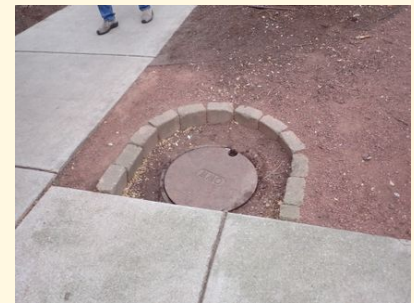
The lid for the watermain shut-off for the building is well below grade and adjacent to a walk which creates a possible trip hazard. In order to reduce the potential for injury, it is recommended that a qualified underground contractor or plumber adjust the lid to grade and that the surrounding area be backfilled and the grade is level.

*Below Grade Shut-off*

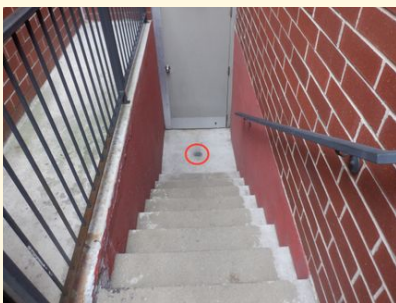
*Small Drain in Open Stairwell*

**🔧 (PSDFAV-7) Repair:** There are small drains adjacent to the lower level exterior entry doors that are easily clogged or overwhelmed by heavy rains. In order to reduce the potential for moisture related damage, it is recommended that a qualified plumber or concrete repair contractor install a larger drainage grate in the walk areas.

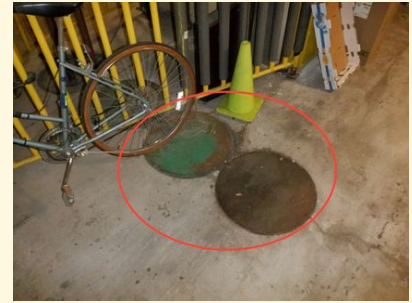
The lids for the triple basin drainage structures in the garage have lightweight metal lids that do not appear to be rated for vehicular traffic and the lids are near one of the parking spaces in the garage. In order to reduce the potential for damage to a vehicle, It is recommended that a qualified plumber or underground contractor install heavy duty manhole castings with appropriate traffic rated lids on the triple basins.

*Lightweight Lids on Triple Basins*

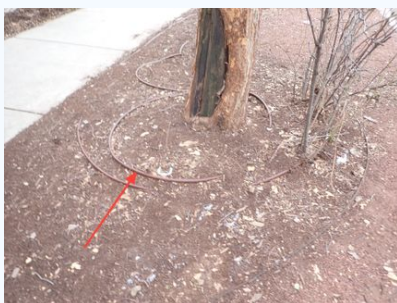
*Exposed Irrigation Components*

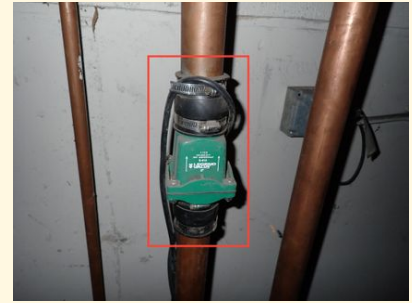
There were several plumbing connections in the home that utilized non-reinforced mission style couplings. In order to reduce the potential for moisture related damage, It is recommended that a qualified plumber install non-shear reinforced mission style couplings at all splice locations.

*Non-reinforced Coupling on Sump Discharge in Garage*

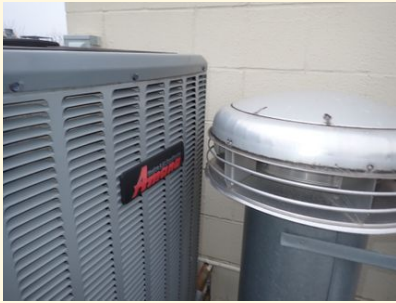
*Vent Pipe Discharging Next to A/C condensers*

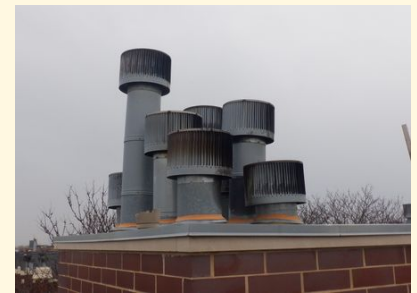
There are several clusters of fireplace vents on the roof, however, many are directly adjacent to other vents and have the potential to backdraft into other units. In order to reduce the potential for noxious gases to enter units from the fireplaces, it is recommended that the vents be re-configured so they are not adjacent to another vent.

*Inadequate Spacing of Fireplace Vents*

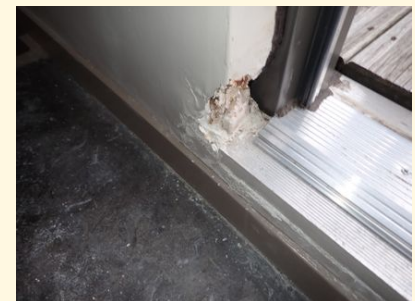
Moisture related damage was observed on the drywall adjacent to many of the rooftop entry doors. The rooftop access doors are exposed to extreme weather conditions that have resulted in deterioration of the door and door seals which can result in potential leakage to the interior. The doors also appear to be leaking by the thresholds and some flashing and other devices have been added as stop-gap measures. In order to reduce the potential for moisture related damage and prolong the life of the door materials, it is recommended that a qualified carpenter or handyman install high quality well sealing storm doors on the exterior of the rooftop access door openings.

*Damaged Wall Areas by Rooftop Access Doors*

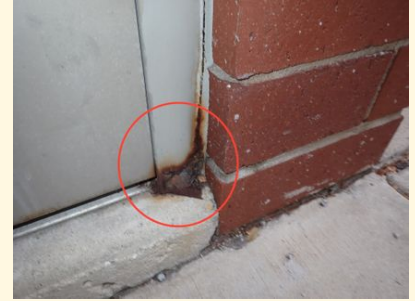
**NOTE:** The cracked and open caulk joints by many of the doors exacerbates runoff entering the joints and deteriorating the metal and the caulk joints should be replaced as noted elsewhere in this report.

*Corrosion on Metal Entry Doors*

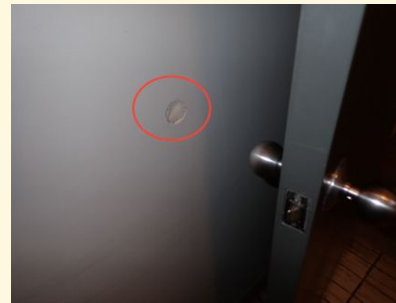
*Damaged Walls by Doors*

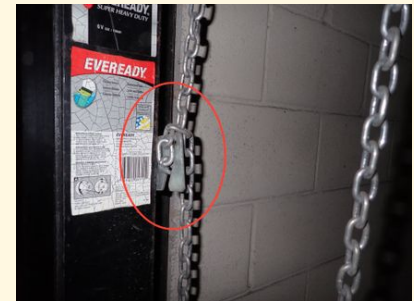
*Door in Fixed Position*

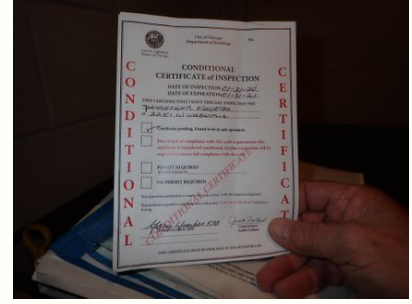
It was noted that the elevator inspection certificate does not have a date within the 12 month inspection period from the current date. The City typically requires that elevators be inspected annually and it is recommended that the potential need for the inspection be raised with the condominium association.

*Expired Elevator Certificate*
