This report is prepared exclusively for **Small Commercial Property**
Inspected On: **2022-11-07**

Company Information

Domicile Consulting LLC
847.732.2503

Inspected By:

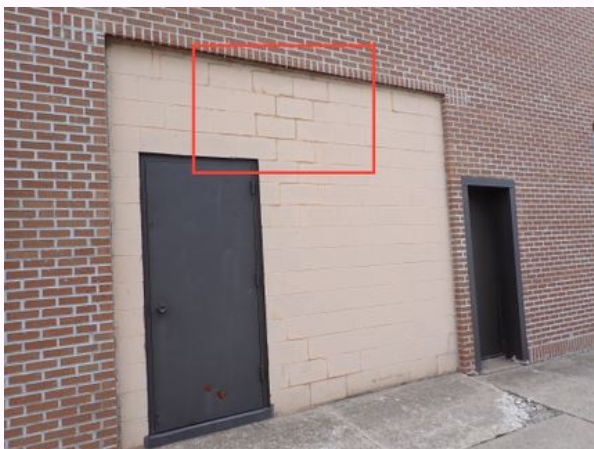
Cracks in Block Wall Areas

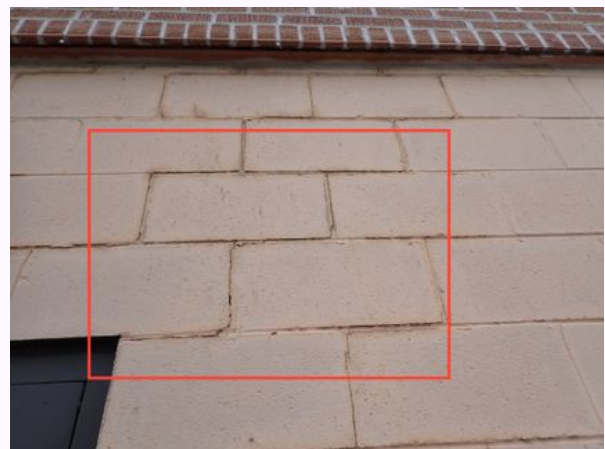
Significant Cracking by Garage Door Lintel

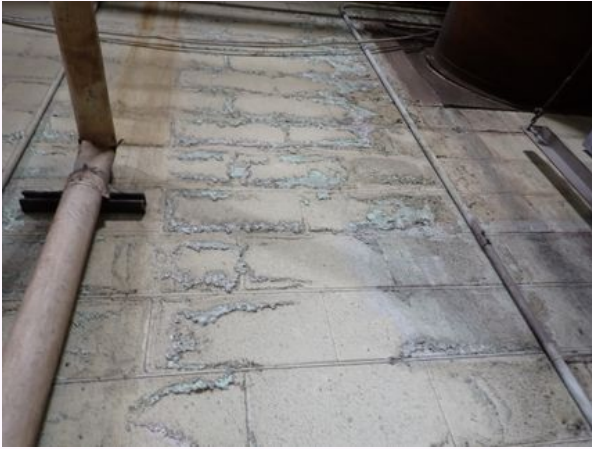
Efflorescence on Interior of Building

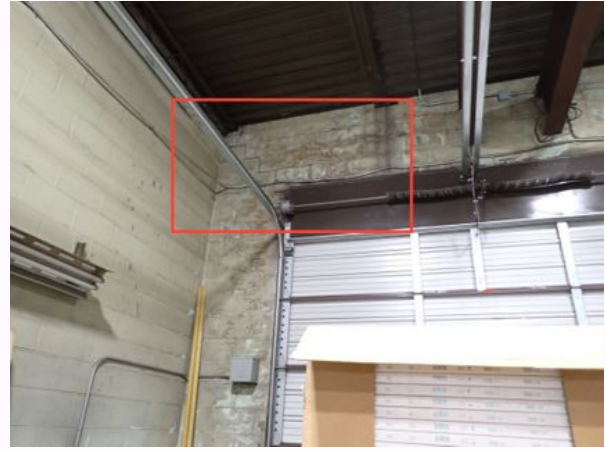
Significant Cracking and Efflorescence Near Garage Door

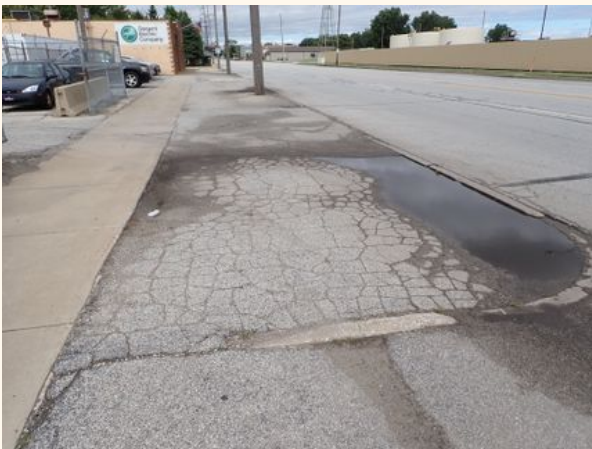
🔧 (EWGCE-2) Repair: The asphalt driveway and parkway is cracked and deteriorated and the open joints exacerbate further deterioration from moisture either saturating and softening the base or from freeze/thaw action in winter. In order to prolong the life of the driveway the severely deteriorated portions should be removed and patched and the entire driveway should then be seal coated. Evaluation and repair by a qualified asphalt contractor is recommended.

Cracked and Deteriorated Parkway Areas

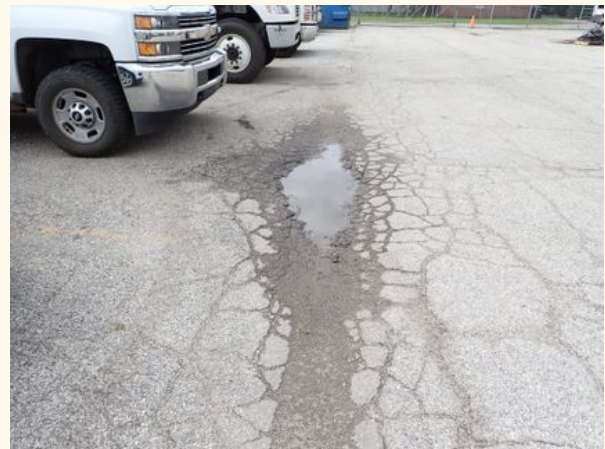
Deteriorated Pavement in Yard Area

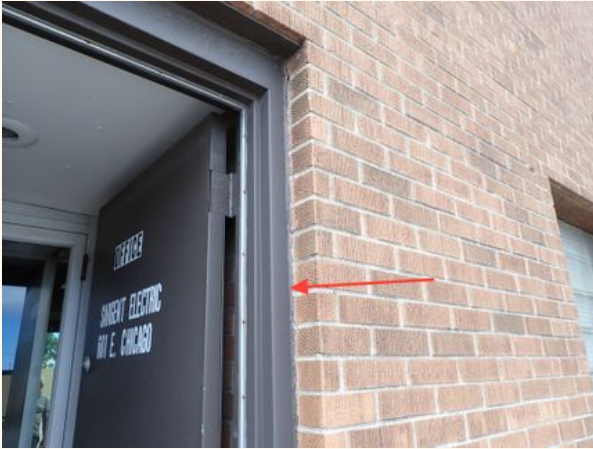
🔧 (EWGCE-3) Repair: The existing caulking around the perimeter of the structure is cracked, missing and old. Exterior sealant performance is **directly related to the joint preparation and application**. For increased service life, performance and aesthetics, the exterior of the structure should be carefully examined and old deteriorated and/or improper caulking should be removed and the exterior of the structure caulked via appropriate means and materials. Proper joint preparation and the use of compliant exterior rated sealants of good quality is recommended .

Cracked and Open Caulk Joints

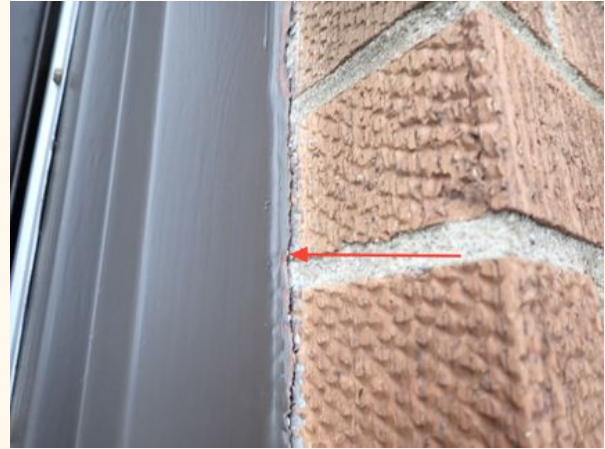
Close-up of Cracked and Deteriorated Caulk Joint

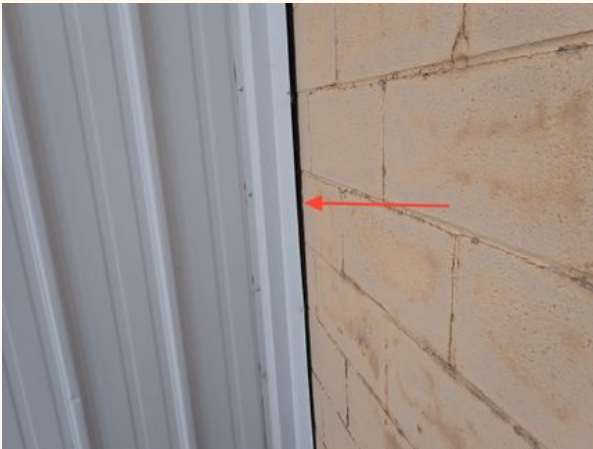
Unsealed Gap by Metal Siding

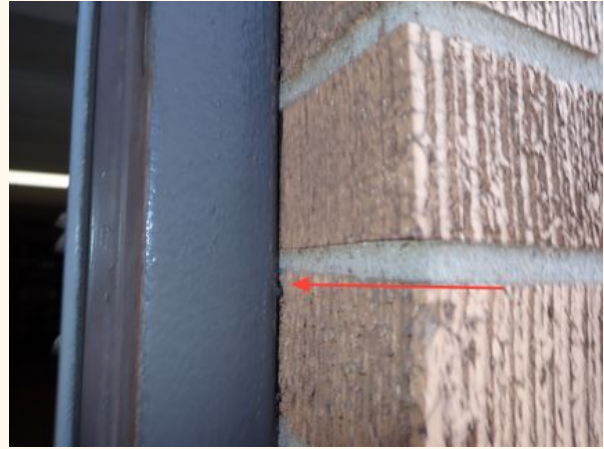
Open Joint Around Doors

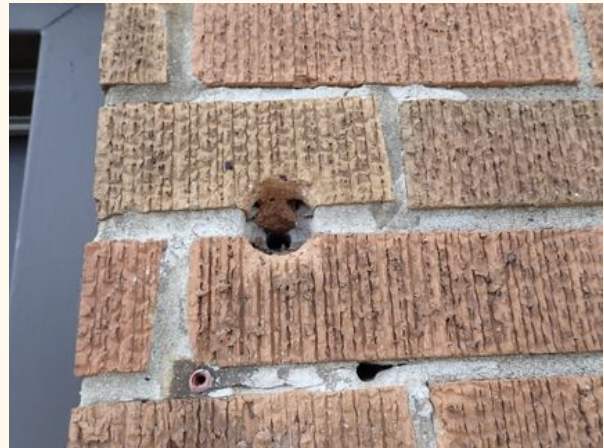
🔧 (EWGCE-4) Repair: The exterior masonry walls are in overall good condition, however, areas of deterioration and damage were noted. The property owner should budget for repairs and maintenance and the exterior walls should be evaluated by a qualified masonry restoration contractor.

Open Holes in Walls

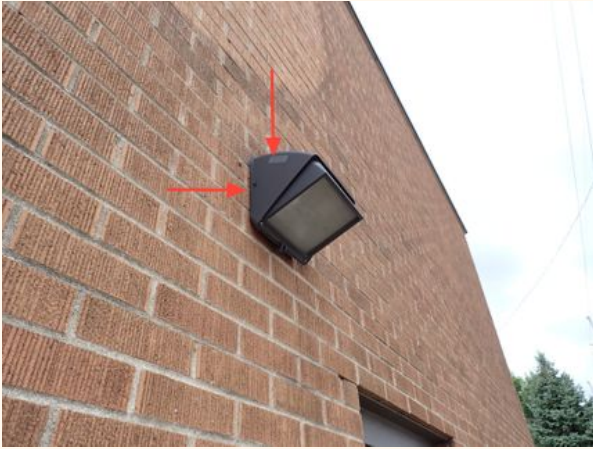
🔧 (EWGCE-5) Repair: In order to prevent moisture penetration into the home and/or moisture contact with energized electrical equipment, caulking is recommended at the top and sides of the exterior electrical lighting fixtures. **It should be noted that the bottom should remain unsealed for drainage purposes.**

Caulking Needed Around Exterior Light Fixtures

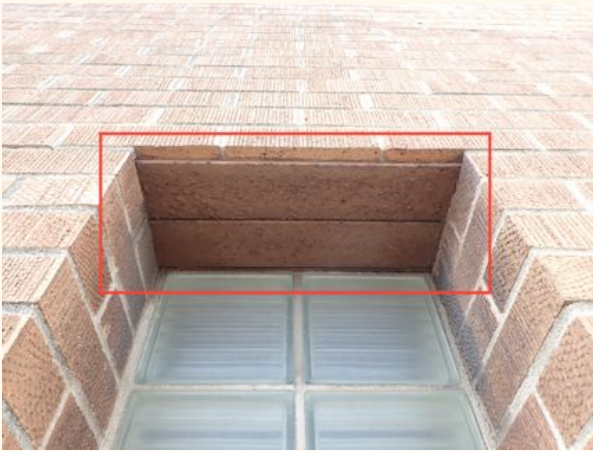
🔧 (EWGCE-6) Repair: In order to provide protection against corrosion and also for proper appearance it is recommended that all of the steel window and door lintels be finish painted with a coating specifically formulated for exterior metal applications. Ideally these lintels would have been painted prior to their installation and this painting should comply with the paint manufacturers specifications for application.

Corroding Paint on Lintels

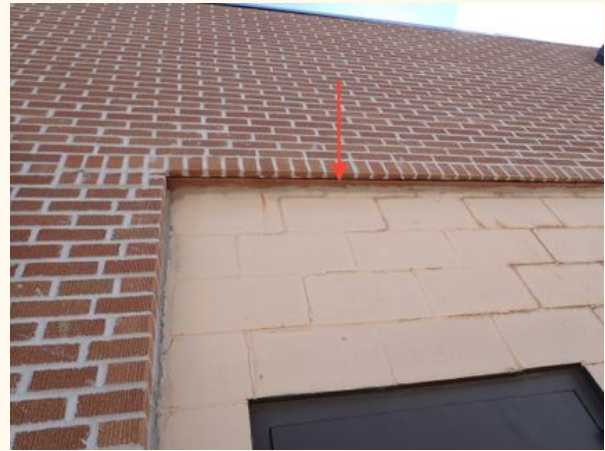
Unpainted and Corroding Lintels

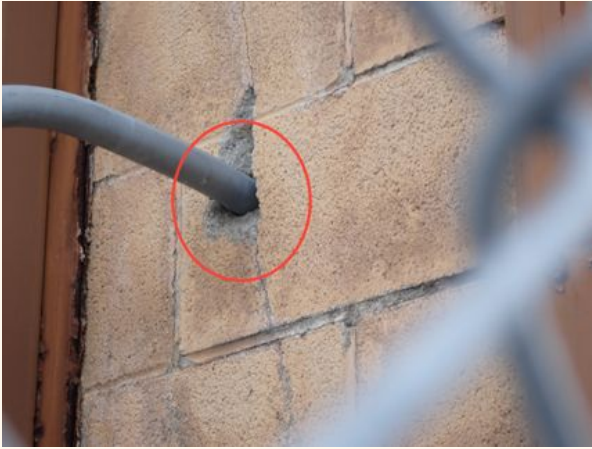
🔧 (EWGCE-7) Repair: In order to reduce the potential for moisture related damage, all exterior wall penetrations such as; piping, conduit, vent caps, etc. should be sealed against moisture intrusion, drafts, and energy losses through the use of the appropriate caulking methods and materials.

Unsealed Wall Penetrations

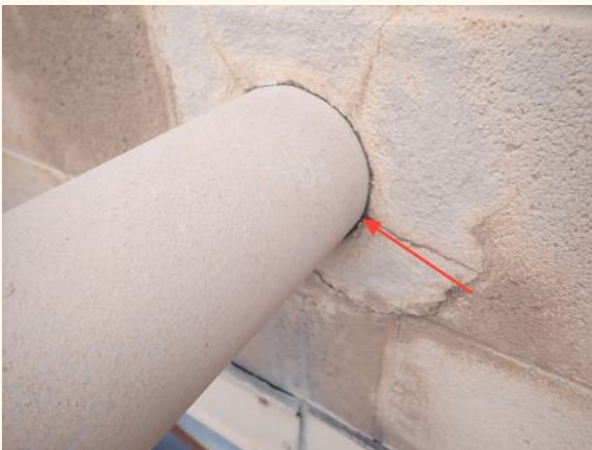
Unsealed Wall Penetrations

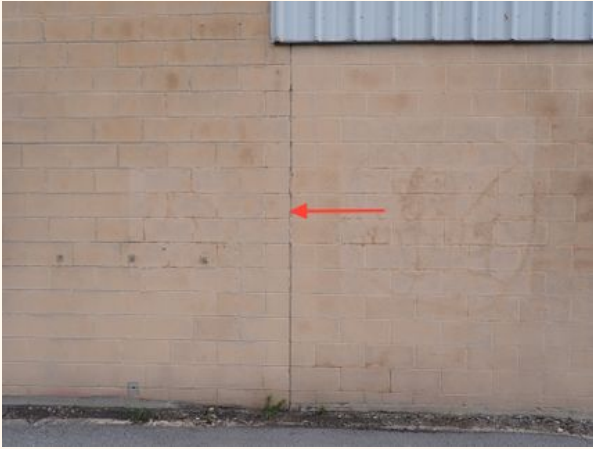
🔧 (EWGCE-8) Repair: Cracking was noted in the masonry joints between dissimilar materials and construction joints on the structure. All dissimilar elements on the exterior walls of the structure such as: brick-to-stone; brick-to-concrete block; concrete block-to-glass block, all interior corners and all construction joints should be joined one to the other and sealed against moisture through the use of backer rod and urethane caulk or its equivalent. These elements have either differing coefficients of expansion and contraction in relation to temperature and moisture and/or are subject to movement which can lead to cracking of the cladding material and/or of the mortar joints. In order to reduce the potential for moisture related damage, the existing cement mortar joints should be ground out and replaced with the appropriate backer rod and ASTM approved caulking by a qualified masonry repair contractor.

Cracked and Open Caulk Joint

This procedure is in keeping with the standards set forth by the Brick Industry Association. Further information is available at the following link: [Accommodating Expansion of Brickwork](#)

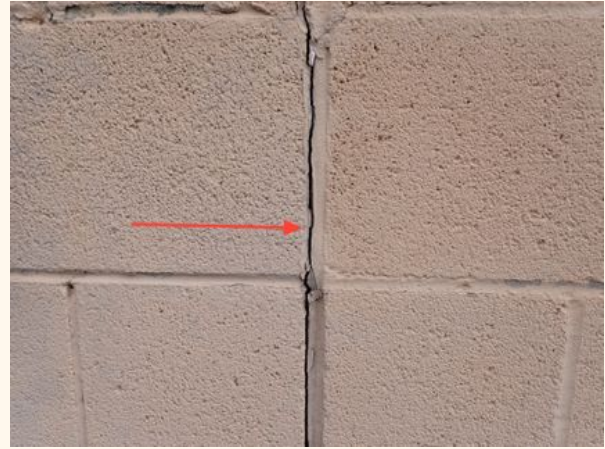
Close-up of Cracked and Deteriorated Mortar Joint

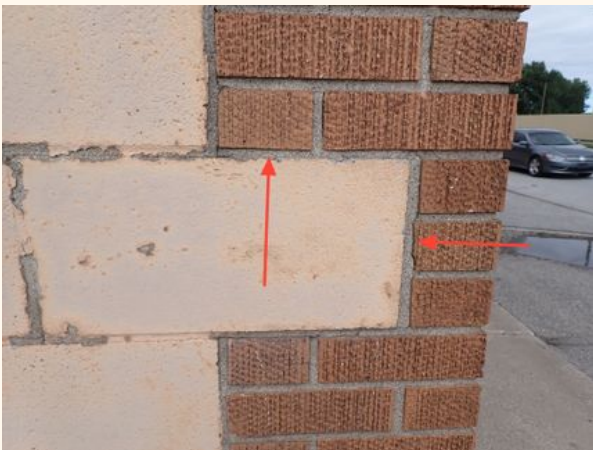
Cracks Noted in Dissimilar Materials Joints

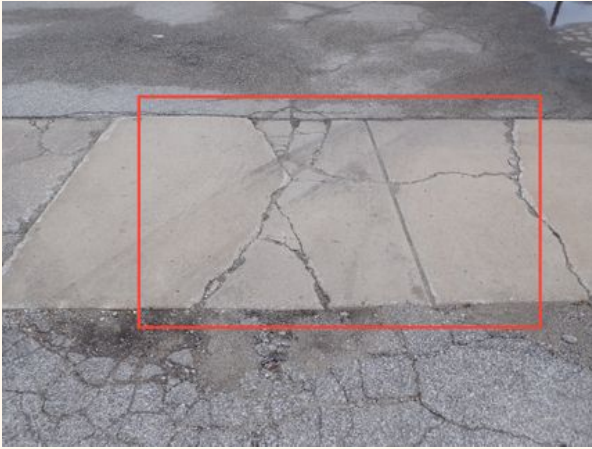
🔧 (EWGCE-9) Repair: The front public sidewalk is cracked, settled and uneven which creates potential trip hazards. In order to reduce the potential for injury, it is recommended that the homeowner contact the local municipality regarding any potential cost sharing sidewalk replacement program. Typically most municipalities will pay for up to half of the cost for sidewalk replacement for the portions of the walk that are determined to be unsafe.

Cracked and Damaged Front Walk

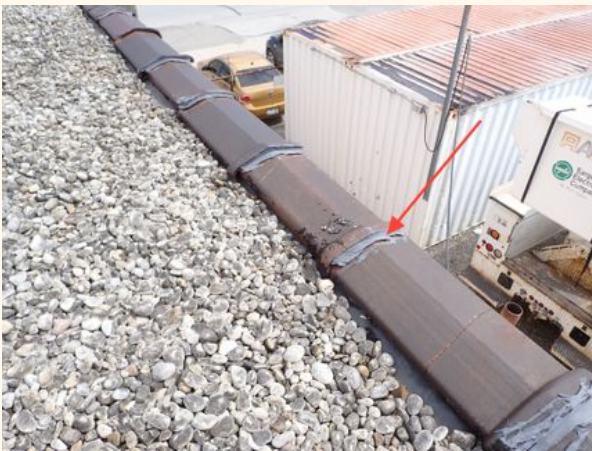
🔧 (EWGCE-10) Repair: The butt joints between the individual sections of clay tile coping have been sealed with cement mortar. The mortar is cracking and the joints are open which creates a risk for moisture saturation/damage to the masonry walls below. The coping tiles serve to protect the underlying brick masonry walls from wetting/drying and freezing/thawing damage and should be neatly joined and properly sealed in order to perform this function. The coping tiles should be repaired or replaced as needed by a qualified masonry or roofing contractor. It is recommended that the individual clay tiles be removed and reinstalled using backer rod and polyurethane caulk to seal the joints.

Large Open Gaps in Clay Tile Joints

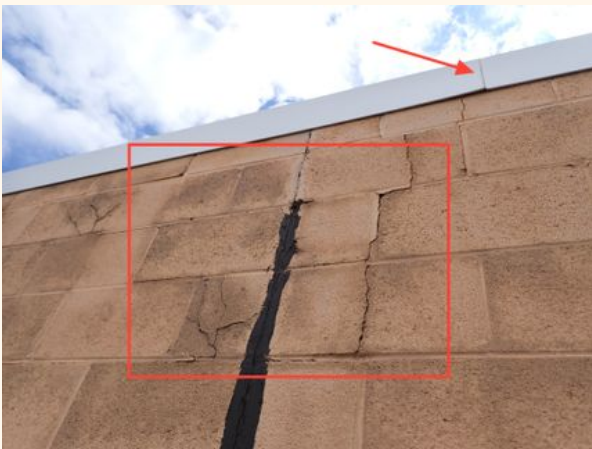
🔧 (EWGCE-11) Repair: The aluminum parapet capping at the top of the masonry parapet walls and metal building does not conform with industry standards as published by the Sheet-Metal and Air Conditioning Contractors National Association (SMACNA). The aluminum wall cap does not promptly shed moisture; does not have sleeved and gasketed overlaps; and is composed of relatively thin aluminum which will expand and contract significantly from temperature changes. These defects greatly increase the risk for moisture penetration into and through the underlying masonry walls. It is recommended that plans be made for the near-term replacement of the existing parapet wall cap with one that reflects industry standards and best practices.

Cracked and Damaged Masonry Below Cap Joint

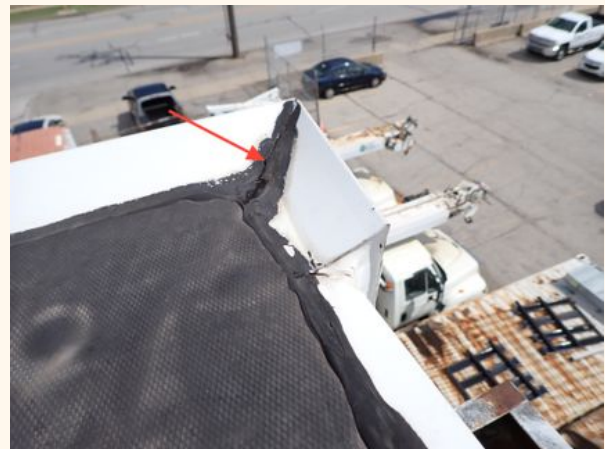
Cracked and Open Corner Joints in Capping

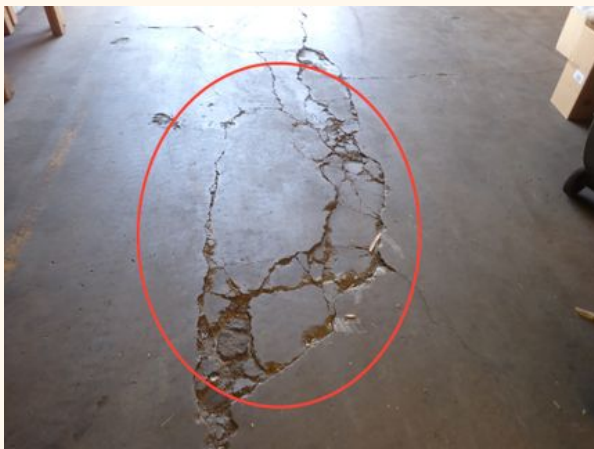
🔧 (GAO-1) Repair: Portions of the garage and interior shop floors are badly damaged and uneven which creates potential trip hazards and instability with fork lift use. In order to reduce the potential for injury, it is recommended that a qualified concrete repair contractor remove and replace the badly deteriorated portions of concrete.

Cracked and Damaged Shop Floor

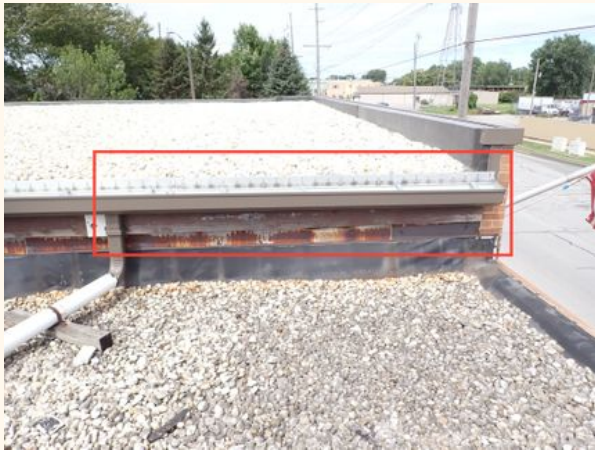
🔧 (RCRFRD-1) Repair: Several gutter sections on at least one of the roof areas was reverse pitched, other gutter sections on the structure appear to be leaking and a loose downspout was observed. For proper roof drainage and to reduce the potential for moisture related damage, the gutters and downspouts on the structure should be evaluated and repaired as needed by a qualified gutter installation contractor.

Reverse Pitched Gutter

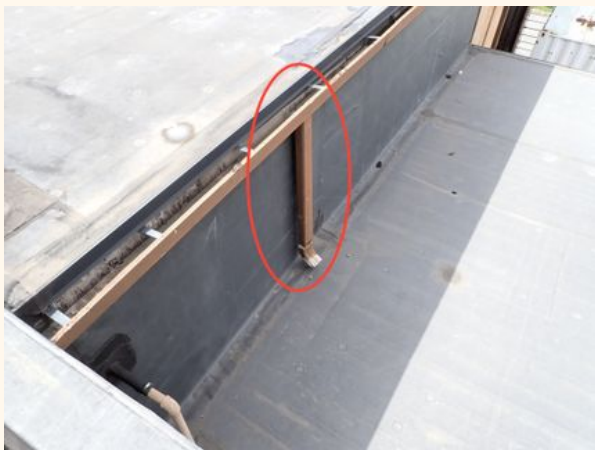
Loose Downspout on Roof

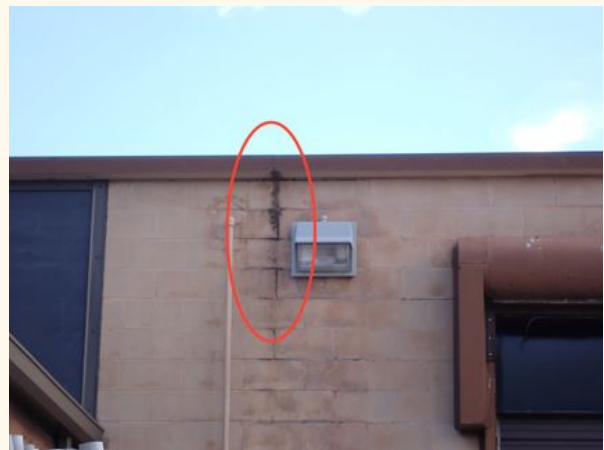
Leaking Gutter Joints

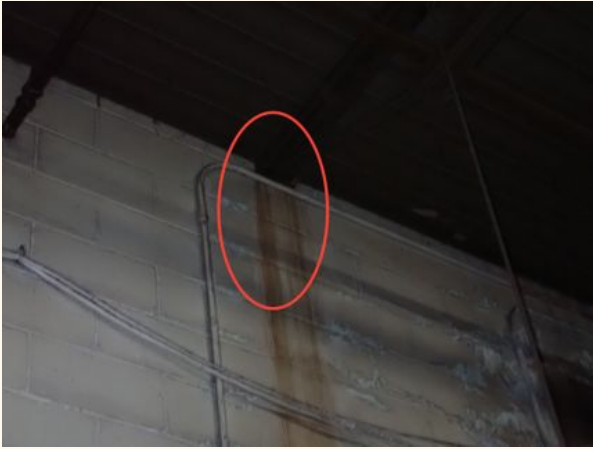
Leakage Stains on Interior

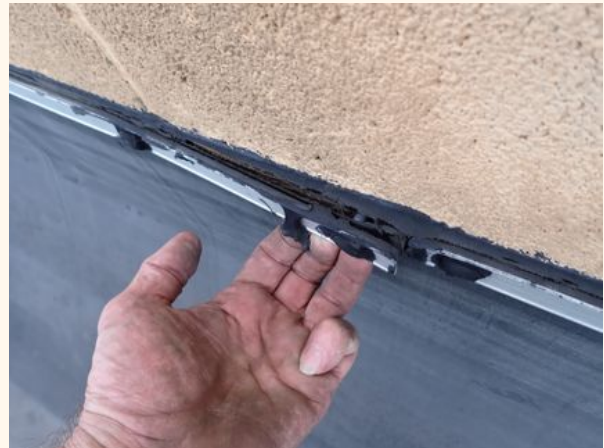
🔧 (RCFRD-2) Repair: Loose and potentially unsealed areas of termination bar flashing and roofing membrane were noted in at least one area that creates the potential for the entry of moisture. In order to reduce the potential for moisture related damage It is recommended that a qualified roofing contractor evaluate and repair the flashing as needed.

Loose and Unsealed Flashing

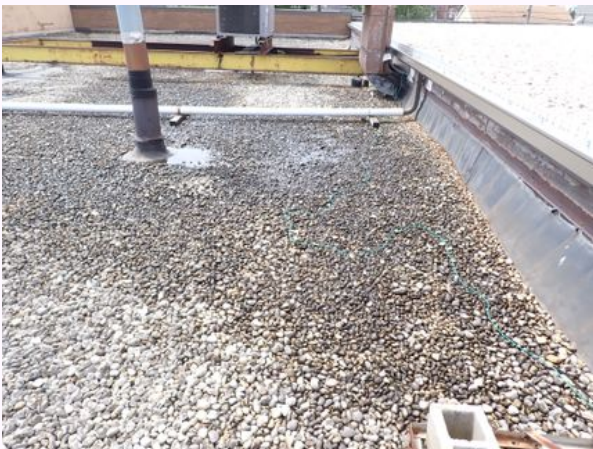
📐 (RCRFRD-4) Future Project: Ponded areas were noted on the low slope roof. Ponding accelerates the rate of roof wear/deterioration and increases the risk for leaking. When a new roof covering is installed, plans should be made to re-pitch the roof using tapered roof insulation.

Large Area of Standing Water

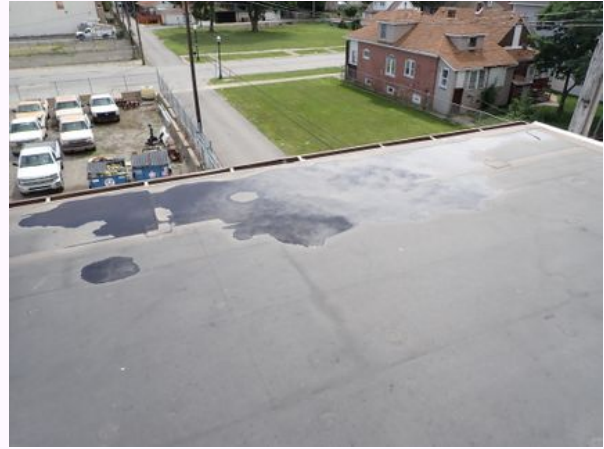
Ponding on Upper Roof

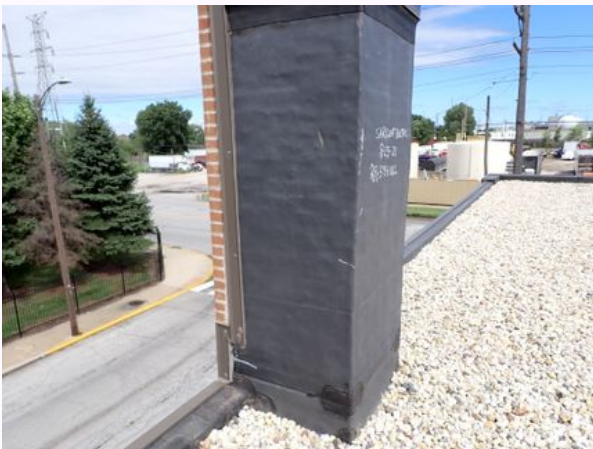
📷 (RCRFRD-5) Future Project: There appears to have been repairs performed on the chimney, however, much of the chimney is covered by roofing membrane. Best roofing practices call for the roof covering to be held back and terminated along masonry walls typically between 12" and 36". When the membrane is wrapped over masonry it prevents moisture from draining/evaporating at that side and will reduce mortar and brick life on the opposite side as moisture seeks pathways to drain or evaporate. It is recommended that the membrane be removed and terminated at an appropriate height on the parapet wall with appropriate base and counterflashing. Once the roofing has been removed the masonry chimney should be evaluated by a qualified masonry restoration contractor and mortar repairs should be expected where the roof material concealed masonry details.

Chimney Covered with Roofing

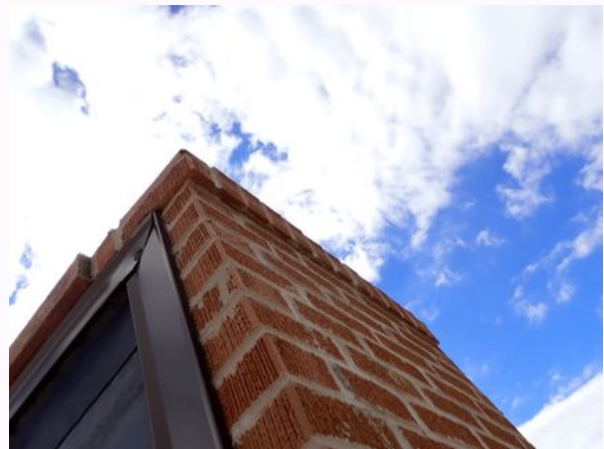
Recent Re-pointing on Chimney

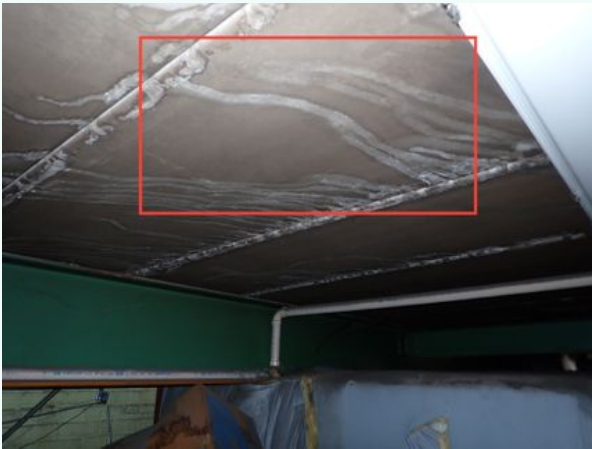
👁️ (RCRFRD-6) Monitor: There appears to have been roof leakage at some point as signs of interior leakage were observed in above the mezzanine and office areas. There were areas of the roof where the rock ballast appears to have been removed and some small cracks and openings were noted on the seams in some repairs and if leakage is noted at some point in the future the roof should be evaluated and repaired as needed by a qualified roofing

Leakage Stains on Underside of Roof Decking

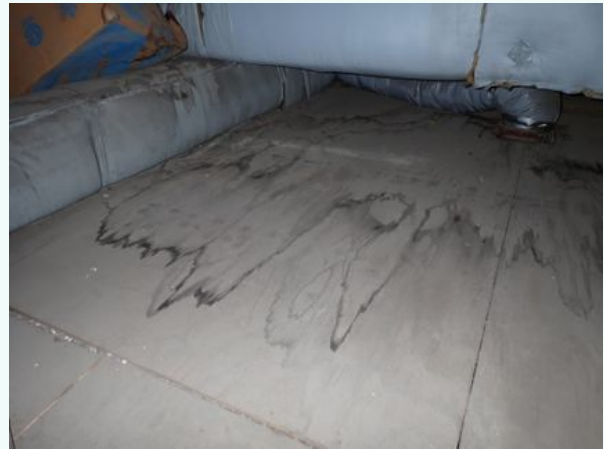
Stains on Mezzanine Flooring

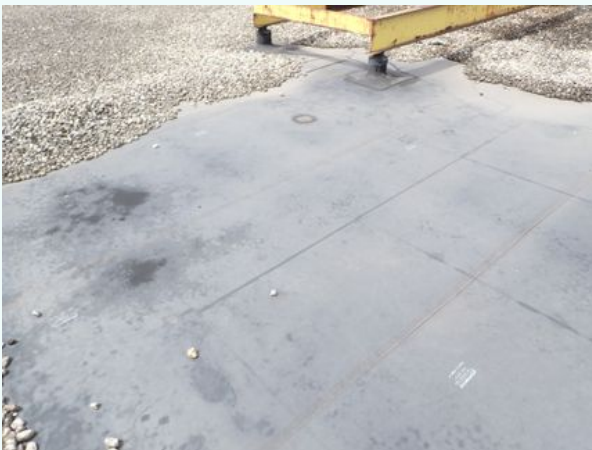
Missing Ballast on Roof

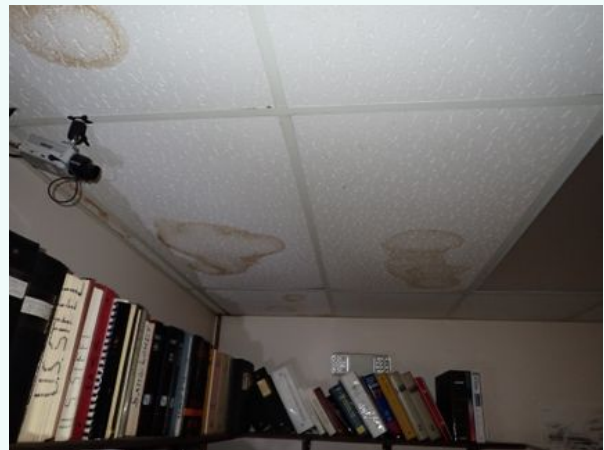
Stained Ceiling Tiles in Office Areas

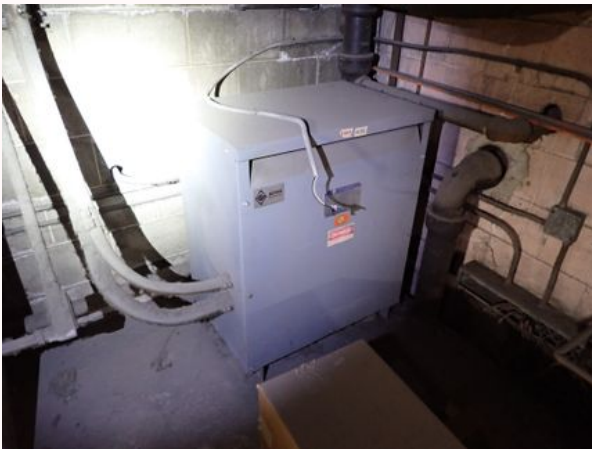
⚠️ (ESGCDAF-1) **Major Concern:** Live disconnected electrical wiring was found in at least one location and in order to reduce the risk for electrical shock and fire, all of the abandoned wiring in the structure should be located and removed or capped off and enclosed inside metal junction boxes by a qualified electrician.

Live Wring By Transformer

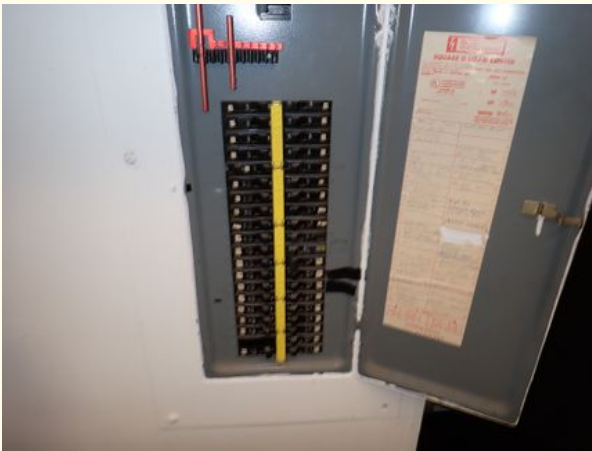
Full Panel in Kitchen

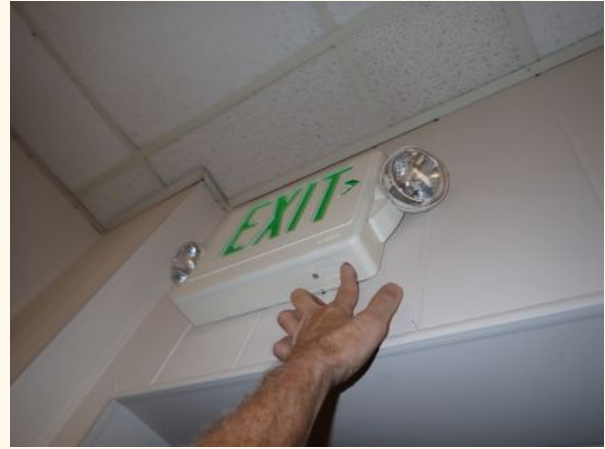
🔧 (ESGCDAF-3) Repair: A spot check of the battery operated emergency lighting system/s revealed one or more non-functioning units. It is strongly recommended that these critical life safety devices be regularly evaluated and repaired as needed by a qualified electrician.

Non-functional Emergency Lighting

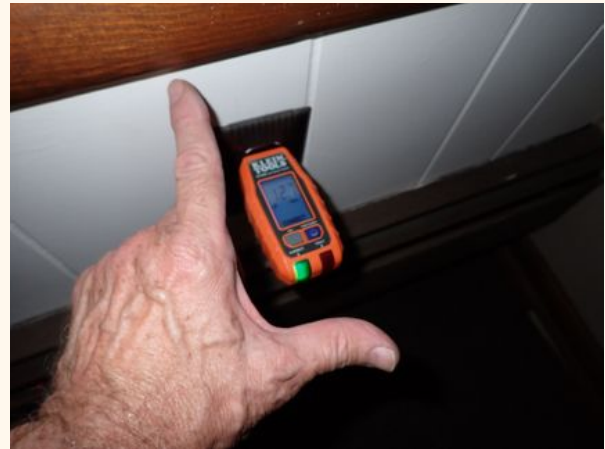
Loose Receptacle in Office

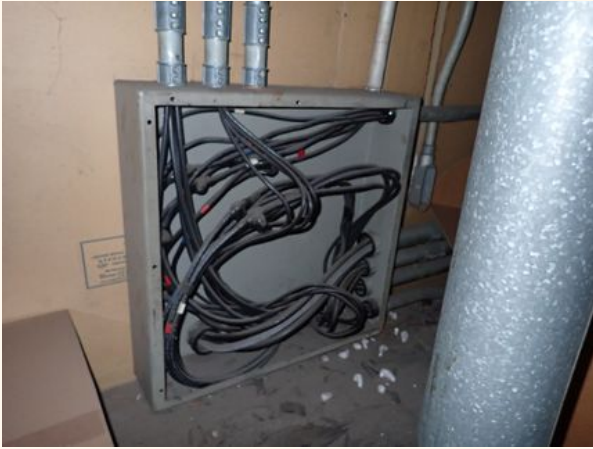
⚠️ (ESGCDAF-7) Repair: In order to reduce the risk for electrical shock from inadvertent contact with exposed current carrying equipment and in order to contain molten copper created by high temperature arcing and sparking of energized wiring, it is recommended that all electrical connections be concealed inside covered metal junction boxes by a qualified electrician.

Exposed Wiring in Mezzanine

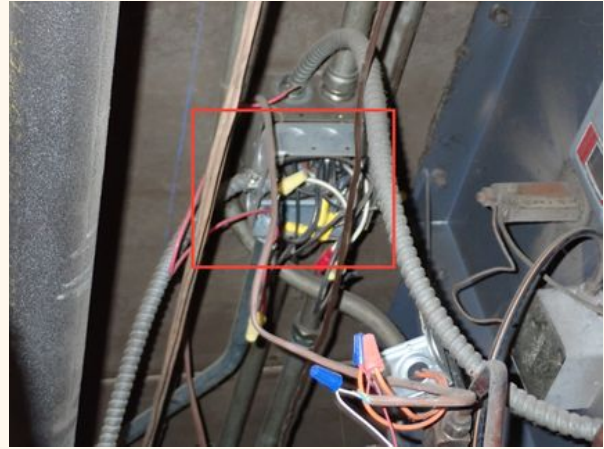
Exposed Wiring on Mezzanine

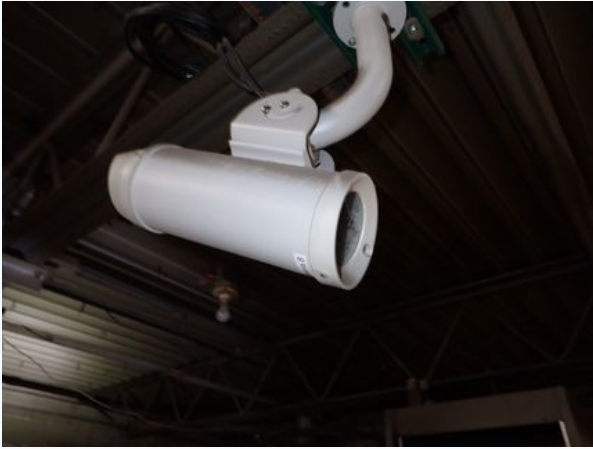
🔍 (ESGCDAF-10) Due Diligence: The evaluation of the low-voltage equipment in the home: alarm, communication, audiovisual, etc., is beyond the scope of the home inspection and should be performed by a qualified low-voltage electrical contractor. In order to reduce the potential for confusion and to reduce clutter around the home, any wiring, panels, cabinets, etc. for any equipment that is no longer in use should be removed.

Low Voltage Surveillance Equipment

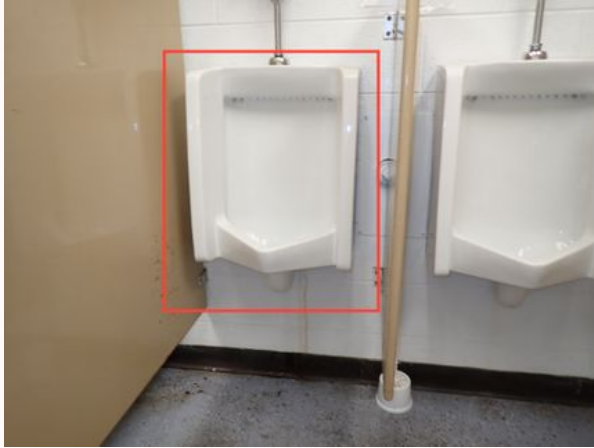
⚠️ **(PSDFAV-1) Major Concern:** The left urinal in the men's restroom in the shop area was actively leaking at the time of the inspection when flushed. In order to reduce the potential for moisture related damage it is recommended that a qualified plumber evaluate and repair the urinal.

Leaking Urinal

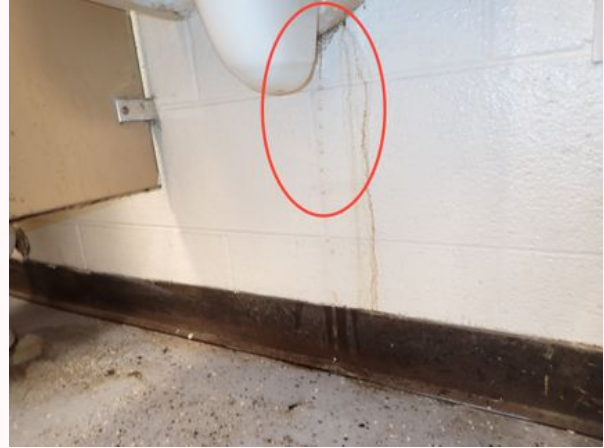
Leakage From Urinal

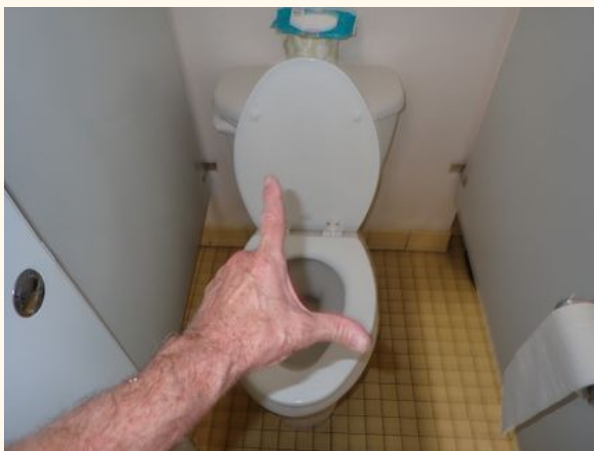
🔧 **(PSDFAV-2) Repair:** The toilet in the office ladies room is not adequately secured to the floor. This can result in deformation of the wax ring seal, leaking and other damage. In order to reduce the potential for moisture related damage and to determine if removal and reinstallation is necessary, the toilet should be evaluated by a licensed and competent plumber.

Loose Toilet

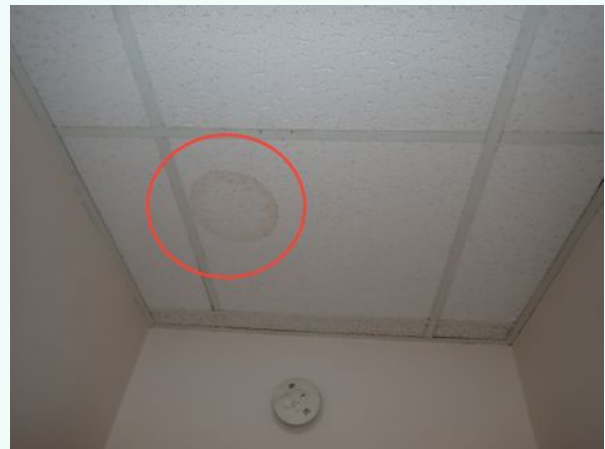
Stain on Ceiling Tile in Hallway

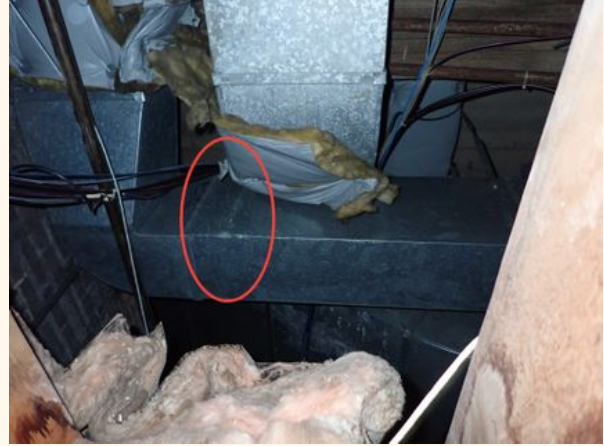
Missing Insulation and Moisture Staining on Ductwork

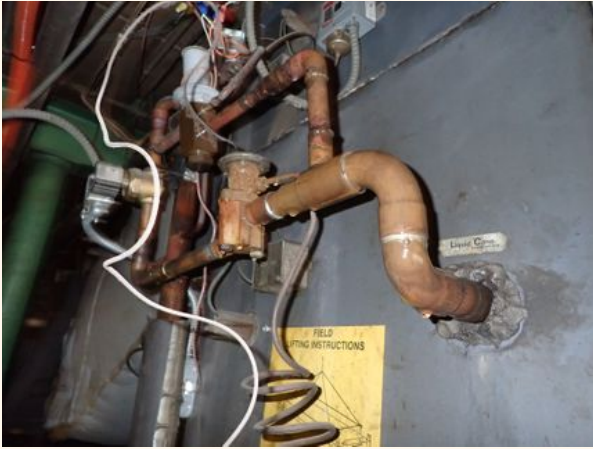
🔧 (HACVAGAS-3) Repair: Condensation resulting in leakage was observed on the A/C refrigerant lines on the HVAC unit in the mezzanine. The deteriorated/missing insulation on the A/C refrigerant lines can result in energy losses that promote the formation of condensation. In order to reduce the potential for moisture related damage and to reduce energy losses and maximize efficiency, the insulation should be replaced by a qualified HVAC contractor.

Leakage on A/C Lines

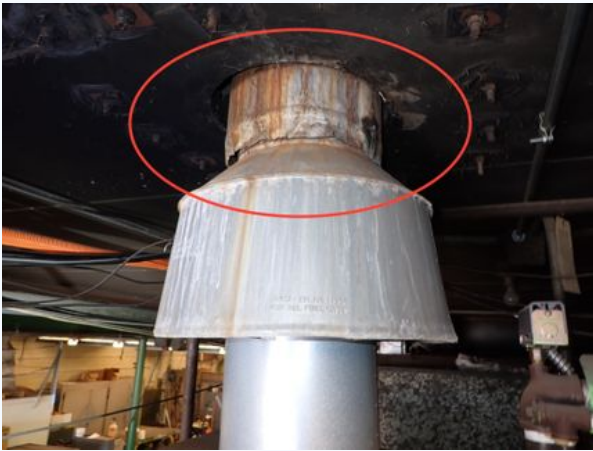
🔍 **(HACVAGAS-4) Due Diligence:** The age of the cast iron boiler in this structure could not be determined as there was not a legible data plate, however, it can provide decades of service if it is maintained properly. It is recommended that any available service records for the boiler be obtained from the seller and be compared to the manufacturer's maintenance requirements. If proper maintenance is being followed, it is recommended that the property owner continue the ongoing service schedules.

Corrosion on Vent Piping

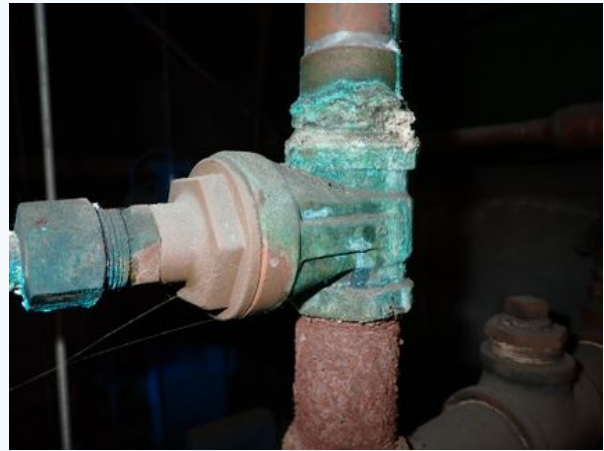
Incipient Leakage on Boiler Piping

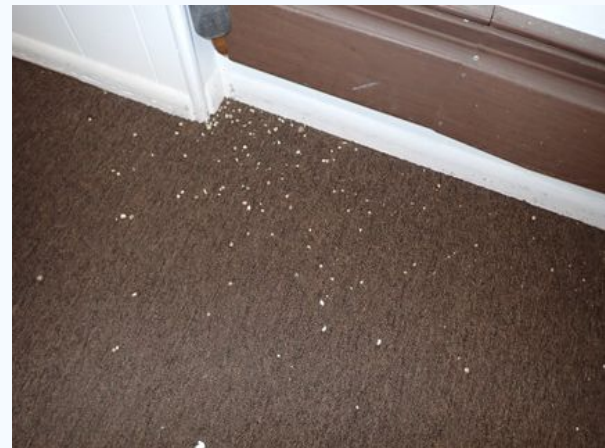
Loose Insulation Fragments in Office

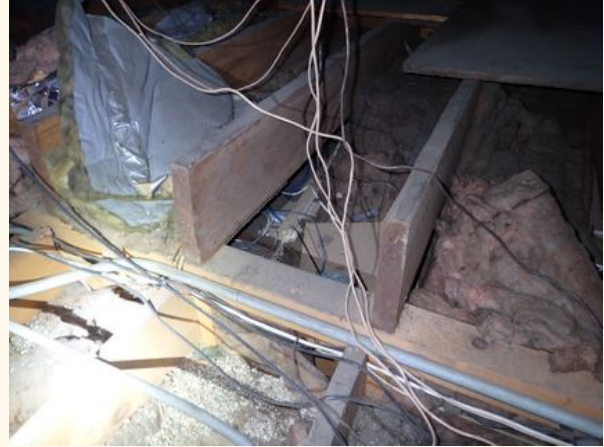
A Variety of Insulation Including Vermiculite

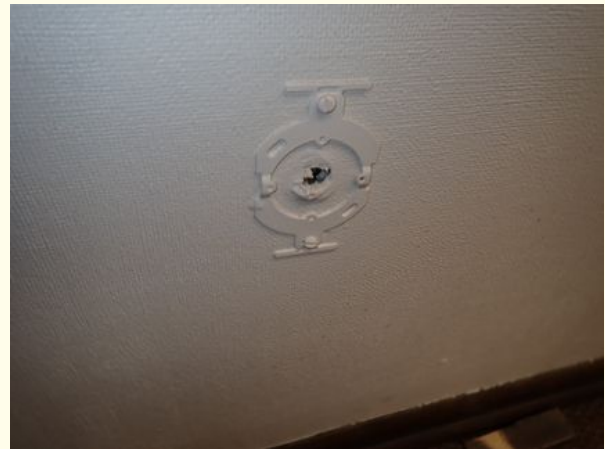
Damaged Walls

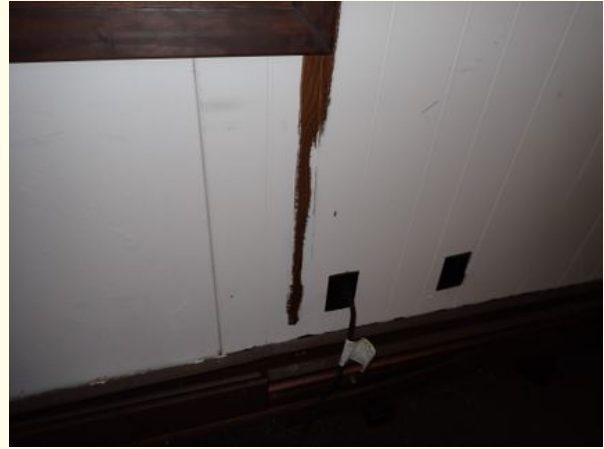
Missing Paint on Wall Finishes

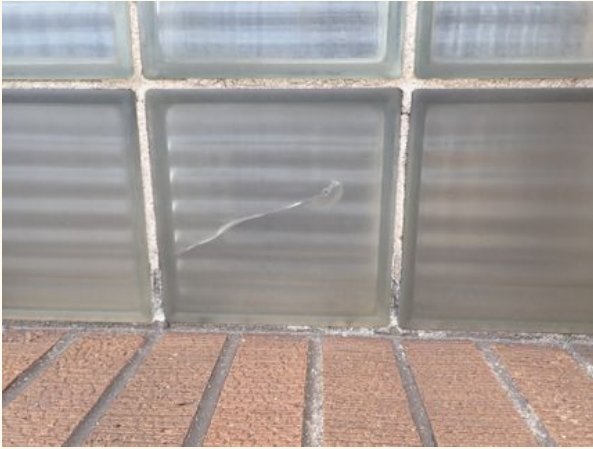
🔧 (WDS-1) Repair: Several broken glazing blocks were noted on the glass block window installation(s). Repair by a qualified masonry contractor is recommended.

Broken Glass Block - BB Hole

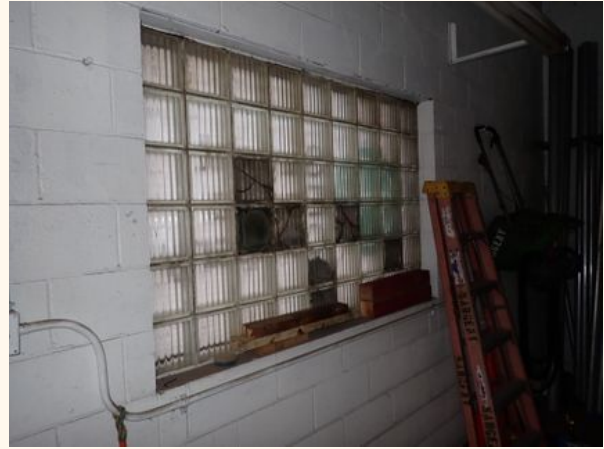
Broken Block Windows in Shop Area

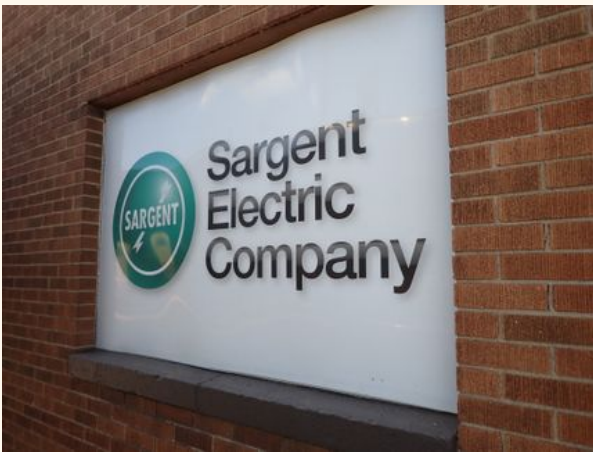
Sign Covers Broken Blocks

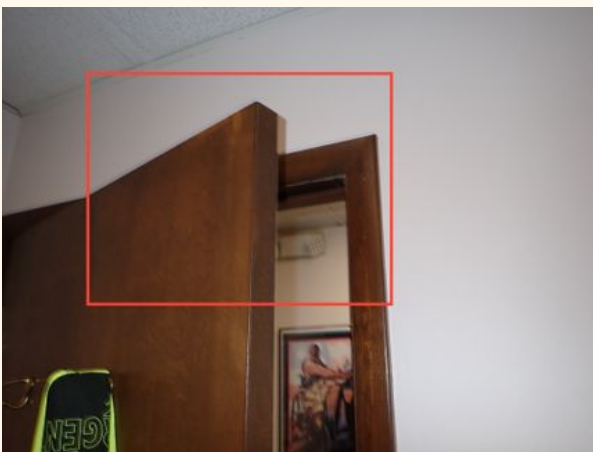
🔧 (WDS-2) Repair: At least one of the doors in the structure failed to close or latch properly. For proper operation it is recommended that any non-functional doors be repaired or adjusted by a qualified carpenter or handyman.

Door on Office Hitting Doorframe

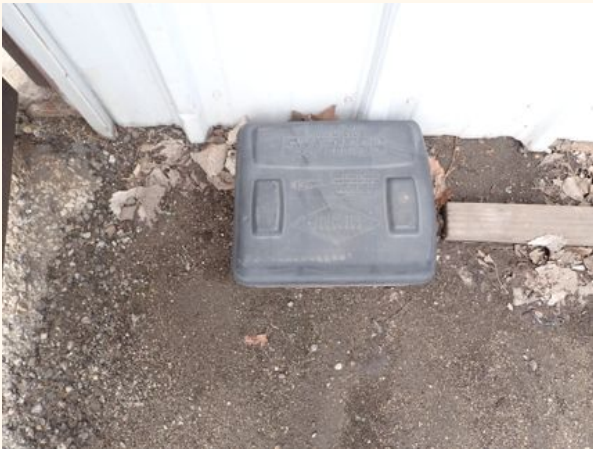
🔧 (O-1) Repair: Large devices typically associated with rats were noted around the perimeter of the property and larger droppings were noted near the home. Rats are extremely common in Cities and are typically attracted to waste and hidden nesting areas. Any areas that provide a safe haven for rats should be cleared of clutter that provides the ability for concealment and all waste should be kept in special waste containers.

Traps Inside and Outside Structure

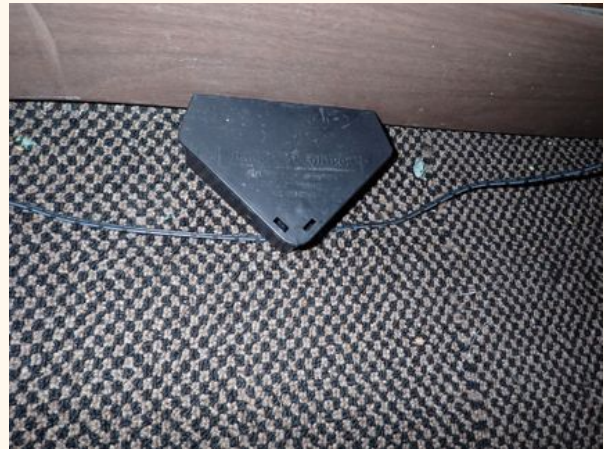
Mouse Trap in Office

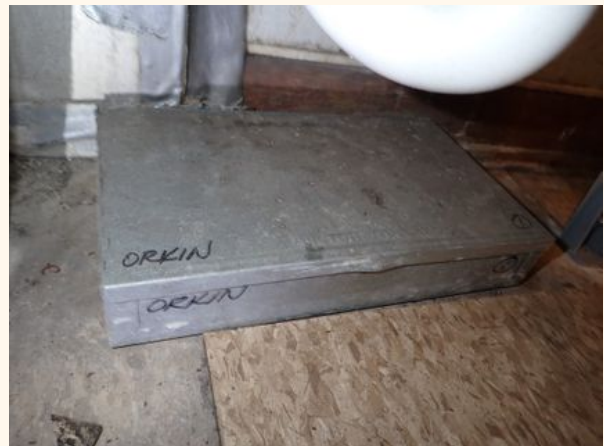
Traps in Shop Area

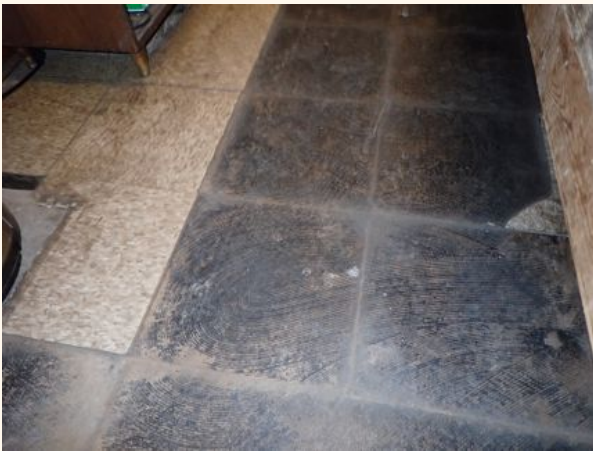
Potential Asbestos Tile and Black Mastic on Floors
