This report is prepared exclusively for **Small Commercial Condominium**
Inspected On: **2022-11-07**

This property is a commercial storefront in a newer condominium building. The unit has no parking space in the garage and limited exposure so there apparently is a reduced share in the monthly assessment fees. The building has a number of deferred maintenance items and there is a noticeable musty smell in the rear stairwell from moisture intrusion via the split faced block walls on the structure. The items in the report that are related to the condominium association should be shared with the members of the association in order to determine if they are having moisture leakage issues and if there are long range plans for reducing moisture intrusion into the building.

Mark Hughes – IL License 450-011855 – Expires 11/30/2022

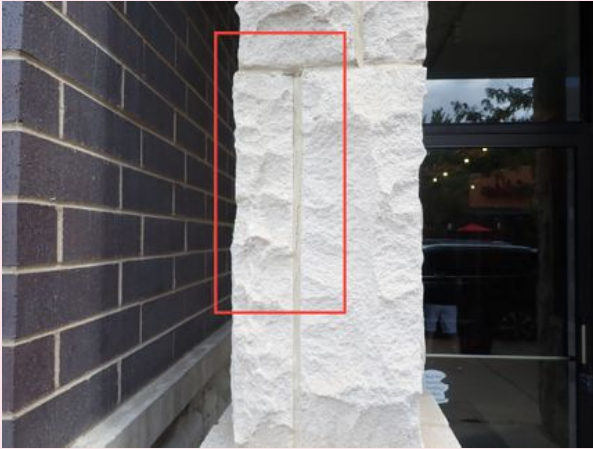
Cracking in Front Column Joints

This procedure is in keeping with the standards set forth by the Brick Industry Association. Further information is available at the following link: [Accommodating Expansion of Brickwork](#)

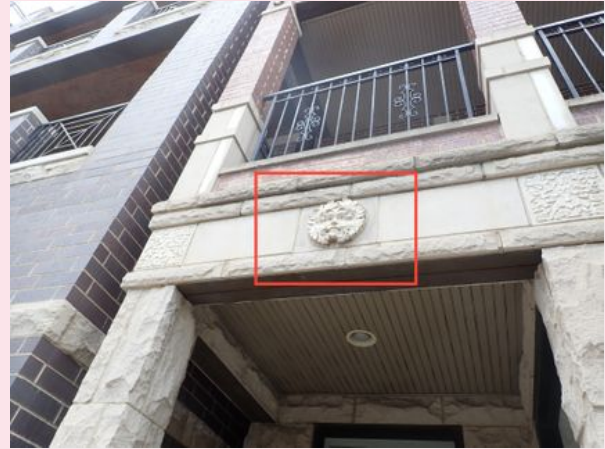
Cracking Around Medallions

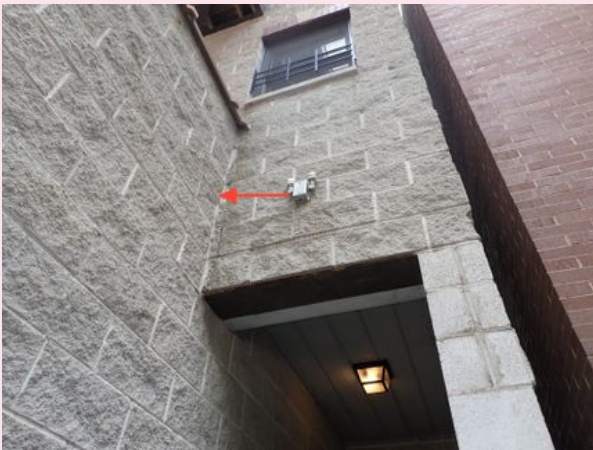
Cracked Mortar in Corner Joint

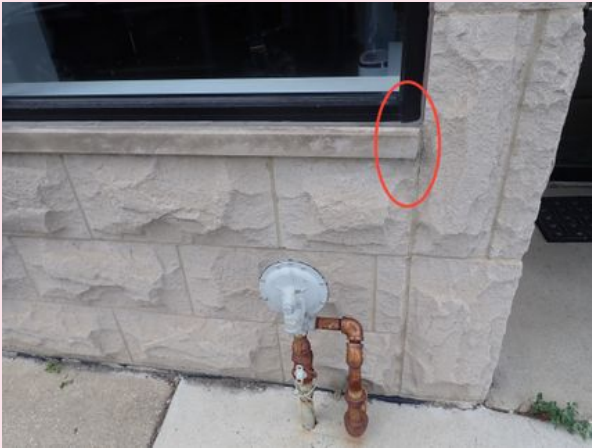
Cracks in Corners of Stone Sills

intrusion to the interior and damage to the brick masonry below the sills, the mortar in the joints should be raked out and sealed instead with a high-quality masonry caulking compound by a qualified masonry restoration contractor or handyman.

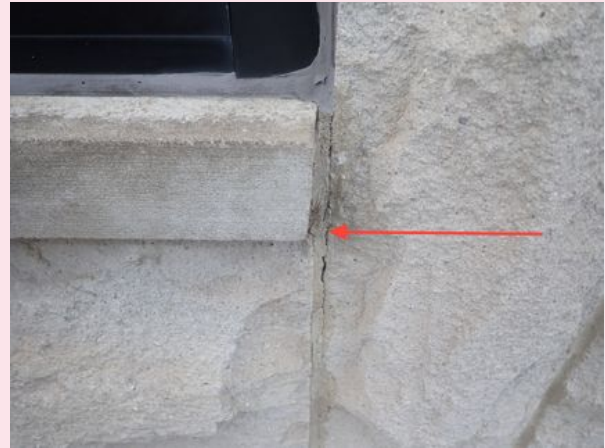
Cracked Mortar Joints and Damaged Masonry Below Stone Sill

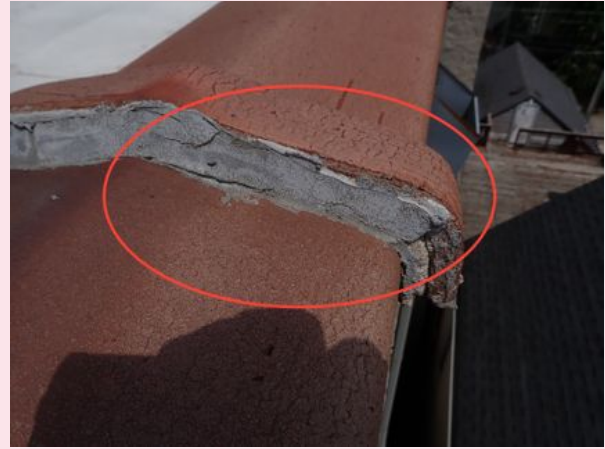
The butt joints between the individual sections of clay tile coping have been sealed with cement mortar. The mortar is cracking and the joints are open which creates a risk for moisture saturation/damage to the masonry walls below. The coping tiles serve to protect the underlying brick masonry walls from wetting/drying and freezing/thawing damage and should be neatly joined and properly sealed in order to perform this function. The coping tiles should be repaired or replaced as needed by a qualified masonry or roofing contractor. It is recommended that the individual clay tiles be removed and reinstalled using backer rod and polyurethane caulk to seal the joints.

Cracked and Open Joints with Caulk Smears

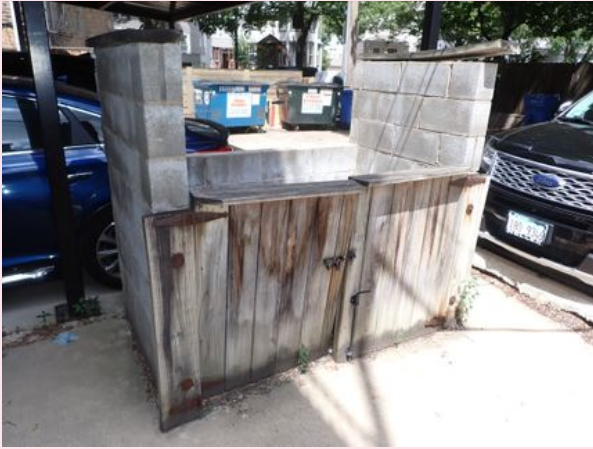
The masonry garbage container structure in the rear has deteriorated joints and damaged and deteriorated wood features that appear to prevent the use of the structure. If use of garbage can storage is desired the structure should be repaired by a qualified masonry contractor and carpenter or should be removed.

Deteriorated Refuse Screen

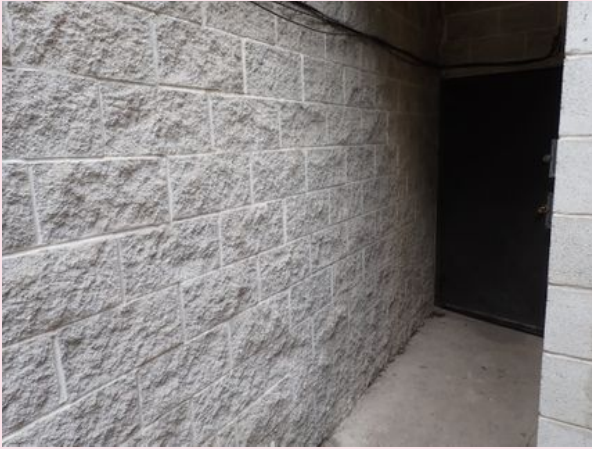
Unsealed Block Walls

The condominium association should, in consultation with a qualified masonry restoration or painting contractor, assess the suitability of high build coatings on the exterior concrete block walls of this building. Any cracks in the mortar should be assessed and re-pointed if needed by a qualified masonry restoration contractor prior to applying any waterproofing coating. Further information regarding high build coatings can be found in the article found at this link: [High Build Coatings](#)

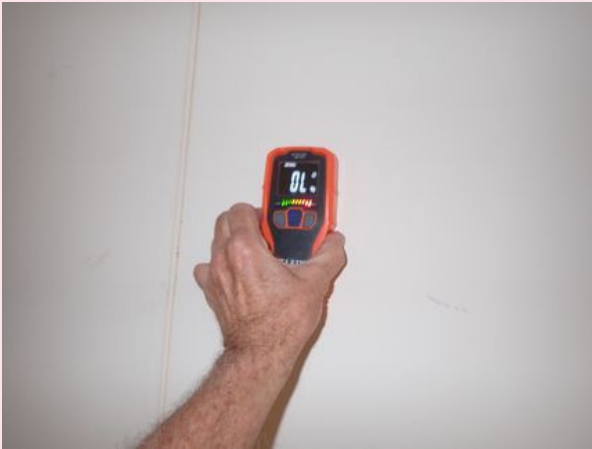
Saturated Humidity Levels in Walls

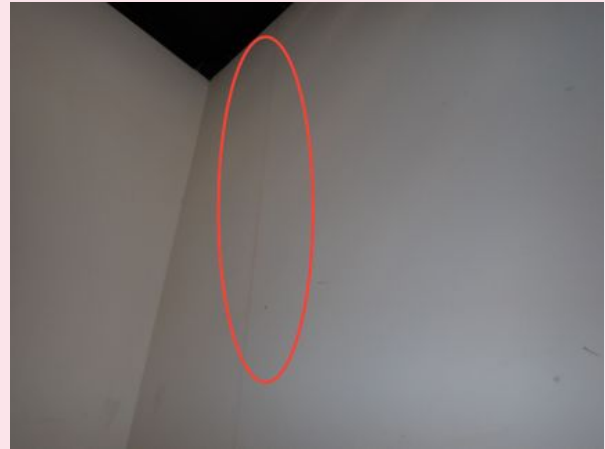
Moisture Stains in Stairwell

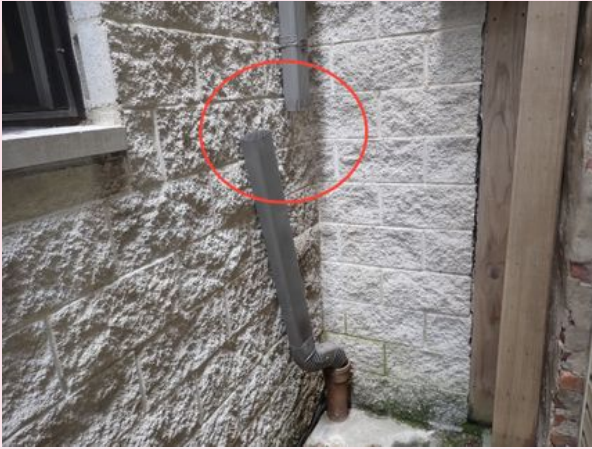
One of the downspouts on the south side is disconnected and is saturating the side of the building. In order to reduce the risk of soil saturation around the foundation, the downspouts around the structure should extend approximately 6 feet away from the foundation walls to well-drained areas.

Disconnected Downspout

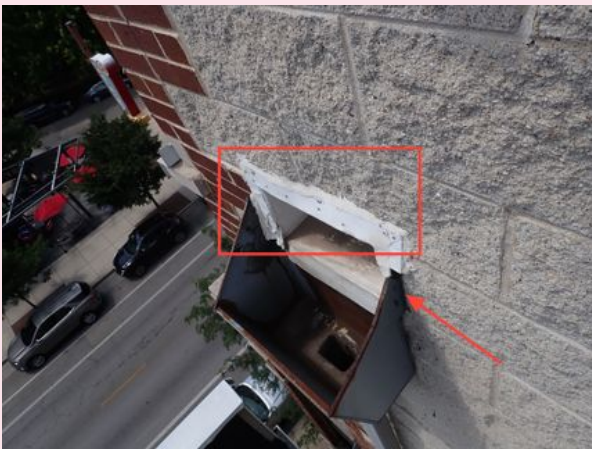
The through-wall scupper openings are not properly configured and present a significant risk for moisture penetration and damage. The multiple applications of contrasting caulk suggests a history of such leaking. It is recommended that plans be made to have a qualified sheet metal or gutter installation contractor reconfigure the scupper openings using heavy gauge Kynar coated aluminum or equivalent sleeved sheet-metal assemblies properly integrated into the modified bitumen roof coverings.

Newer Sealant on Top - Older Sealant and No Flange on Sides

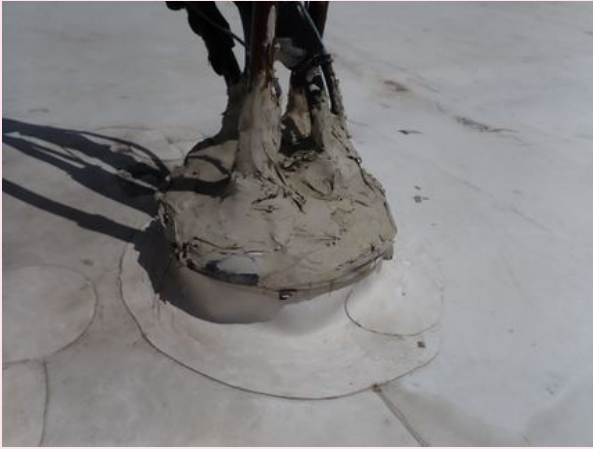
The A/C refrigerant line roof penetrations are sealed with caulk and/or tar which is a high maintenance, low performance solution that creates the potential for damaging and mold causing moisture to enter the structure. It is recommended that the roof penetrations be repaired by a qualified roofing and/or HVAC contractor and the solutions should include pitch pocket flashing or rubber boot flashing specifically designed for the various diameter tubing sizes in order to separate the lines and create the potential for more effective sealing of the A/C refrigerant lines.

Multiple Layers of Sealant on Roof Boots

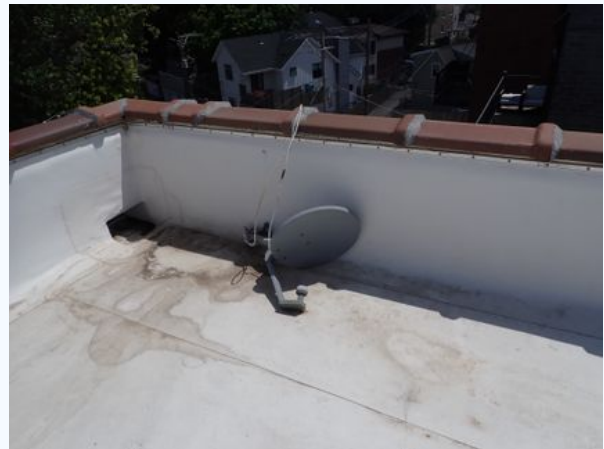
Loose Satellite Dish on Roof

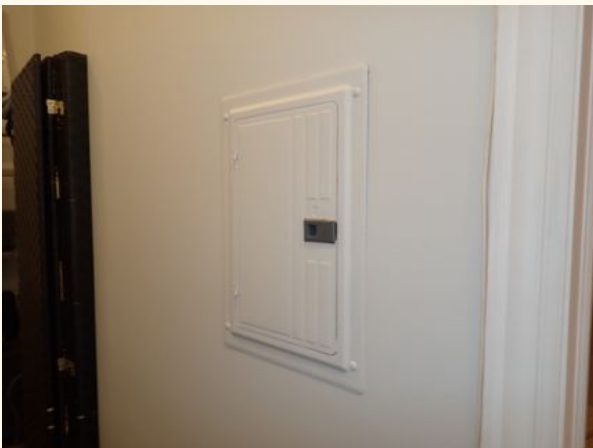
🔧 (ESGCDAF-3) Repair: The cover for the electric service panel has been painted. This makes the cover difficult to remove and although the inspector took measures like scoring the paint along the edges of the cover with a utility knife, the painted surfaces were damaged in the process of removing the cover. It is highly recommended that the panel cover not be re-painted and that an appropriate piece of art or other wall covering be used to cover the panel.

Painted Panel Cover

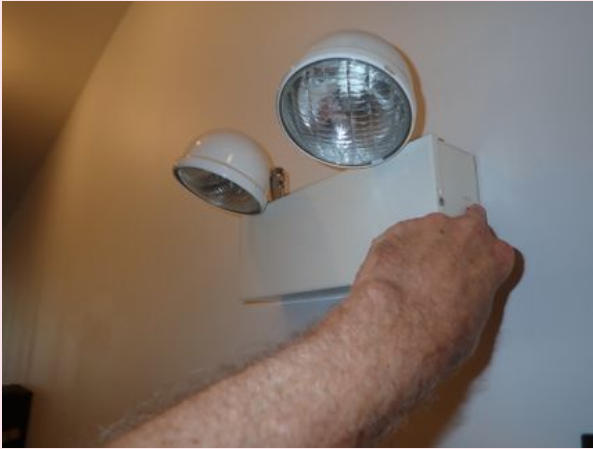
A spot check of the battery operated emergency lighting system/s revealed one or more non-functioning units. It is strongly recommended that these critical life safety devices be regularly evaluated and repaired as needed by a qualified electrician.

Non-operational Lights in Unit

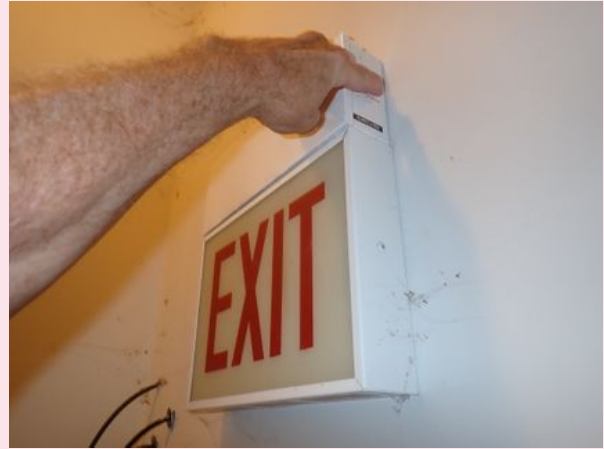
Non-operational Lights on Exit Sign

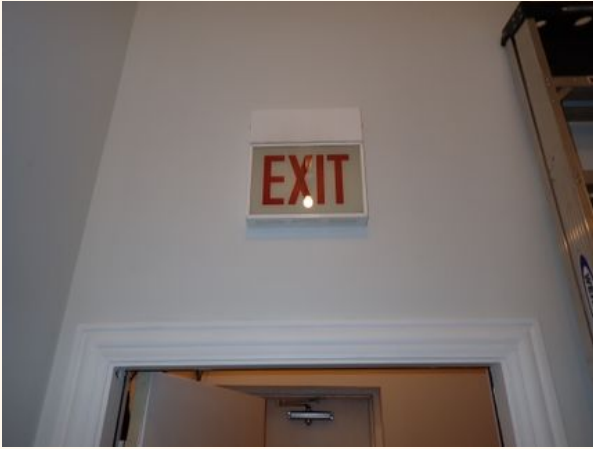
🔧 (ESGCDAF-6) Repair: The emergency exit light in the rear of the unit was not lit at the time of the inspection and for proper safety in the unit the bulb should be replaced or the unit made functional by a qualified electrician or handyman.

Unlit Exit Sign

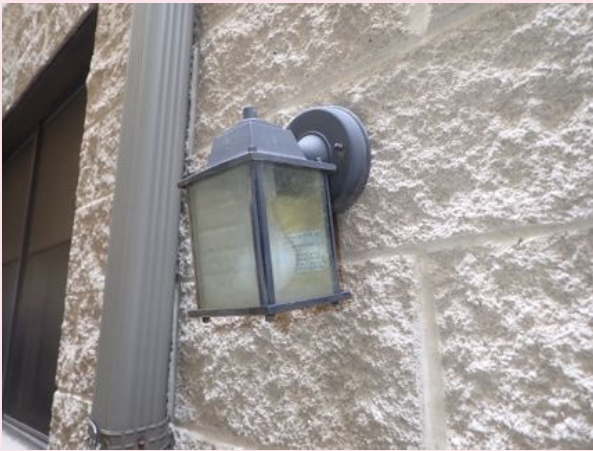
The exterior light fixture on the south side of the structure is loose and unsealed. Loose electrical fixtures can result in arcing/sparking during use and present an increased risk of fire and the unsealed condition can allow electricity to come into contact with energized equipment. Any loose electrical fixture in the structure should be evaluated and repaired as needed by a licensed electrician.

Loose and Unsealed Fixture

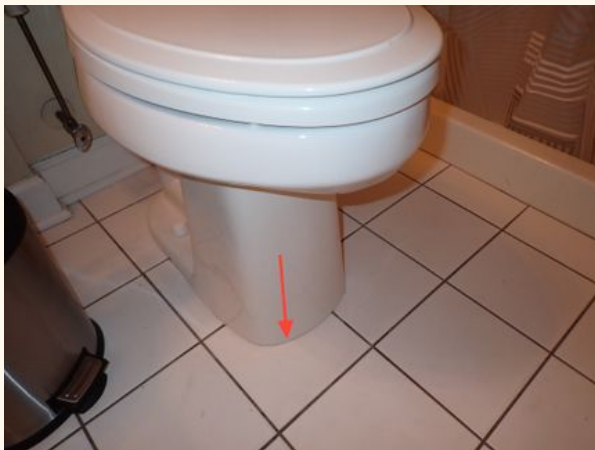
🔧 (PSDFAV-3) Repair: The gap between the toilet base and tile floors should be sealed using the appropriate materials and methods in order to reduce a "fouling area". If mop water, bathtub water or a less pleasant "bathroom liquid" gets underneath the toilet, there is no way to clean it up. In order to reduce this risk and promote proper sanitation in the bathroom, caulking around the base of the toilet is recommended.

Unsealed Base on Toilet

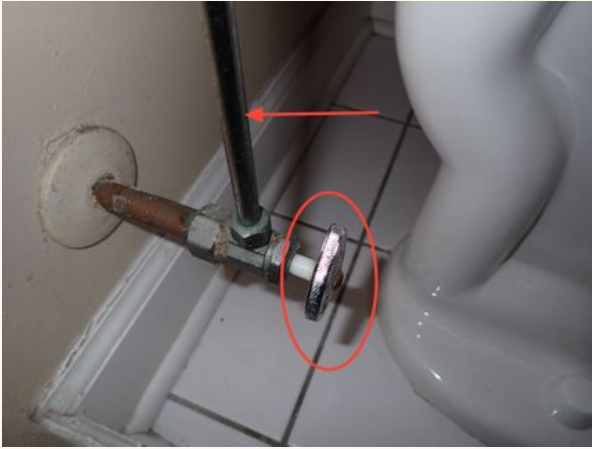
🔧 (PSDFAV-4) Repair: Older style gate valve shut-offs were noted on supplies to many of the plumbing fixtures in the residence. **These supplies can be prone to leakage when operated and they were not opened or closed at the time of the inspection.** In order to be able to shut off water to service plumbing fixtures in the future, the valves should be replaced with 1/4 turn ball valves by a qualified plumber. Also, the toilet in the unit is connected by a solid supply line that is prone to leakage from movement. **In order to reduce the potential for moisture related damage, it is highly recommended that the supply line for the toilet be replaced with braided stainless toilet supply.**

Older Gate Valve and Solid Supply on Toilet

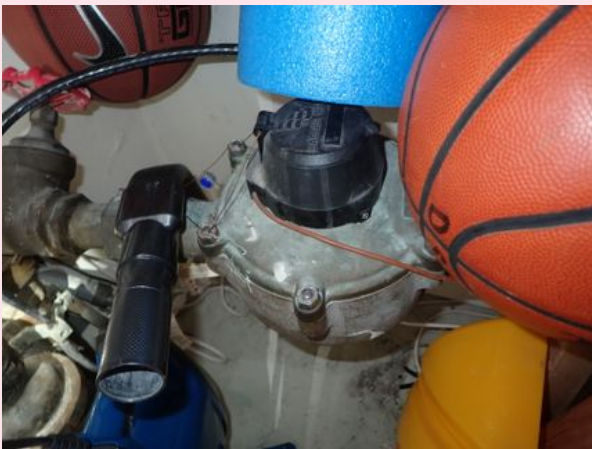
Buildings constructed in the City of Chicago which are 40 feet or taller are typically required to have water pressure booster pumps installed at the time of construction. No such system was noted in the subject property and the upper level units in this structure may have reduced flow when multiple fixtures are running. In order to ensure there is adequate water pressure to the upper level units, a qualified plumbing contractor should evaluate the water supply system in the structure and install such a system if it is determined that one is needed.

No Booster Pump in Building

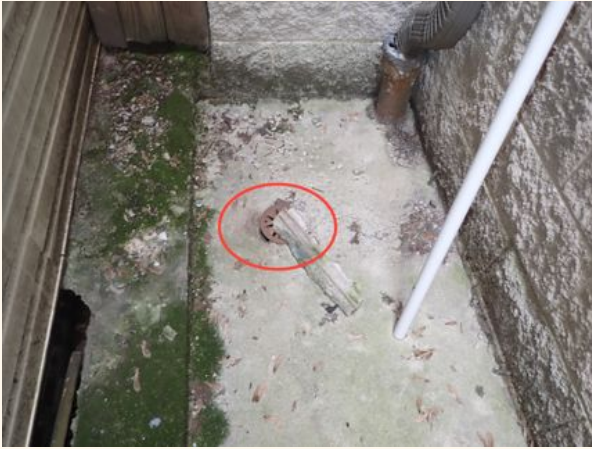
🔧 (PSDFAV-6) Repair: In order to reduce the risk for clogging and flooding in the basement stairwell, the installation of a dome style cover on the exterior basement stairwell landing drain is recommended.

Domed Style Cover Needed on Side Drain

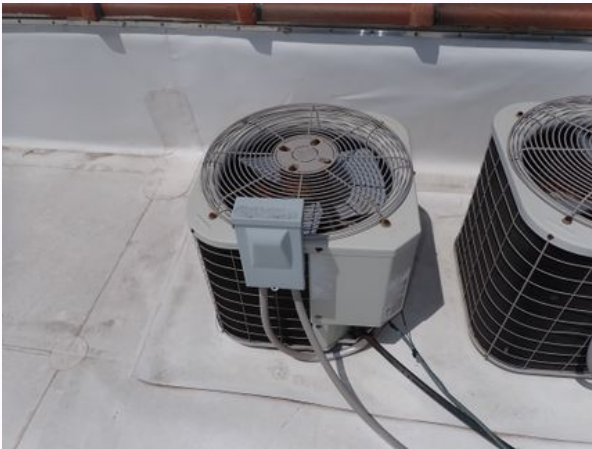
that is used in the unit is being phased out and no new or imported R-22 is allowed in the U.S. and technicians will only be able to use recycled, reclaimed or previously produced R-22 to service equipment. Therefore, it will become more expensive to service the unit in the future. The cost to retrofit the HVAC system to use the new R-410 A replacement refrigerant is expensive and involves replacing the evaporator coils in the furnace.

Older A/C Unit

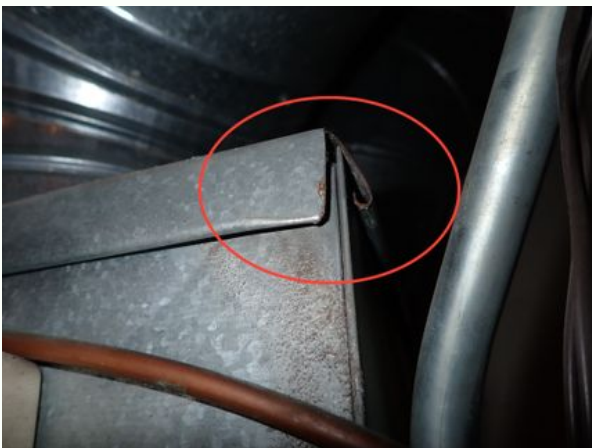
(HACVAGAS-2) Efficiency: Gaps may be present in the supply and return air duct work and/or in the HVAC plenums. These gaps create air leaks which can reduce the efficiency of the HVAC unit, and which can negatively impact both indoor air comfort and indoor air quality. The supply and return air ducts should be sealed using approved materials and methods; duct mastic is the preferred material for accessible duct sealing, however, complete duct sealing may be needed in some areas and there are companies that perform this service. Here is a link to questions and answers regarding this process from one such company: [Top 10 Questions Still Asked About Aroseal](#)

Air Noted Leaking from Gaps in HVAC Ductwork

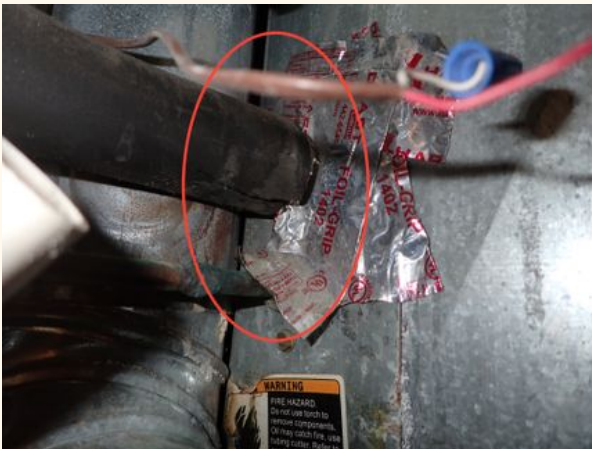
🔧 (HACVAGAS-3) Repair: Condensation staining and air gaps were noted on the air conditioning lines set and condensate drain entry points into the HVAC unit and **leakage stains were observed in the combustion chamber of the furnace.** In order to prevent further condensation and possible damage to the HVAC equipment, these entry points should be sealed a licensed and competent HVAC contractor.

Air Noted Leaking from Gaps in Lines Set Tubing Penetration

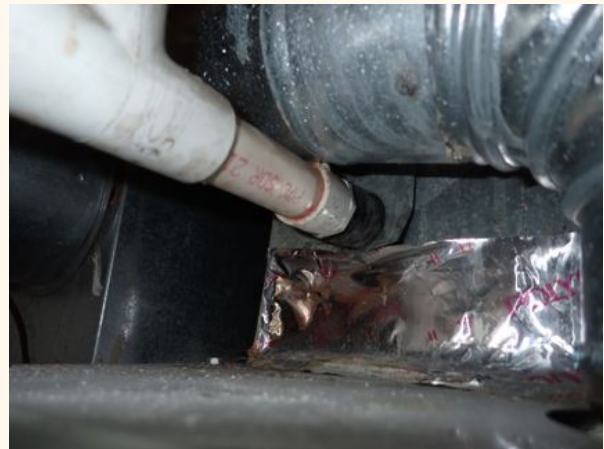
Air Noted Leaking from Gaps in Condensate Drain Penetration

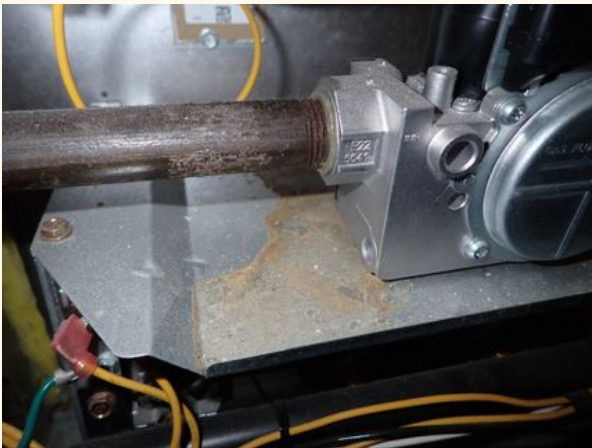
Leakage Stains in Furnace

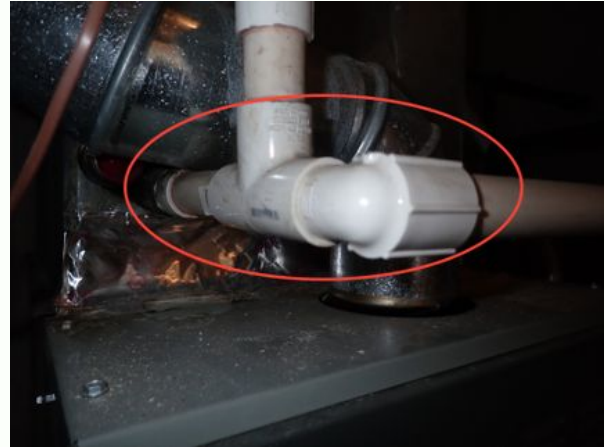
Trap Missing on AC Condensate Drain

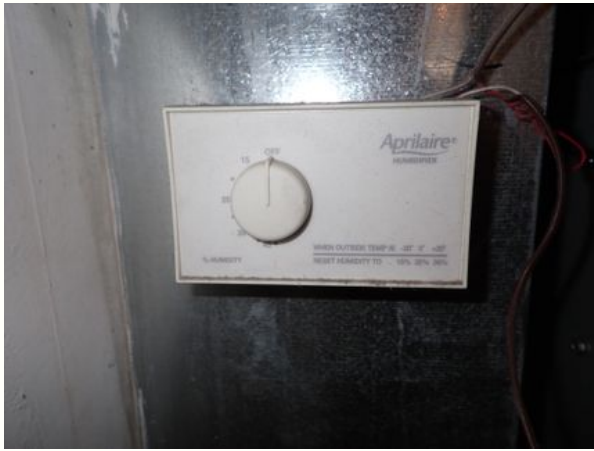
🌿 **(HACVAGAS-5) Note:** The humidistat control is located near the furnace which presents an 'out of sight, out of mind' situation for the homeowner. The humidistat requires frequent adjustment during the heating season, therefore, it is recommended that the humidistat be relocated next to the thermostat by a qualified HVAC contractor.

Humidistat Located in Furnace Closet

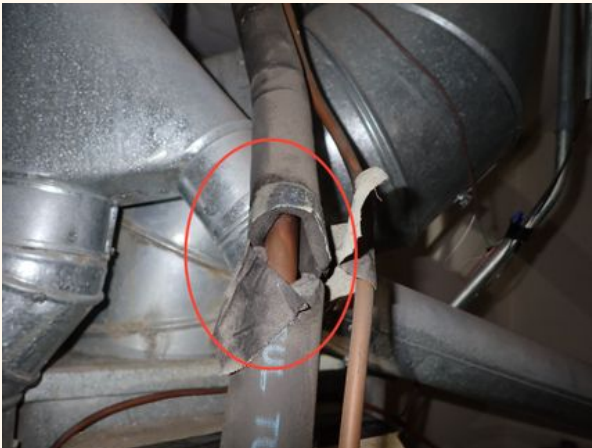
🔧 (HACVAGAS-6) Repair: The deteriorated/missing insulation on the A/C refrigerant lines can result in energy losses that promote the formation of condensation. In order to reduce the potential for moisture related damage and to reduce energy losses and maximize efficiency, the insulation should be replaced by a qualified HVAC contractor.

Interior Gap in Insulation

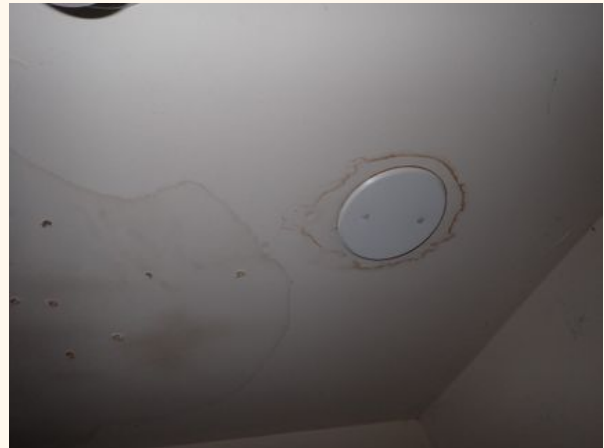
Moisture Stains in Ceiling of Furnace Closet

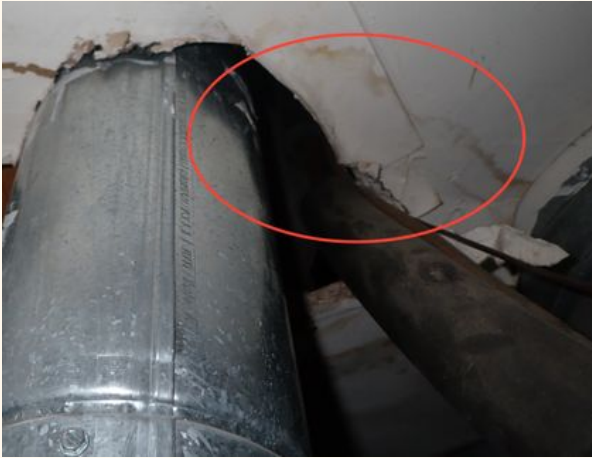
Stains by Piping in Ceiling of Furnace Closet

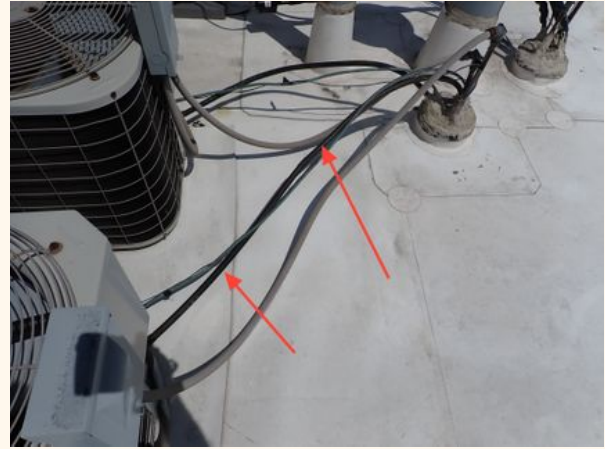
Missing Insulation on Rooftop A/C Refrigerant Line

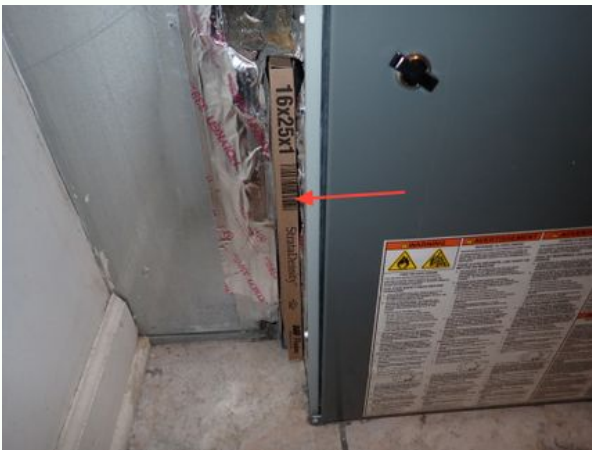
🍃 **(HACVAGAS-7) Efficiency:** The filter rack for the HVAC system is unsealed. In order to prevent "air filter bypass" and the resulting dirt accumulation inside the operating components of the HVAC system, it is recommended that the large gaps around the HVAC air filter slot be sealed.

Open Filter Rack Allows Unfiltered Air to Bypass Filter

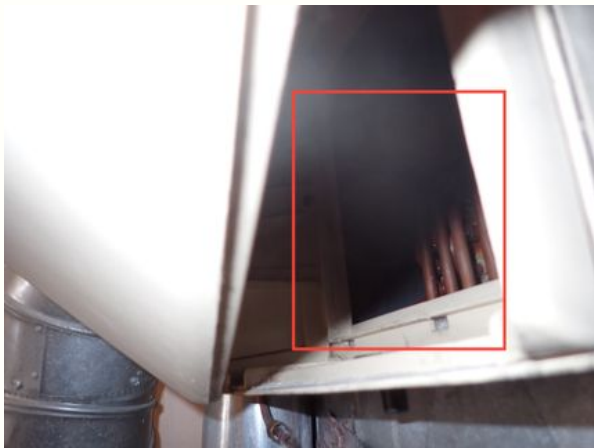
No Water Pad Inside Humidifier

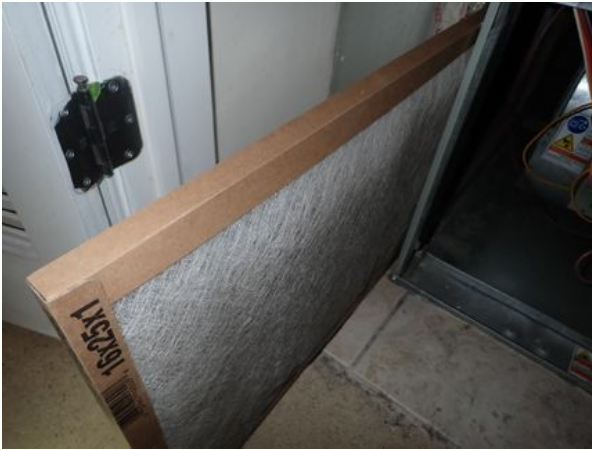
The use of thin pleated media filters can improve air quality for those with allergies, however, allergen filters will typically create a drastically reduced flow of air across the heating and cooling portions of the HVAC equipment, thereby significantly reducing the capacity and efficiency of the furnace and the air-conditioning system. Optimal air filtration is provided by 4 inch or 5 inch deep pleated filters since they allow for excellent dust capture and free conditioned air flow simultaneously. In order to determine the cost and feasibility for the installation of these high-performance HVAC air filters, it is recommended that the furnace/s in the home be further evaluated and potentially improved by a qualified HVAC contractor.

One Inch Thick Filters used in HVAC System

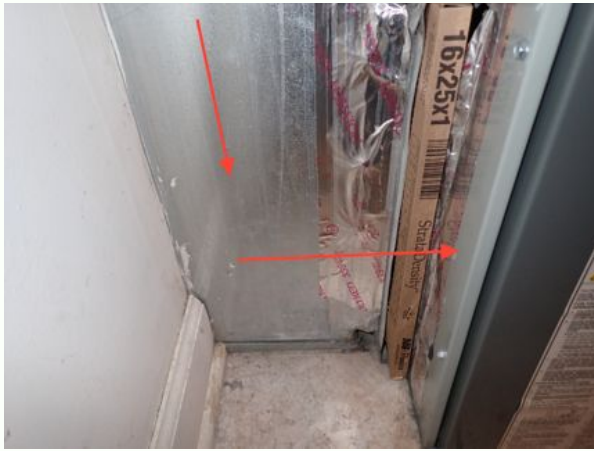
**(HACVAGAS-10) Efficiency:** The lack of a sweeping air return into the HVAC system reduces the efficiency of the airflow movement through the system thereby increasing heating and cooling costs. It is recommended that the return duct be evaluated by a qualified HVAC professional and that a cost be determined for reconfiguring the return ductwork for improved airflow capabilities.

Non-sweeping Return

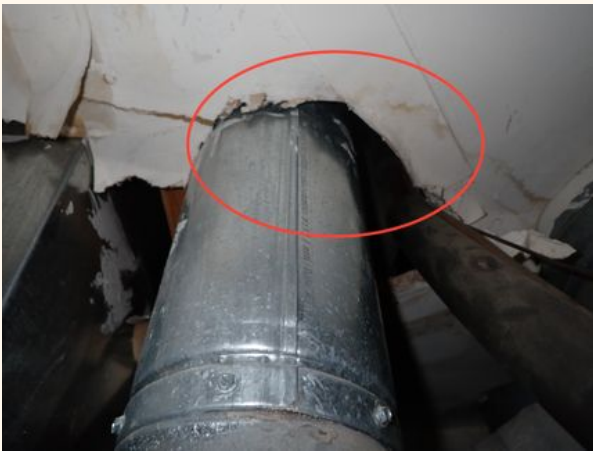
🔧 (IVAE-1) Repair: Open gaps were noted in the ceiling of the furnace closet that can allow smoke, carbon monoxide, and superheated gases to pass into other areas of the condominium in the event of a fire. In order to close off the gaps it is recommended that all opening be sealed with intumescent foam or other appropriate fireproofing materials.

Unsealed Gaps in Furnace Closet

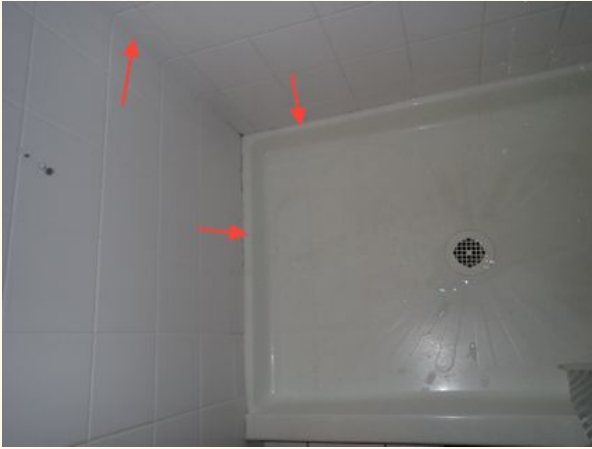
Corner Tile Joints Prone to Cracking

that the grout be raked out completely prior to re-caulking.

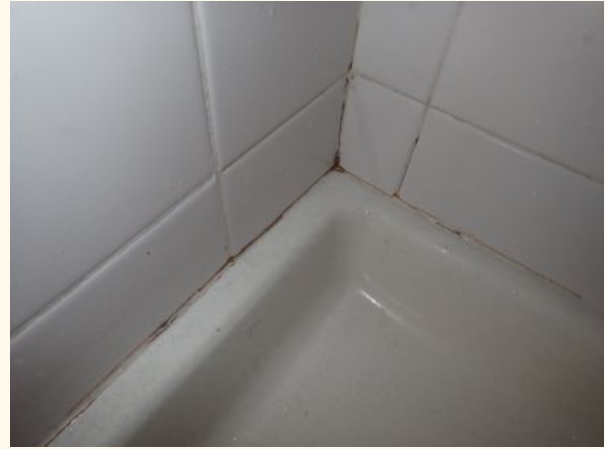
Mold Noted in Joints

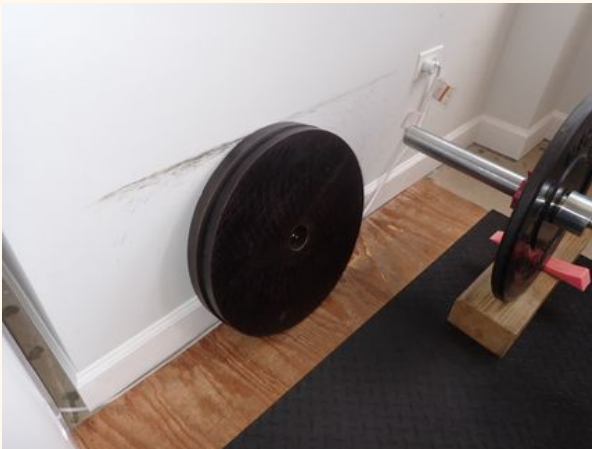
Damaged Wall Finishes

Persistent cracks in common areas for cracking like above doors and windows should be repaired with a flexible repair material. Here is a link to information regarding one such product: [Applying Krack Kote](#)

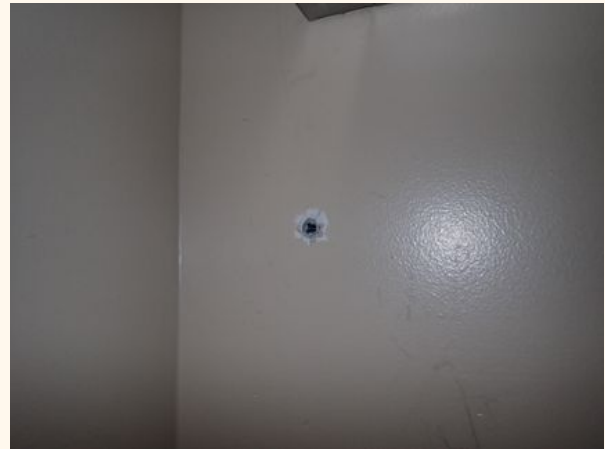
Screws in Walls

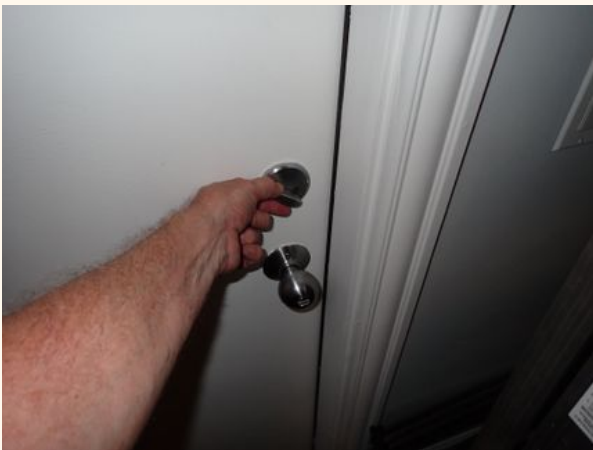
🔧 (WDS-1) Repair: At least one of the doors in the residence failed to close or latch properly. For proper operation it is recommended that any non-functional doors be repaired or adjusted by a qualified carpenter or handyman.

Difficult to Latch Rear Entry Door

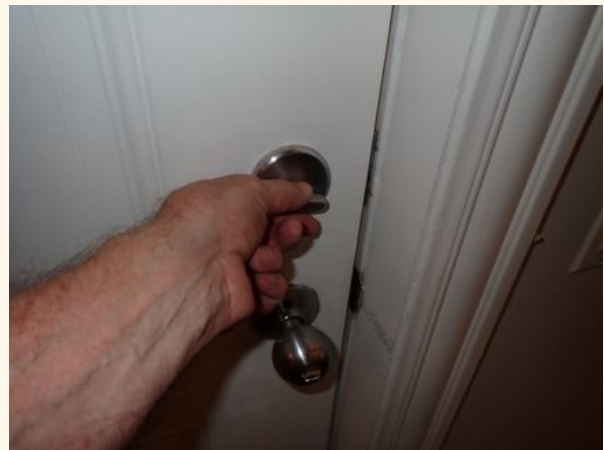
Difficult to Latch Side Entry Door

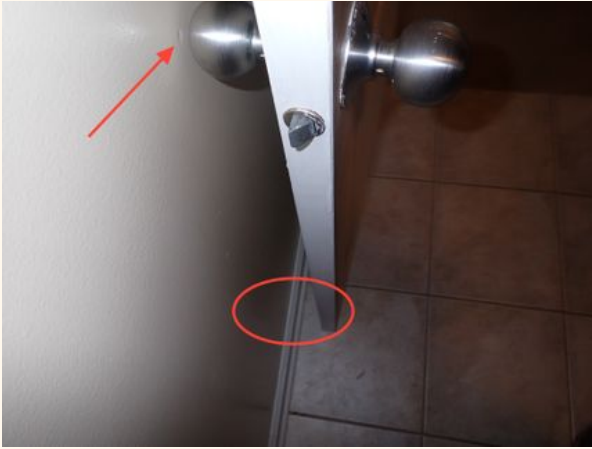
🔧 (WDS-2) Repair: Damaged finishes were noted on the walls adjacent to many of the doors. In order to protect the adjacent finishes and components from damage, door stops (hinge mounted, floor mounted, or wall mounted) should be installed by a qualified handyman.

Damaged Wall - Missing Doorstop

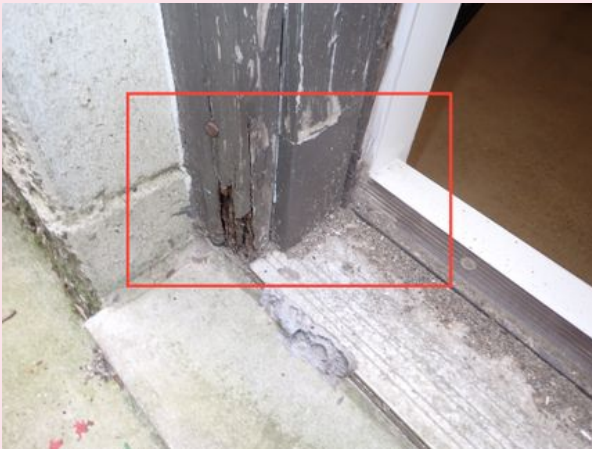
The lower portion of the doorframe on the exterior side entry door are deteriorated and elevated moisture levels were measured. In order to reduce the potential for further moisture related damage, it is recommended that a qualified carpenter evaluate and replace the deteriorated portions of the doorframe, possibly with materials that are less affected by moisture like PVC lumber.

Deteriorated Side Doorframe

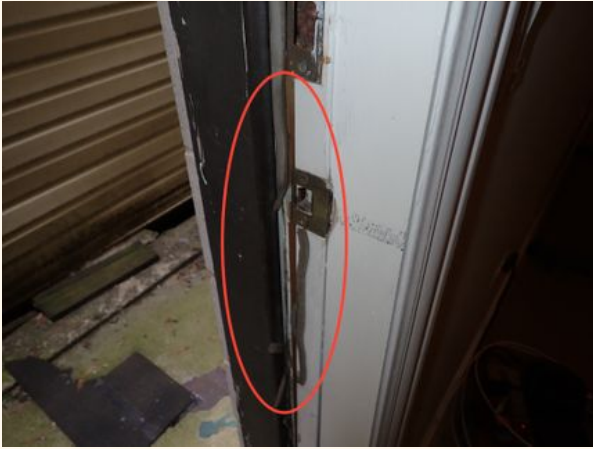
🔧 (WDS-4) Repair: The weatherstripping around the exterior entry door/s is deteriorated and/or missing. In order to conserve energy, reduce cold drafts and reduce noise levels inside the living space, the installation of high quality rubber bulb weatherstripping by a qualified handyman is recommended at the top and sides of the exterior entry door(s).

Missing Weatherstripping

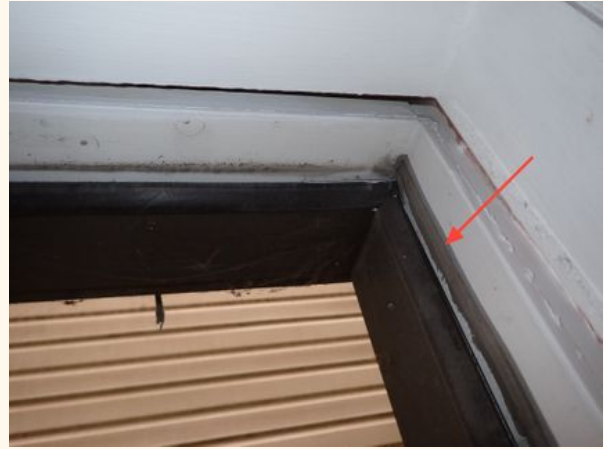
Low Quality and Missing Weatherstripping

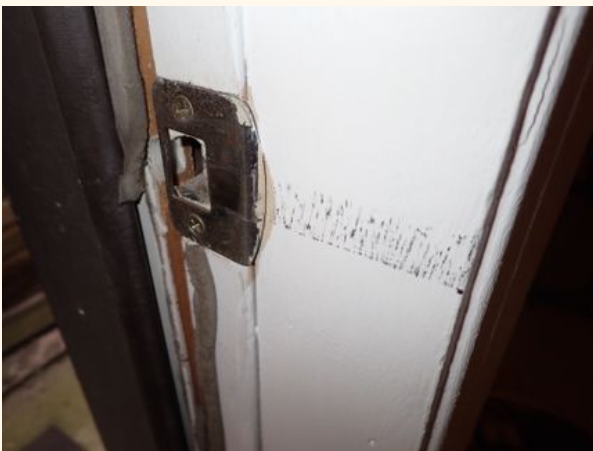
🔧 (WDS-5) Repair: The door latch on the exterior entrance door is damaging the doorframe. In order to prevent recurring disfigurement and damage to the doorjamb(s), the installation of an extended strike plate by a qualified carpenter or handyman is recommended.

Damaged Side Doorframe

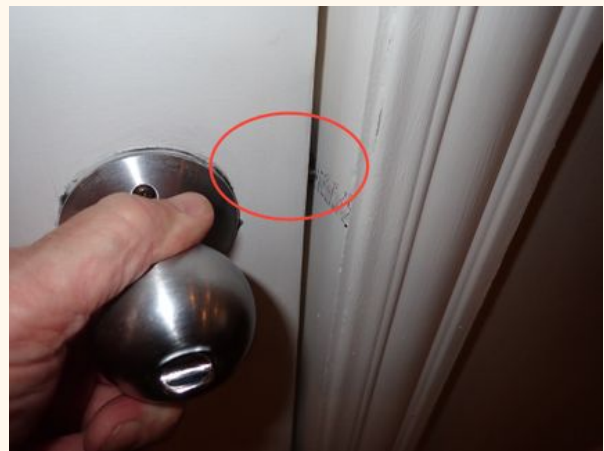
Latch Damaging Doorframe

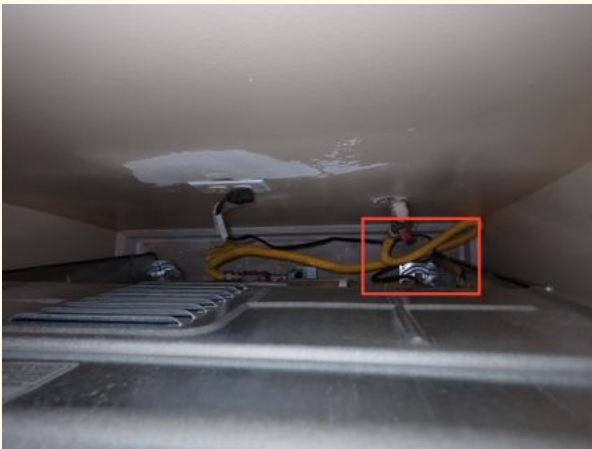
🔧 (IA-1) Repair: The kitchen range is unsecured and has the ability to tip under the right circumstances. In order to reduce the potential for scald and burn injuries related to the instability of the kitchen range, an anti-tipping device (Federally mandated and shipped with all ranges) should be installed behind the kitchen range.

Missing or Ineffective Anti-tip Device

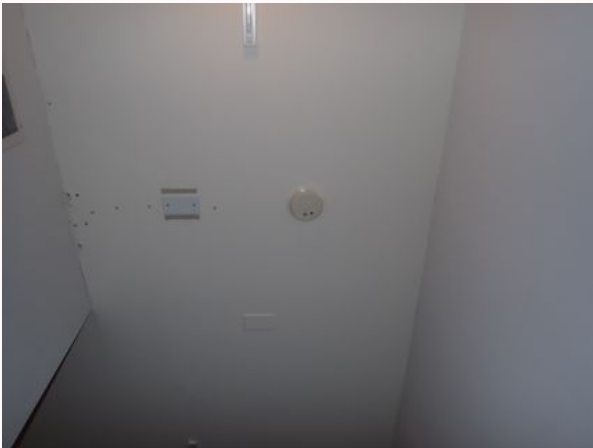
⚠️ **O-1 OTHER:** The smoke detectors noted in the unit appeared to be at or beyond the end of their service lives, typically taken to be 10 years for smoke detectors and 5 years for carbon monoxide detectors. It is recommended that the smoke detector and carbon monoxide detector systems be upgraded to reflect current life safety codes which include; smoke detectors on each level of living space and in each sleeping room, hard-wired 120 V smoke detectors that are interconnected in order to alarm simultaneously when any individual smoke detector responds, and carbon monoxide detectors and every level of living space and within 15 feet of a sleeping room. The installation of these critical life safety devices by a licensed and competent electrician is recommended.

Older Detector in Unit
