This report is prepared exclusively for **Some Customer**
Inspected On: **2022-11-25**

Domicile Consulting LLC
847.712.7874

This property was a mid sized commercial structure that was nearly 30 years old. There was some deferred maintenance on the exterior and the HVAC systems need replacement and significant attention in the not too distant future. It is highly recommended that the buyer read the report carefully, especially with regards to the future costs that may be incurred.

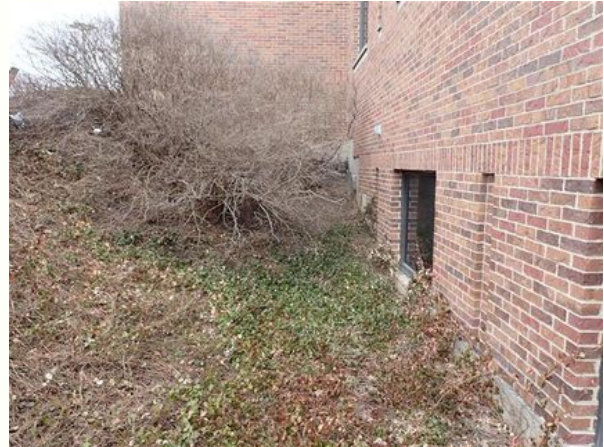
✦ **(IGPC-1) Note:** The grounds are generally level around the building with positive drainage away from the structure, however, there is a sunken garden area on a portion of the front of the building where the water drains towards the structure. No excessive moisture or staining was noted in the lower level walls of the storage room adjacent to the sunken garden area at the time of the inspection.

Sunken Garden Area

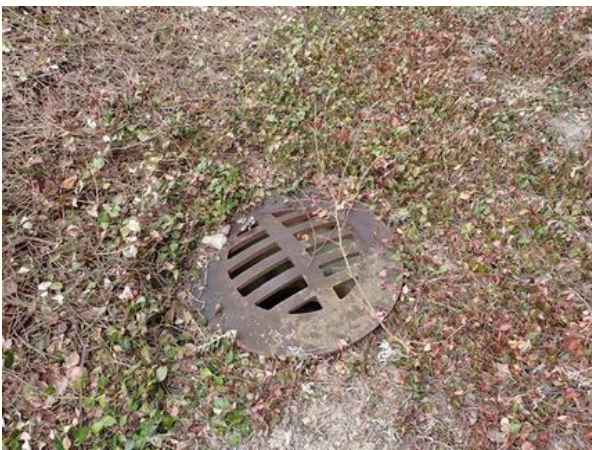
Large Drain in Garden Area

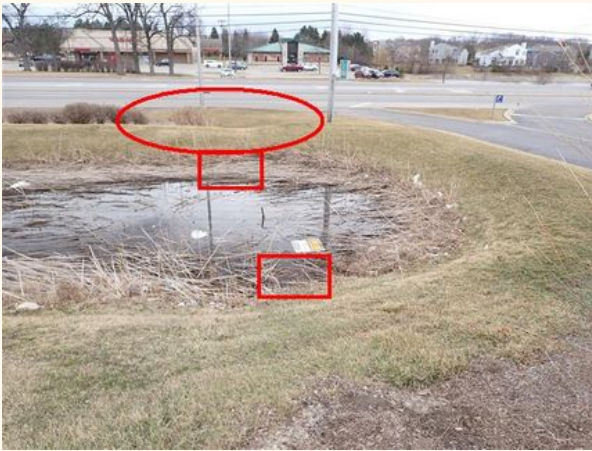
Basin Overflow Low Spot and Presumed Inlet and Outlet for Pond

maintain the proper operation of the basin, it is recommended that a landscape designer that specializes in retention basin design evaluate the basin. If undesirable species are present, a plan for cleaning and restoring the basin should be developed.

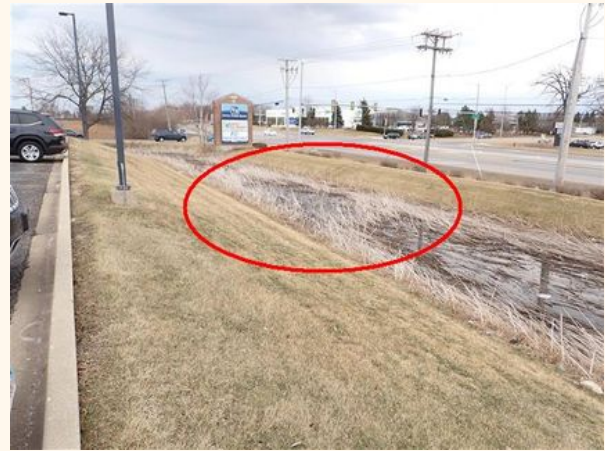
🔧 **IGPC-2 | GENERAL PHYSICAL CONDITION:** The majority of the drainage is contained on site and is tributary to what appears to be a standing water retention basin on the front of the property. The retention basin has significant plant growth in and around the basin that appears to be clogging the inlet and outlet of the basin as they were not visible at the time of the inspection. This plant growth limits the effectiveness of the basin and may have undesirable species and in order to maintain the proper operation of the basin, it is recommended that a landscape designer that specializes in retention basin design evaluate the basin. If undesirable species are present, a plan for cleaning and restoring the basin should be developed.

Basin Full of Plant Growth

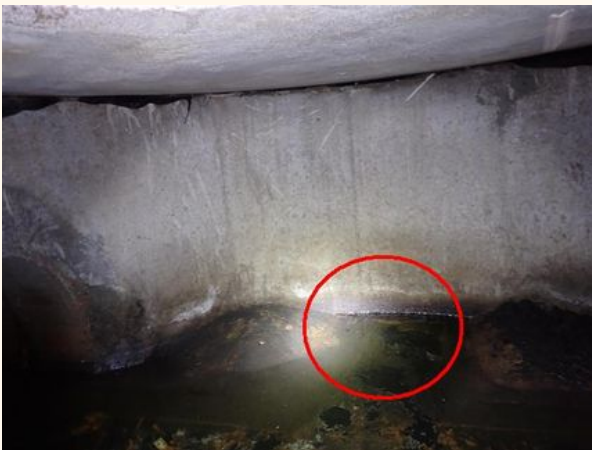
Possible Discharge Pipe in Manhole by Grand Ave

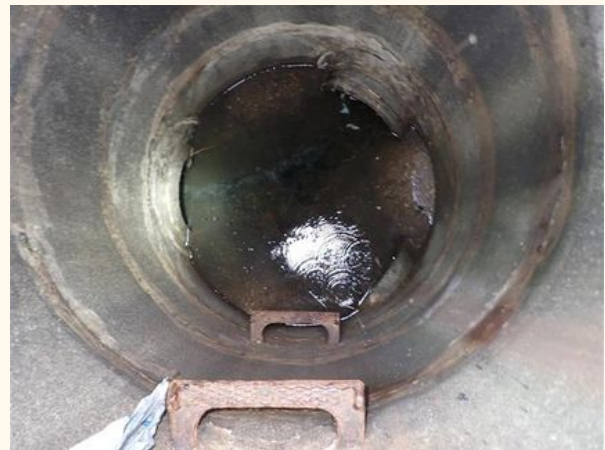
Standing Water in Inlet in Parking Lot

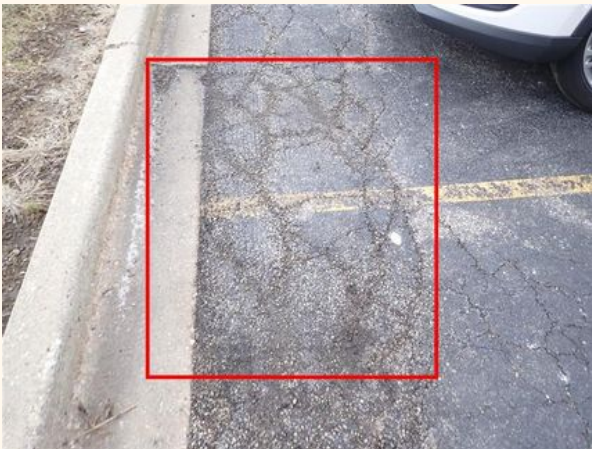
🔧 (IGPC-4) Repair: The asphalt paving is cracked and deteriorated and the open joints exacerbate further deterioration from moisture either saturating and softening the base or from freeze/thaw action in winter. In order to prolong the life of the asphalt the severely deteriorated portions should be removed and patched, minor cracks should be filled and the entire paved area should then be seal coated. Evaluation and repair by a qualified asphalt contractor is recommended.

Cracked Paving by Curb

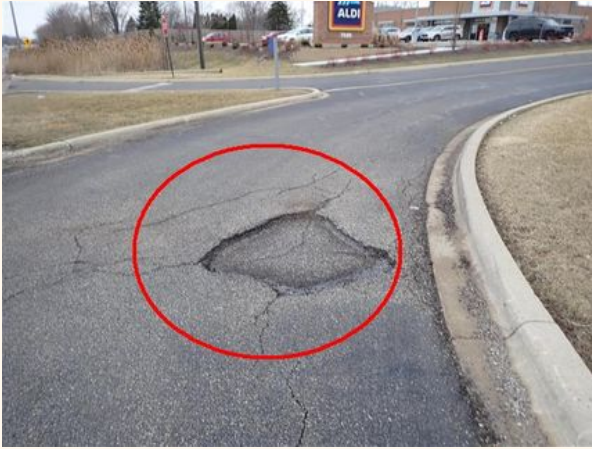
Large Hole in Apron by Grand Ave

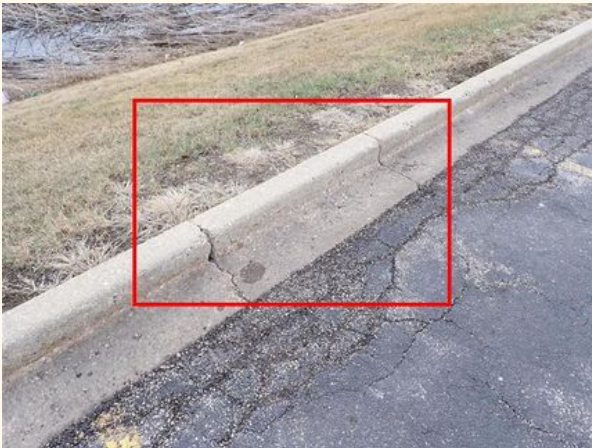
🔧 (IGPC-5) Repair: The existing curb is in generally good condition, however, some portions are cracked and damaged and some areas do not drain completely which can contribute to the deterioration of the asphalt paving. In order to reduce the potential for moisture related damage to asphalt areas, damaged areas of curb and gutter should be replaced prior to any asphalt patching or seal-coating that may be considered.

Cracked Curb Sections

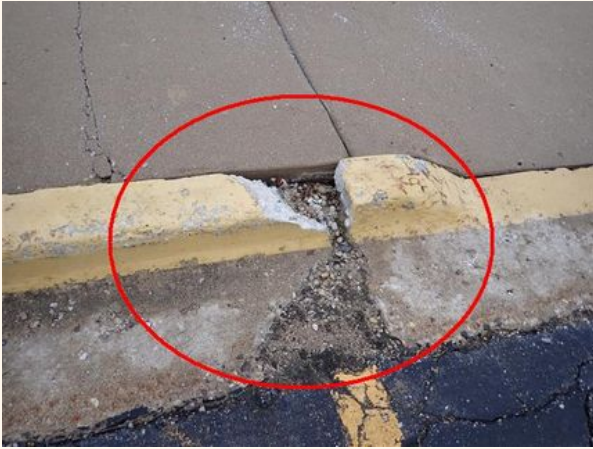
Damaged Curb by Handicapped Ramp

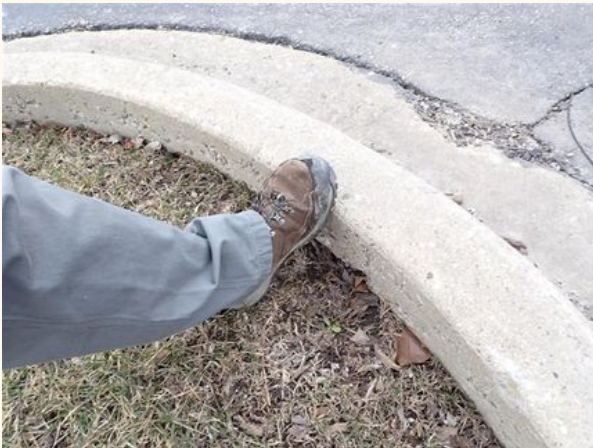
🔧 (IGPC-6) Repair: There are drop-offs behind the curb that create possible trip hazards and also leave the back of the curb unsupported and more prone to snowplow damage. In order to reduce the potential for injury and damage, it is recommended that a qualified landscaping contractor backfill the low areas adjacent to the curbs with topsoil and that the areas be restored with appropriate grass seed mix.

Drop-offs Behind Curbs

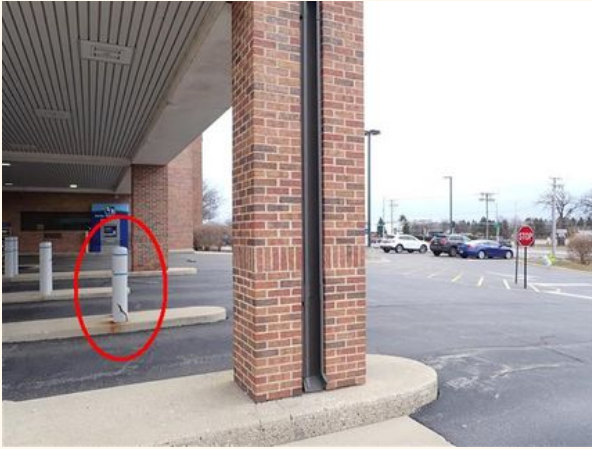
🔧 (IGPC-7) Repair: The plastic covering on one of the bollards by the drive-thru was cracked and the bollard beneath was heavily corroded. It is unknown if the plastic covering is accelerating the corrosion of the bollard or the bollard is corroding from exposure. In order to provide the intended protection for the drive-thru lanes, it is recommended that the corroded bollard be evaluated and repaired or replaced by a qualified concrete contractor and at least one covered bollard should be more closely examined in order to determine if there is a widespread problem.

Damaged and Corroded Bollard

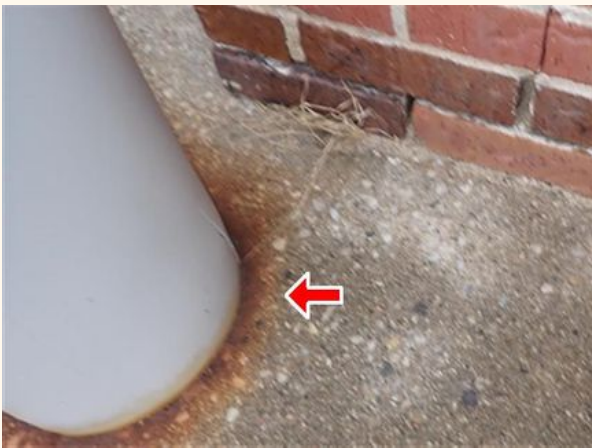
Corrosion Noted Around Bases of Bollards

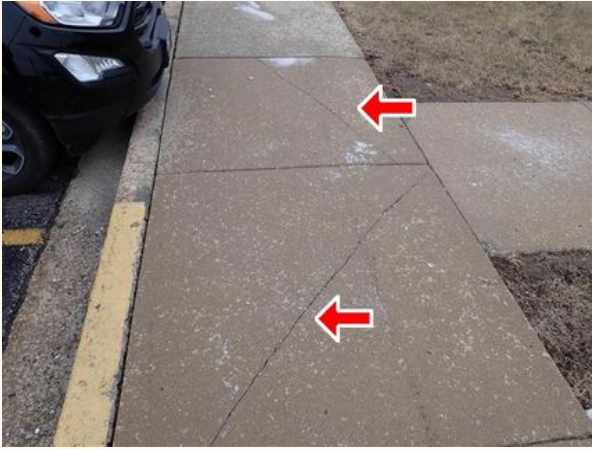
🔧 (IGPC-8) Repair: The exterior concrete walks have cracks which can allow moisture penetration that creates the potential for further damage from freeze/thaw cycles. In order to reduce the potential for moisture related damage, the cracks should be sealed by a qualified concrete repair contractor.

Cracks in Walks

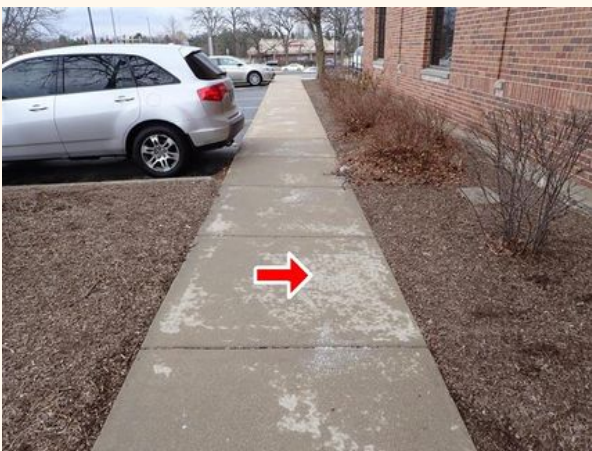
⚠️ (IGPC-9) Repair: Several of the sidewalk squares have settled and are sloping towards the building preventing those areas from draining. In order to reduce the potential for excess moisture to affect the foundation, it is recommended that either the settled slabs be replaced or it may be possible to lift the slabs through slabjacking.

Sidewalk Slopes Towards Building

Here is a link to information from a contractor regarding options for settled concrete: [Three Options for Repairing Sunken Concrete](#)

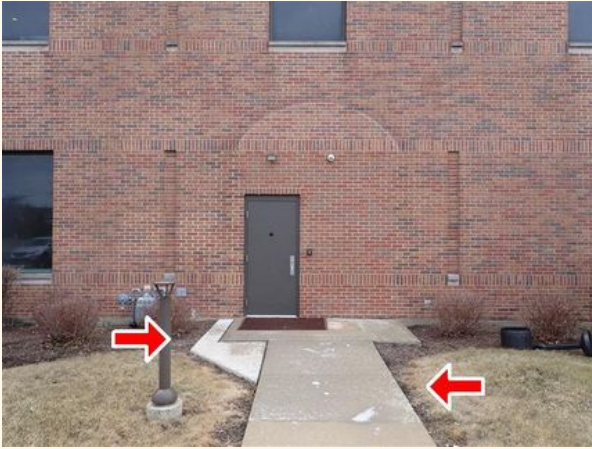
⚠️ (IGPC-10) Repair: There are drop-offs along the edges of the walk that create possible trip hazards. In order to reduce the potential for injury, it is recommended that a qualified landscaping contractor backfill the low areas adjacent to the walk with topsoil and that the areas be restored with appropriate grass seed mix.

Drop-offs Near Rear Entrance

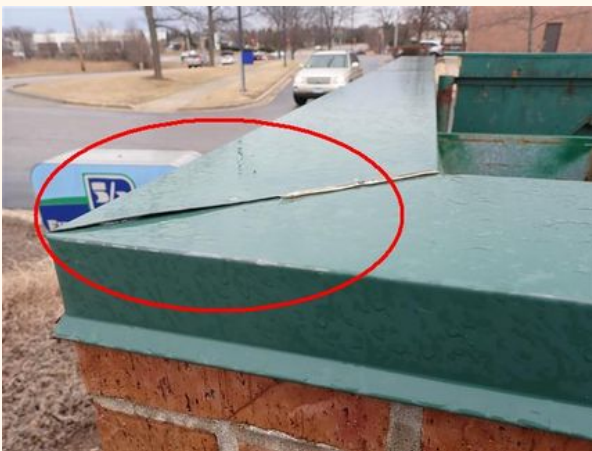
🔧 (IGPC-11) Repair: Damage to the masonry walls surrounding the waste container storage were observed. The metal capping at the top of the masonry walls does not conform with industry standards as published by the Sheet-Metal and Air Conditioning Contractors National Association (SMACNA). The metal wall cap does not promptly shed moisture; does not have sleeved and gasketed overlaps; and is composed of relatively thin metal which will expand and contract significantly from temperature changes. These defects greatly increase the risk for moisture penetration into and through the underlying masonry walls. It is recommended that plans be made for the near-term replacement of the existing wall cap with one that reflects industry standards and best practices. As a part of the cap replacement, any cracked wall areas should be re-pointed and repaired as needed by a qualified masonry contractor.

Unsealed Corner Joints on Caps

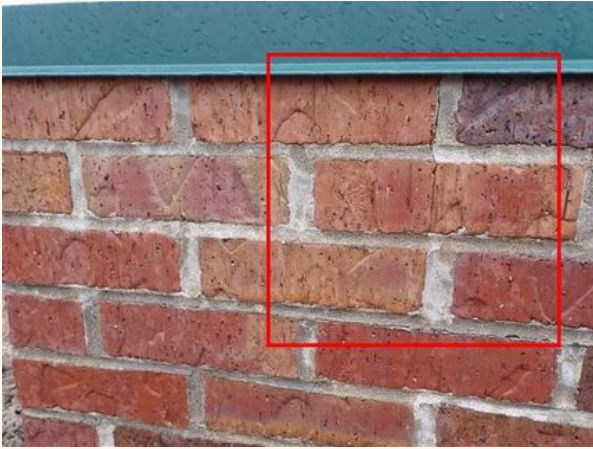
Cracks Noted in Masonry Below Cap

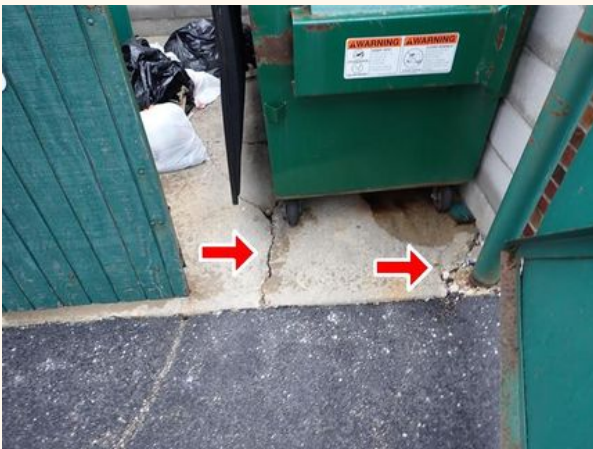
Also, concrete slab that also surrounds the posts for the gates on the waste enclosure is badly cracked, especially around the posts which may affect the stability of the gates and the slab should be evaluated and repaired or replaced by a qualified concrete repair contractor.

Cracked and Damaged Slab

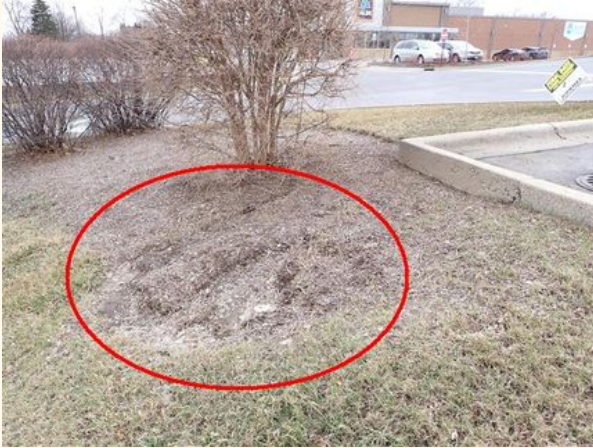
🔧 (IGPC-12) Repair: The existing bushes, trees and landscaping installations are overgrown and/or dead and in need of trimming and/or removal. Also, some erosion is occurring on the more severe slopes and alternatives like groundcover rather than mulch may provide for more stable installations. For proper appearance of the property the vegetation in the exterior areas should be evaluated by a qualified arborist and/or landscaping contractor and be addressed as needed.

Eroding Areas Around Trees

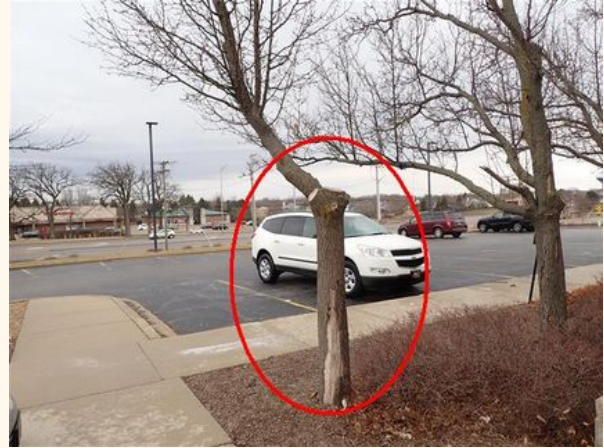
Trees with Significant Limb Loss

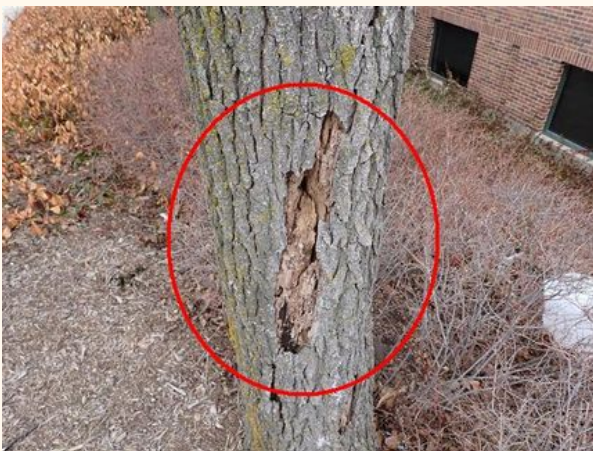
Decay and Disease on Trees

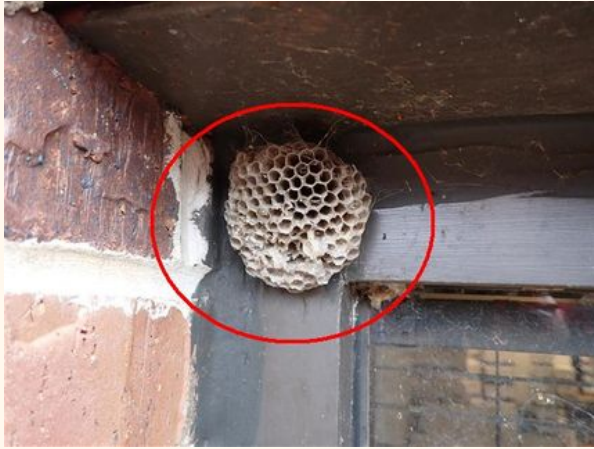
🔧 IGPC-13 | GENERAL PHYSICAL CONDITION: Nests for flying stinging pests were noted in several locations around the structure and in order to discourage further nest building, extreme care should be taken to remove all old and active nests. There are many ways to discourage these insects from establishing residences on your property, one way is to plant vegetation that repels bees and wasps. Here is a link to an article with information regarding this practice: [10 plants that repel bees and wasps](#)

Numerous Nests Noted on Exterior of Structure

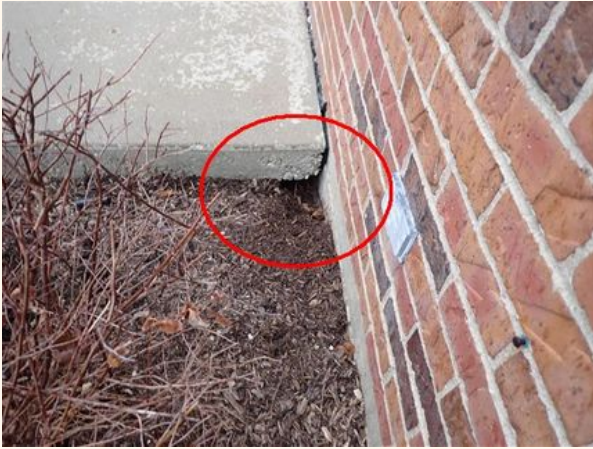
🔧 (IGPC-15) Repair: It appears that an animal may have taken up residence under the rear sidewalk. In order to determine if an animal is present, it is recommended that the area be closely examined and if none is found, the entrance should be sealed with materials that would deter future burrowing.

Hole Beneath Rear Sidewalk

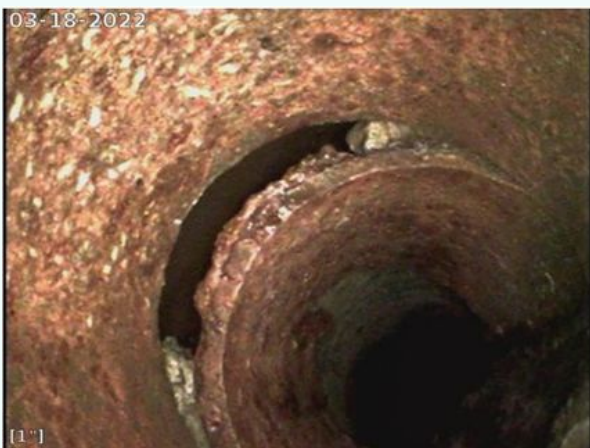
🕒 **(IU-4) Monitor:** The main sewer pipe was televised as a part of this inspection and the report is available in the "Attachments" section of the report. **The pipe that extends to the sanitary manhole in the western drive appears to have a separation immediately past the foundation.** It's possible that the cast iron pipe that is most likely present cracked from settlement of the backfill around the structure after the building was completed. While the separation of the pipe appeared to be minimal and did not appear to be causing problems, open joints like this can allow surrounding soil to enter possibly resulting in a sinkhole and/or clogging of the manhole. If such a sinkhole develops it will be immediately adjacent to the building and the pipe will need to be repaired by a qualified underground contractor or plumber if that situation develops

Pipe Separation on Sanitary Main

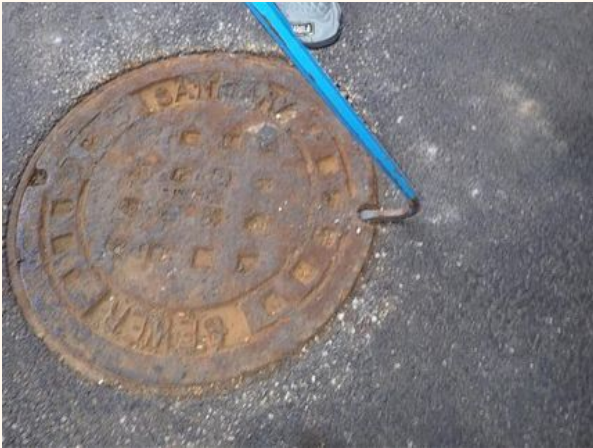
🔧 **(IU-5) Repair:** The manhole cover for the sanitary main located in the west drive on the property is heavily corroded and could not be removed at the time of the inspection and

Corroded Manhole Cover

therefore further evaluation of the sewer could not be performed. In order to be able to assess the sewer and perform any maintenance that may be needed, it is recommended that a qualified underground contractor or plumber remove the lid and examine the sewer.

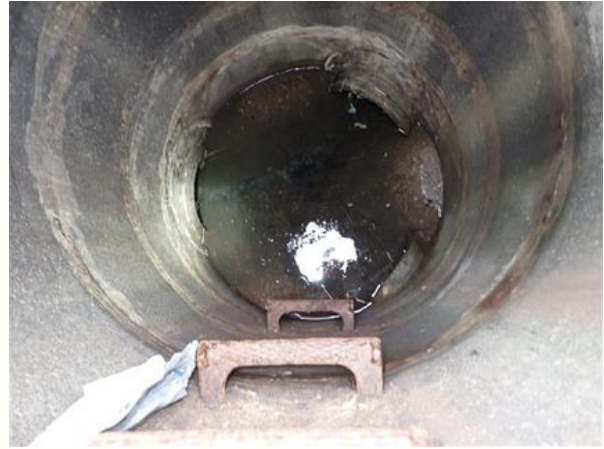
✦ **(IU-7) Note:** The storm sewers on the property appeared to be functional, however there was standing water in the lowest basin that may be caused by blockage of the drainage outlets as discussed elsewhere in this report.

Standing Water in Manhole in Parking Lot

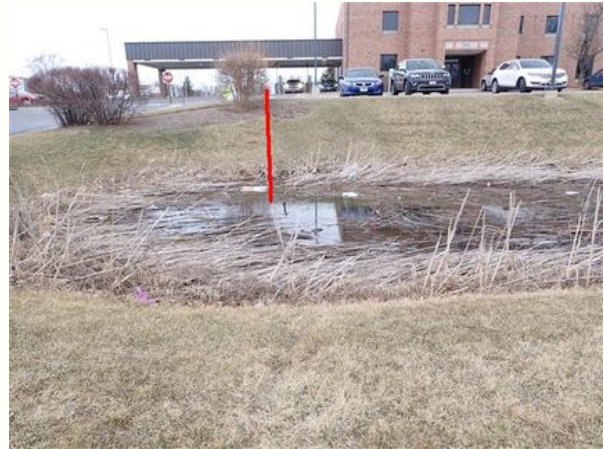
Storm Sewer From Manhole into Pond

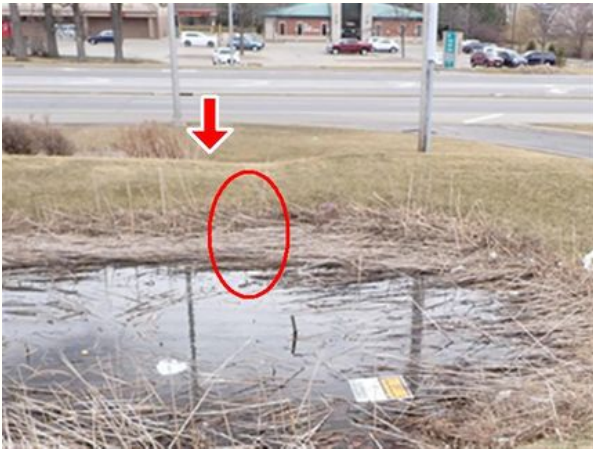
Manhole By Street - Presumed Pipe From Pond

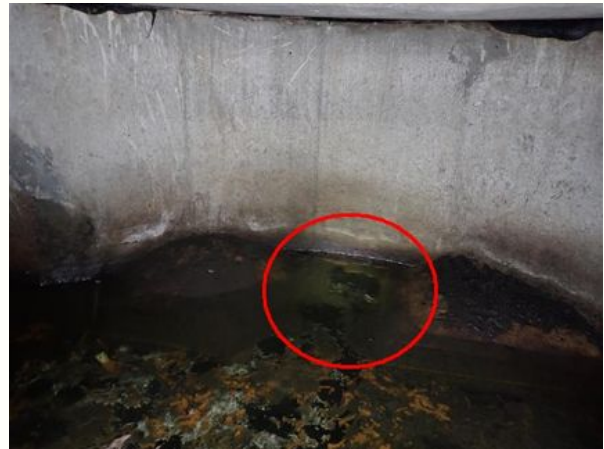
Possible Pipe Location in Manhole by Street

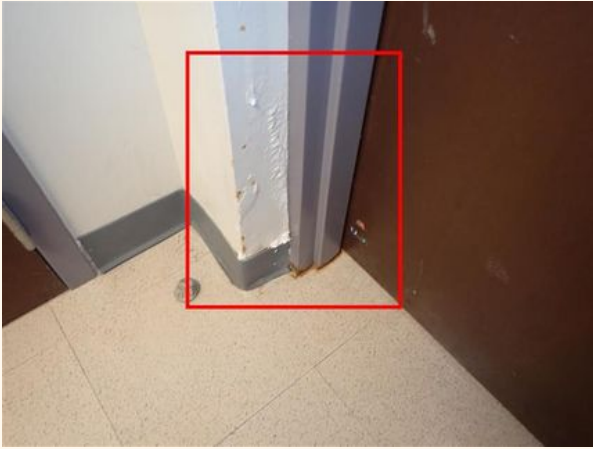
🔧 (ISFABE-1) Repair: Moisture related staining and damage was noted in the basement level on the walls of both of the stairwells and by the elevator. Corrosion and damage was observed on both of the metal doorframes on the access doors from the stairwells and on the metal framing inside the access panel area by the elevator. It appears there is moisture seeping into the stair wells and by the elevator and it is unknown if there are cracks or excessive hydrostatic pressure along the foundation. In order to further diagnose what is occurring it would be necessary to remove the wall coverings in these locations. In order to reduce the potential for continued moisture related damage, further evaluation and potential repairs by a qualified waterproofing/foundation repair contractor is recommended.

NOTE: Some of the moisture related damage in the NE corner stairwell may be related to leakage from the rear access door as extensive damage was noted on the doorframe and walls surrounding that door and moisture could be entering via a poorly sealed door as discussed in the "Fenestration System" section below.

Moisture Stains and Damage by Lower Level Doors

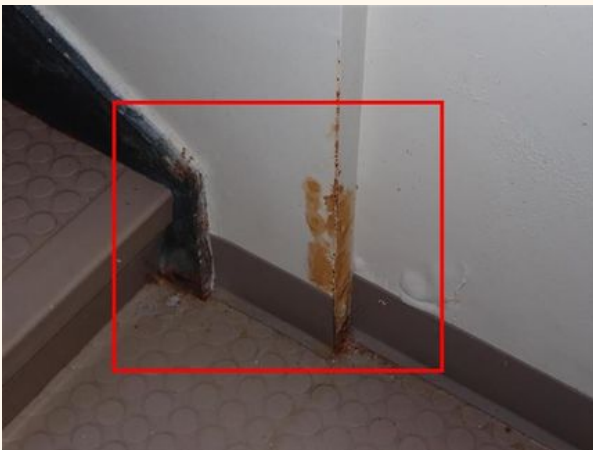
Moisture Stains and Damage on Stairwell Walls

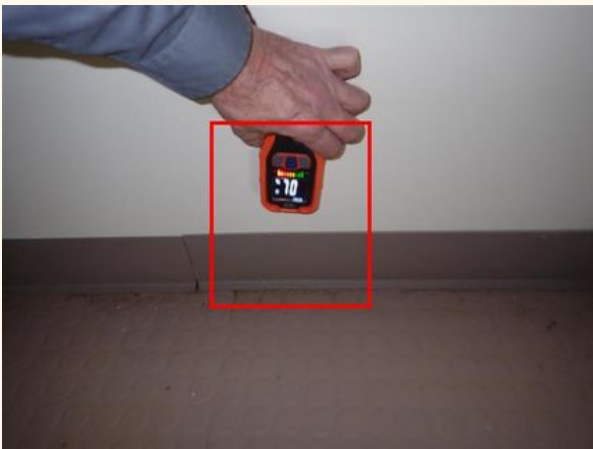
Elevated Humidity Measured in Areas with No Damage

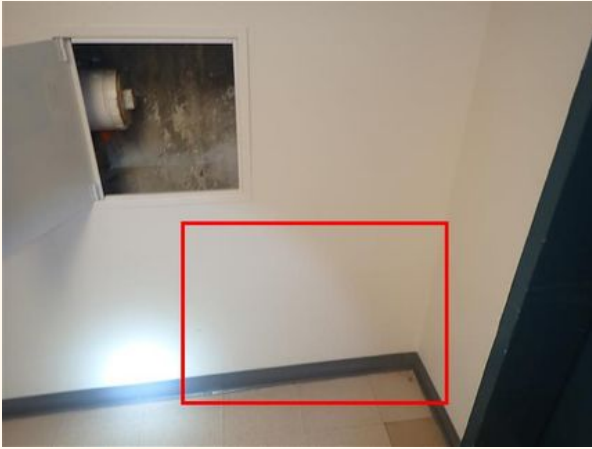
Moisture Related Damage by Elevator

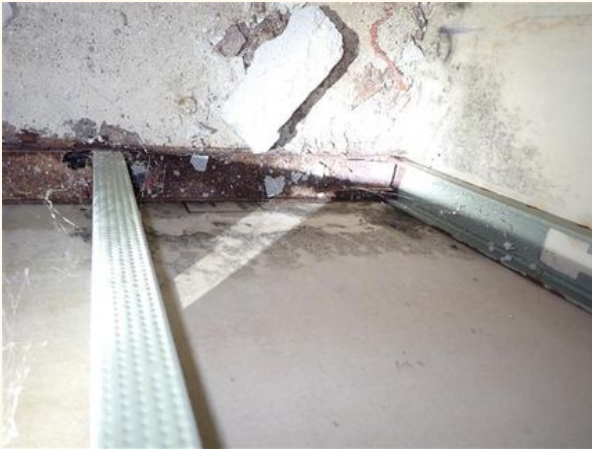
Corrosion on Framing by Elevator

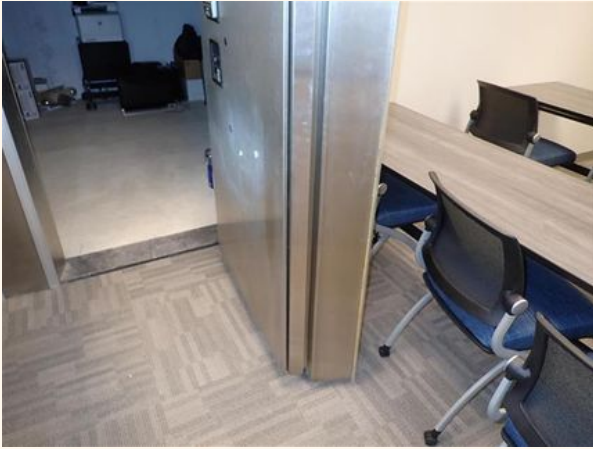
🔧 (ISFABE-2) Repair: Moisture related staining was observed on the interior of the bank vault and seepage may be occurring along what appears to be a cold joint in the foundation and also through honeycombing in the concrete. Since this is a bank vault, there may have been more reinforcement than is installed in a normal foundation which can make it difficult to consolidate the concrete during pouring resulting in a porous wall. Also, if the concrete was not delivered and poured in a timely fashion, the newly placed concrete does not bond with the concrete beneath. The plans for the building can be reviewed to confirm the presence of the additional reinforcement and given the lack of inward movement on the wall it is doubtful that there are structural concerns, however, the leakage through the concrete is difficult to eliminate and typically requires the installation of an exterior membrane on the foundation wall and evaluation and repair by a qualified foundation repair contractor is recommended.

Bank Vault

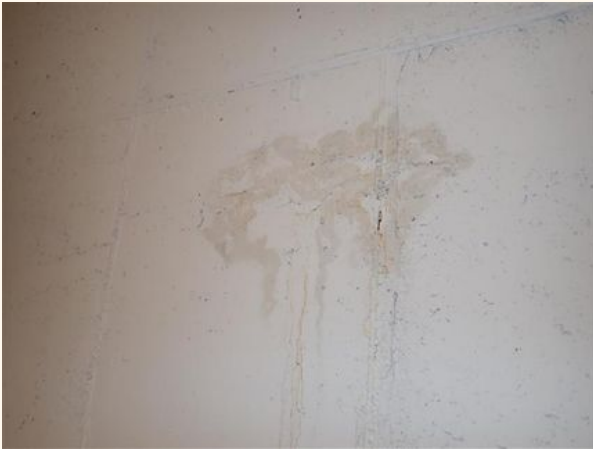
Leakage Through Honeycombed Area

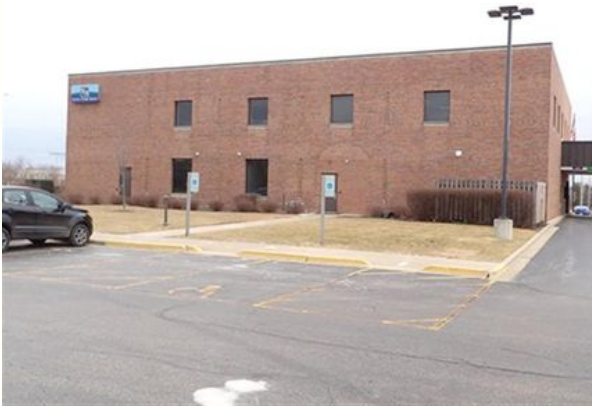
✦ **(ISFABE-3) Note:** The foundation was not visible or accessible at the time of the inspection as most of the basement wall areas are finished and very little of the foundation was exposed near the surface and therefore could not be evaluated, however, there was no significant cracking, openings or gaps in the exterior walls and around the windows at the time of the inspection that would suggest significant settlement of the structure has occurred.

No Significant Cracking in Exterior Masonry Walls

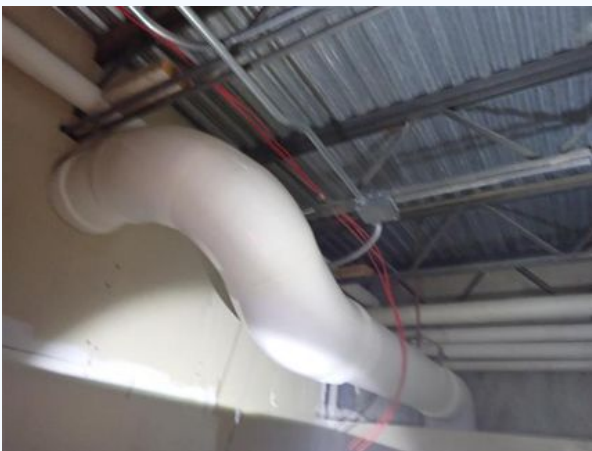
Q (ISFABE-4) Due Diligence: The framework for the structure was not readily visible but is believed to be a steel beam and girder support system with truss supported pans and poured concrete floors. Confirmation of the structures framing should be able to be confirmed through review of the building plans for the structure.

Visible Pans and Trusses Between Floors

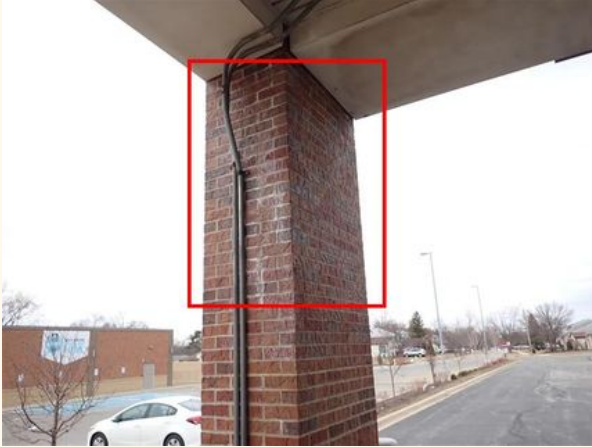
P (ISFABE-5) Repair: Efflorescent staining was observed on the NW column for the drive thru and moisture related damage was observed near several of the joints in the steel façade material on the top of the drive thru canopy. There is a large shelf on the façade that appears

Efflorescent Stains on Column

to be collecting water running down the face of the metal and directing it into specific locations on the canopy. In order to reduce the potential for continued moisture related damage, it is recommended that a qualified metal fabricator and/or roofing contractor evaluate and repair the façade as needed

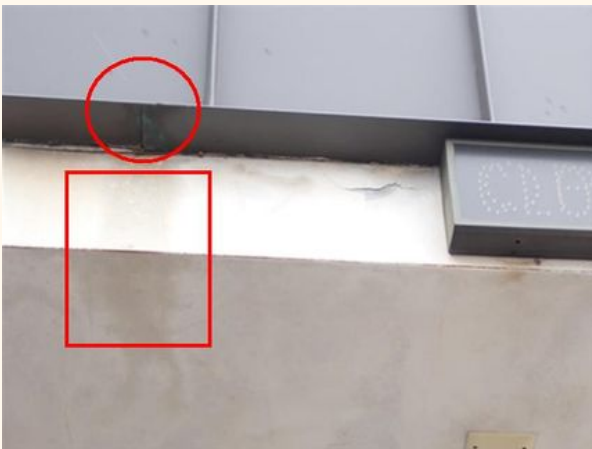
Moisture Stains on Façade Shelf and Damaged Fascia Below

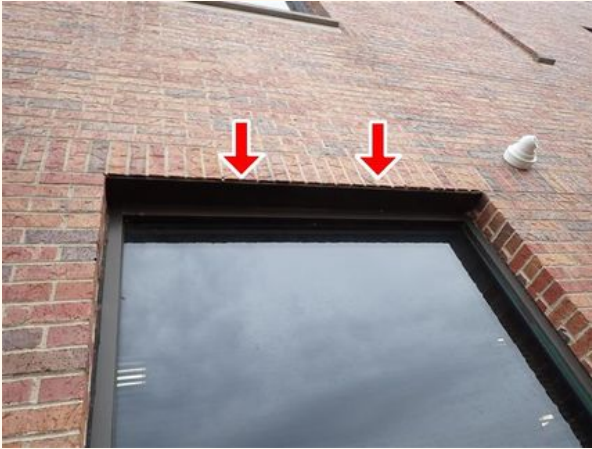
🔧 (ISFABE-6) Repair: The masonry wall flashings are either missing or improperly installed. The flashings should be used in conjunction with stainless steel drip edge, should be 'end dammed' and should be present at the following locations: the top of the foundation wall; above the masonry pockets where the floor joists are set into the masonry wall; above and below every window, door and all lintels/beams. Missing or improperly installed wall flashing can allow moisture to enter the structure and cause rot, mold growth and structural damage. The exterior masonry walls of this structure should be evaluated and repaired by a qualified masonry contractor.

No Drip Edge Observed Above Windows

NOTE: While the cost to retrofit missing or improperly installed masonry wall flashings for the window and door lintels can vary significantly depending on the height of the work, the need for sidewalk canopies, proximity of overhead power lines, etc., a commonly quoted cost for such work is approximately \$225 per lineal foot.

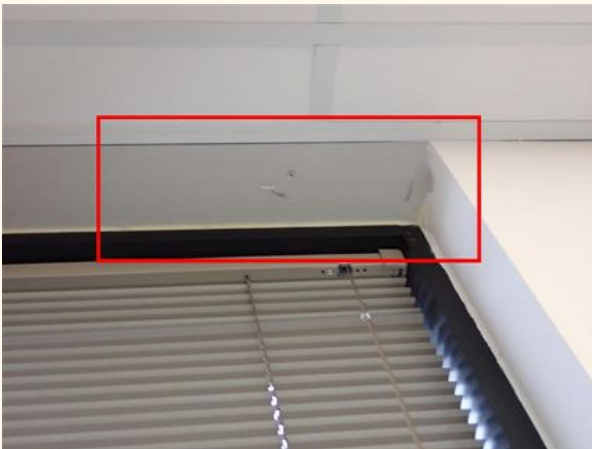
Potential Repaired Window Areas

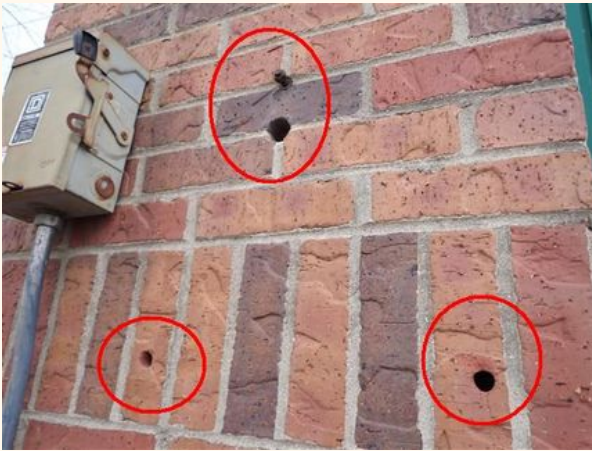
🔧 (ISFABE-7) Repair: Large open holes were noted on the masonry sign in front of the property. These openings create the potential for the entry of moisture that can damage the masonry via freeze/thaw damage. In order to reduce the potential for moisture related damage, it is recommended that a qualified masonry contractor evaluate and repair the sign as needed.

Holes in Sign

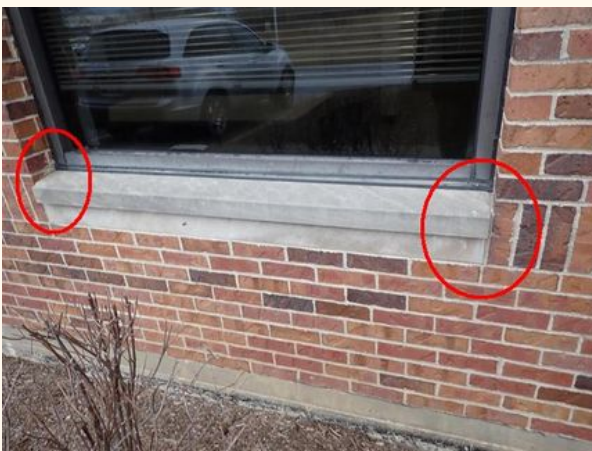
🔧 (ISFABE-8) Repair: While the mortar joints at the corners of the stone window sills and between all limestone copings were in generally good condition, hairline cracks were noted in some corners. In order to reduce the risk of moisture saturation, moisture intrusion to the interior and damage to the brick masonry below the sills, the mortar in the joints should be raked out and sealed instead with a high-quality masonry caulking compound by a qualified masonry restoration contractor or handyman.

Mortar Joints in Corners of Stone Sills

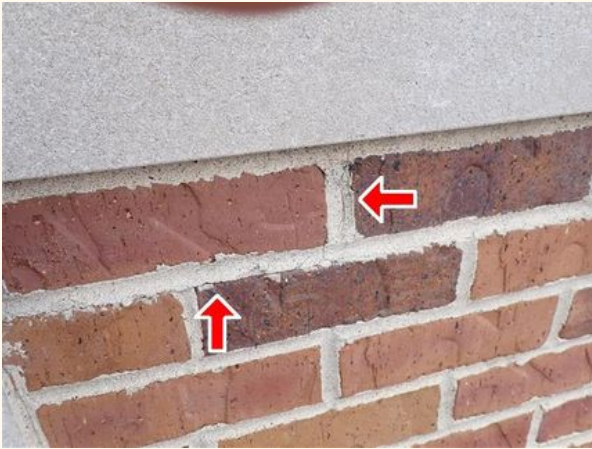
🔧 (ISFABE-10) Repair: The exterior masonry walls are in overall good condition, however, minor areas of deterioration and damage were noted. In order to reduce the potential for damaging and mold causing moisture to enter the home, the exterior walls should be evaluated and repaired by a qualified masonry restoration contractor.

Cracks Below Capping on Roof

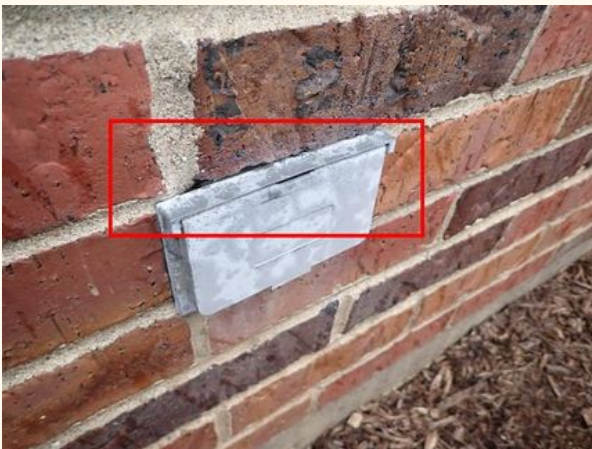
🔧 (ISFABE-11) Repair: All exterior wall penetrations such as; piping, conduit, vent caps, etc. should be sealed against moisture intrusion, drafts, and energy losses through the use of the appropriate caulking methods and materials.

Unsealed Receptacles

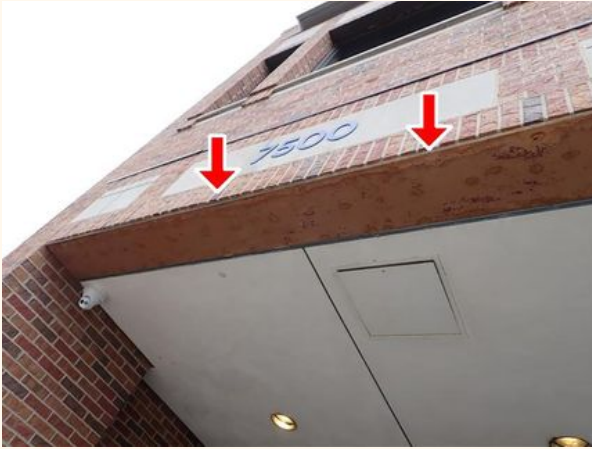
🔧 (ISFABE-12) Repair: The large steel lintel above the front entrance appears to be unpainted and corrosion was noted. In order to provide protection against corrosion and also for proper appearance it is recommended that all of the steel window and door lintels be finish painted with a coating specifically formulated for exterior metal applications. Ideally these lintels would have been painted prior to their installation and this painting should comply with the paint manufacturers specifications for application.

Corrosion on Lintel

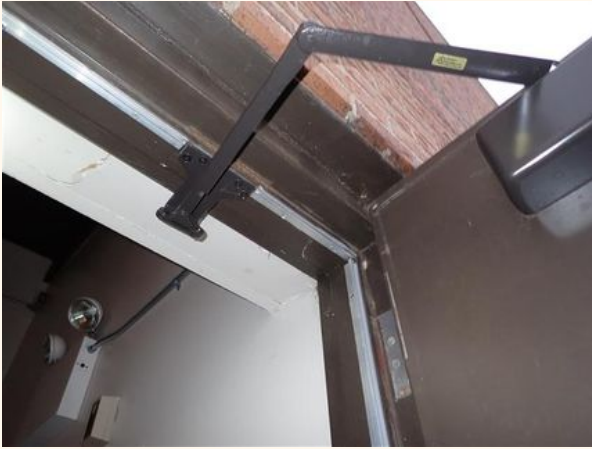
🔧 (ISFABE-13) Repair: Corrosion was noted around the lower portion of the rear exterior doorframe and moisture related damage and elevated humidity levels were noted in the walls adjacent to the door. It appears that the weatherstripping is missing in areas around the perimeter of the door which allows moisture to enter the gaps between the door and the doorframe. In order to reduce the potential for moisture related damage, it is recommended that a qualified handyman install appropriate weatherstripping around the perimeter of the door and the doorframe be repaired or replaced as needed.

Gap in Weatherstripping Around Rear Entrance Door

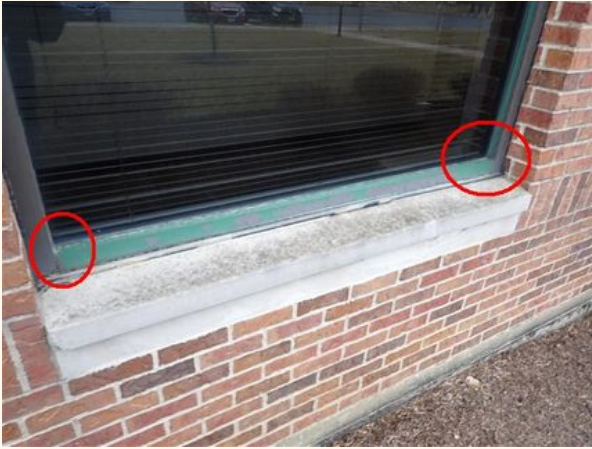
🔧 (ISFABE-14) Repair: Gaps and openings were noted in the exterior corners of the aluminum window installations. Potential moisture related damage was observed on the interior of the windows and In order to reduce the potential for moisture related damage, it is recommended that a qualified window installation contractor evaluate and repair the windows as needed.

Unsealed Corners on Windows

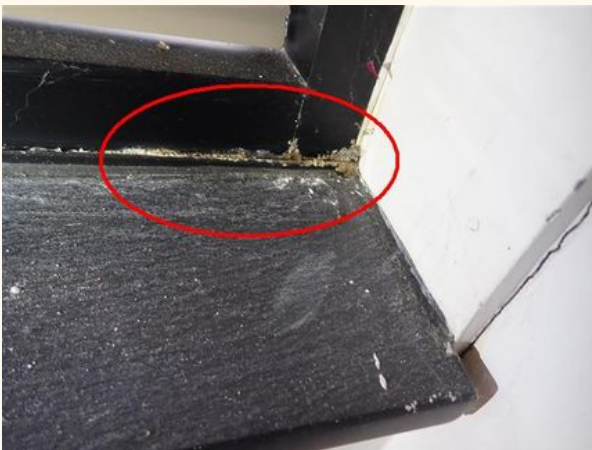
Moisture Related Damage Noted in Corners of Windows

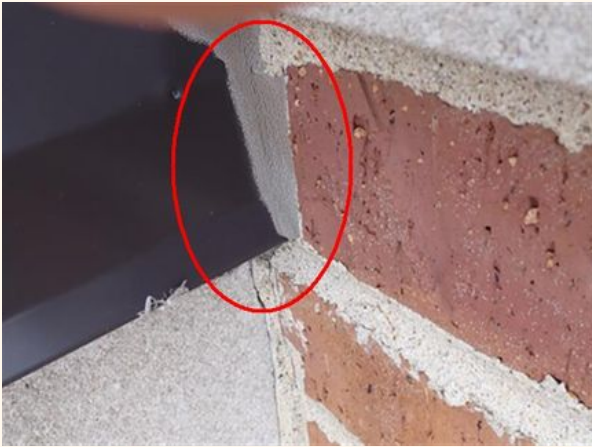
🔧 (ISFABE-15) Repair: The caulking at the corners of the capping where it meets the masonry are weathered and cracked. Exterior sealant performance is **directly related to the joint preparation and application**. For increased service life, performance and aesthetics, the exterior of the structure should be carefully examined and old deteriorated caulking should be removed and the exterior of the structure caulked via appropriate means and materials. Proper joint preparation and the use of compliant exterior rated sealants of good quality is recommended.

Weathered and Cracked Caulking on Roof Flashing Joints

All caulk joints should then be inspected annually and be repaired as needed. **ALL** exterior wall penetrations such as: piping, conduit, vent caps, exterior light fixtures and receptacles should be sealed against moisture intrusion through the use of the appropriate caulking methods and materials. An intentional opening/gap at the base of electrical fixtures should remain open to allow any moisture penetration an avenue of escape.

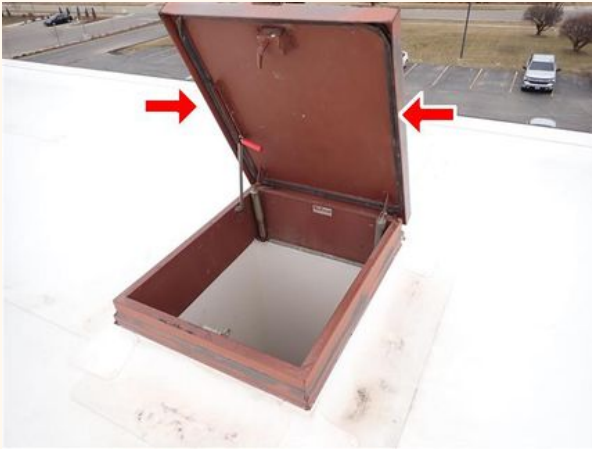
🔧 (ISFABE-16) Repair: The rubber seals on the Bilco roof hatch are more than likely nearing their life expectancy and while no moisture stains were present near the roof hatch at the time of the inspection, in order to reduce the potential for moisture related damage the seals should be replaced by a qualified roof hatch installation contractor.

Older Seals on Edges of Roof Hatch

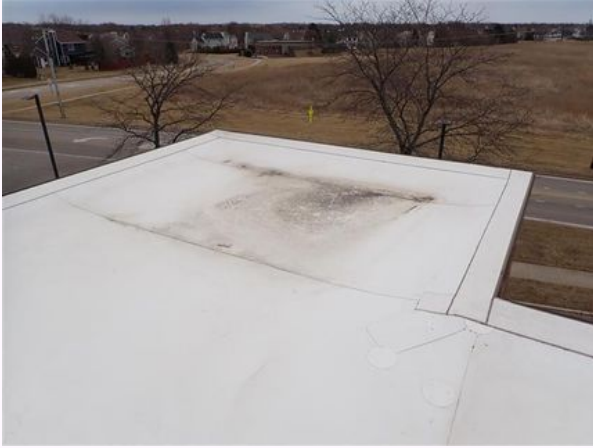
📄 (ISFABE-17) Future Project: The roof covering appeared to be in generally good condition, however, one small area of ponding was noted in the NE corner of the roof at the time of the inspection. There did not appear to be any signs leakage in the visible portions of the upper level ceilings at the time of the inspection. Ponding accelerates the rate of roof wear/deterioration and increases the risk for leaking. When a new roof covering is installed, plans should be made to re-pitch the roof using tapered roof insulation.

The roof is perceived to be a rubber roof membrane and there is most likely insulation beneath the roofing membrane. Typically a flat roof like this would have a lifespan of 40 to 50

years and if the structure was built in 1980, the replacement of the roof may need to be taken into consideration in the not too distant future.

Small Ponding Area on Roof

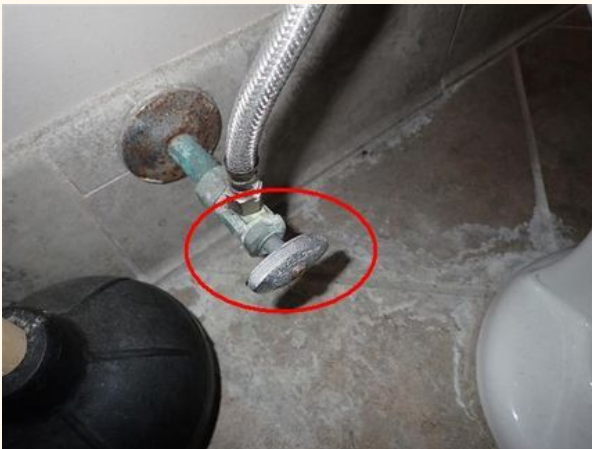
🔧 (IMAES-1) Repair: Older style gate valve shut-offs were noted on supplies to many of the plumbing fixtures in the structure and at least one was missing an operating handle. **These supplies can be prone to leakage when operated and they were not opened or closed at the time of the inspection.** In order to be able to shut off water to service plumbing fixtures in the future, the valves should be replaced with 1/4 turn ball valves by a qualified plumber.

Gate Valves on Toilet Supplies

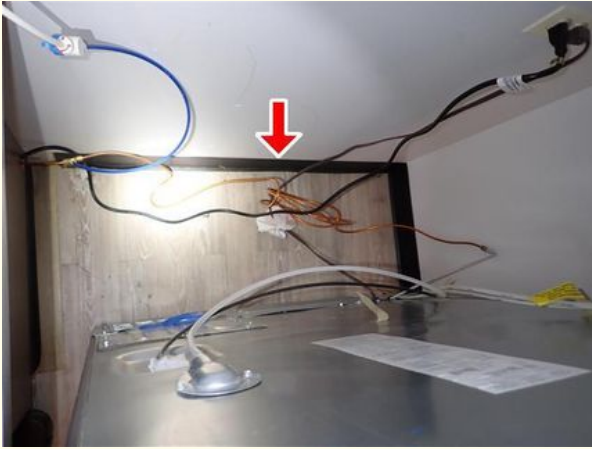
🏠 (IMAES-2) Improve: The refrigerator in the lower level break room has a copper water supply line that is flexible and easily damaged. For optimal resistance against leakage and water related damage to the surrounding finishes, the copper water supply tubing should be replaced with braided stainless steel tubing.

Copper Water Supply on Refrigerator

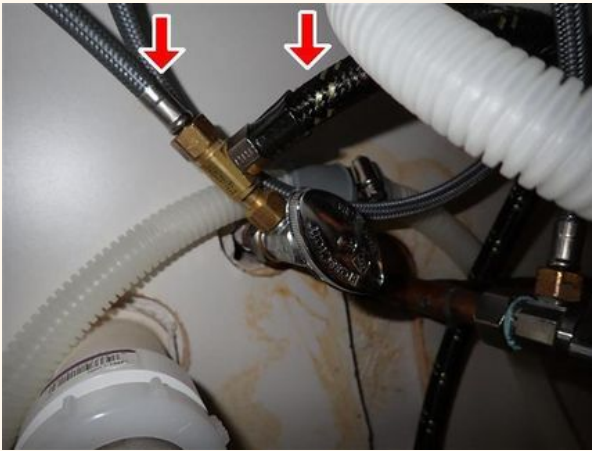
🔧 (IMAES-3) Repair: The hot water supplies for the dishwasher in the lower level break room and kitchen faucet are connected to the same shut-off valve. If the dishwasher is leaking or requires servicing, the supply for the dishwasher should be able to be isolated from the sink supply. In order for the occupants to have hot water at the kitchen sink while the dishwasher is being serviced or is out of commission, it is recommended that separate shut-off valves be installed by a qualified plumber.

Shared Sink Supply

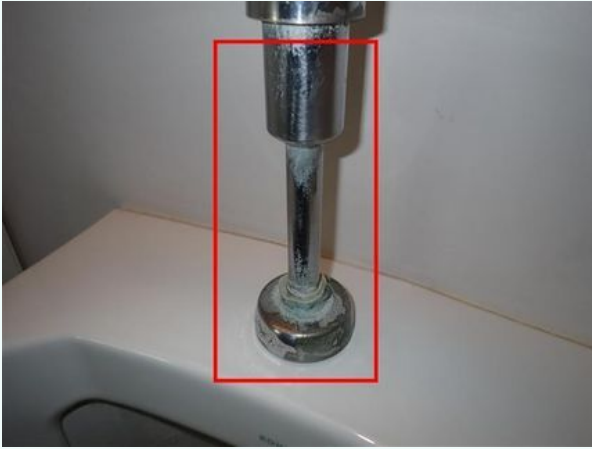
👁️ (IMAES-4) Monitor: Incipient leakage staining was noted on the supply piping for at least one of the urinals, however no active leakage was noted at the time of the inspection. If active leakage is noted at some point in the future, repair by a qualified plumber is recommended.

Incipient Leakage on Urinal Supply Piping

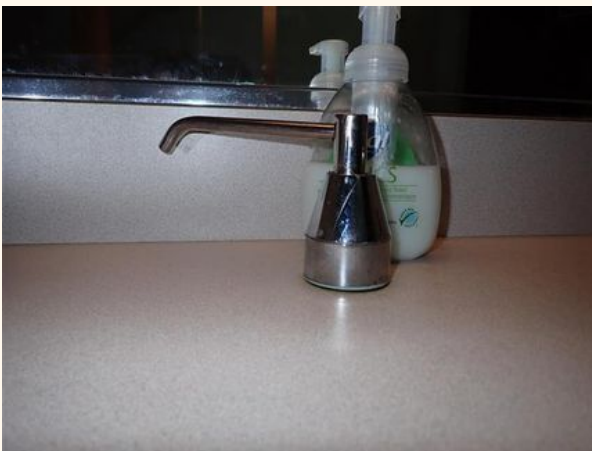
🔧 (IMAES-5) Repair: The soap dispenser storage containers were missing in most of the bathrooms and as a result the dispensers were non-operational at the time of the inspection. If use of these devices is desired, replacement of the containers is recommended.

Non-functional Soap Dispensers

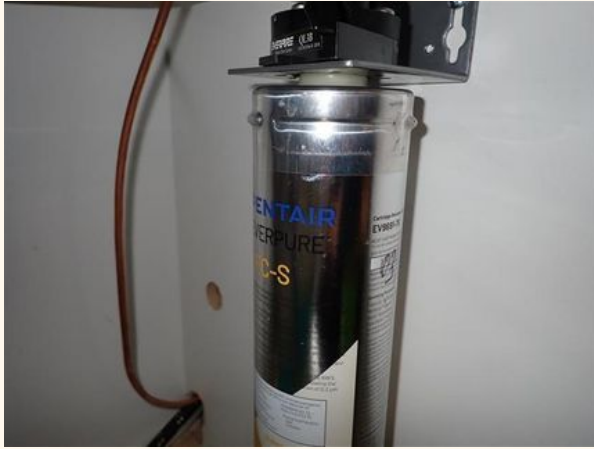
🔧 (IMAES-6) Repair: There is a water filtration system in use in the lower level break room for the coffee maker and fridge. The filters for this system require periodic replacement and in order to ensure the desired water quality, it is recommended that the manufacturers information with regards to the recommended schedule for filter replacement be reviewed.

Filtration System in Basement Break Room
