This report is prepared exclusively for **Some Customer**
Inspected On: **2022-11-25**

Domicile Consulting LLC
847.712.7874

This property was a mid sized commercial structure that was nearly 30 years old. There was some deferred maintenance on the exterior and the HVAC systems need replacement and significant attention in the not too distant future. It is highly recommended that the buyer read the report carefully, especially with regards to the future costs that may be incurred.

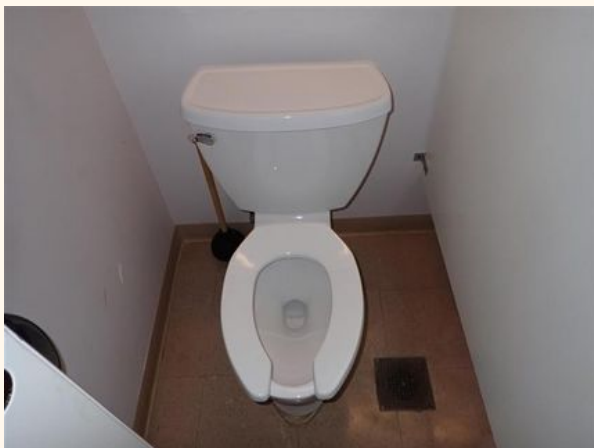
🔧 (IMAES-7) Repair: At least 75% of the toilets in the structure are not adequately secured to the floor. This can result in deformation of the wax ring seal, leaking and other damage. In order to determine if removal and reinstallation is necessary, **all of the toilets** in the structure should be evaluated by a licensed and competent plumber.

Loose Toilets in Nearly Every Bathroom

Also, the gap between the toilet base and tile floors should be sealed using the appropriate materials and methods in order to reduce a "fouling area". If mop water, bathtub water or a less pleasant "bathroom liquid" gets underneath the toilet, there is no way to clean it up. In order to reduce this risk and promote proper sanitation in the bathroom, caulking around the base of the toilet is recommended.

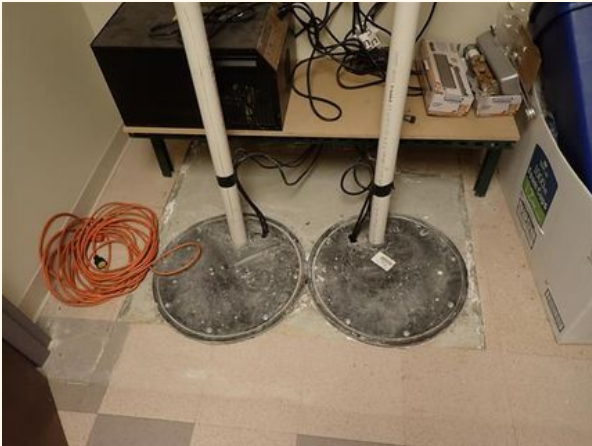
🔧 (IMAES-8) Repair: Sump and waste ejector pumps have limited effective services lives that typically range between five to ten years. In order to ensure effective drainage of the sump

and/or waste pits and reduce the potential for flooding and moisture related damage, it is recommended that a qualified plumber evaluate the existing pump(s) and unless it is clear that the pump(s) have been serviced recently, replacement of the pump(s) is recommended.

Unknown Age of Sump Pumps

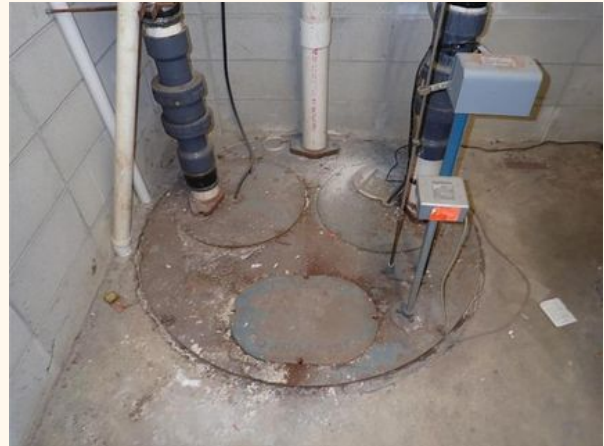
Waste Ejector Pumps in Mechanical Room

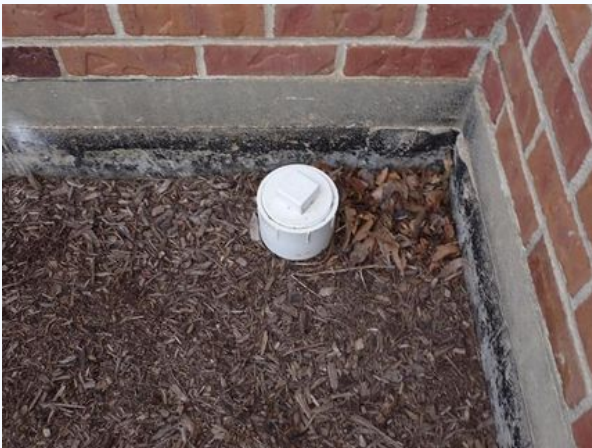
Q (IMAES-9) Due Diligence: There is a clean-out on the east side of the building and an attempt was made to televise the pipe and mud was encountered approximately 9 feet into the pipe. It is unknown what this pipe is connected to and the building plans (if available) should be reviewed in order to determine what purpose this pipe serves and whether it should be cleaned and/or serviced.

NOTE: In responses to a questionnaire submitted to the current owner as a part of the inspection, it was noted that the recent flooding that occurred in the building was from a back-up of the sump pump system. In order to determine if a blockage still exists, any relation of this pipe to the sump pump should be explored.

Clean-out in Corner

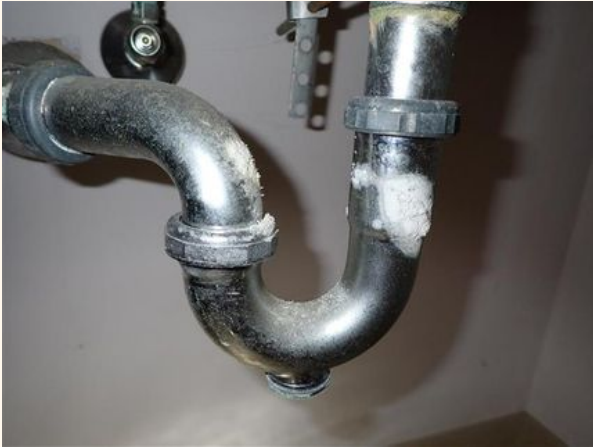
P (IMAES-10) Repair: Heavy corrosion was noted on many of the lavatory drain traps that could result in a leak. In order to reduce the potential for moisture related damage, the drain trap piping in every bathroom and kitchen sink should be replaced preemptively by a

qualified plumber.

Corrosion on Drain Trap Piping

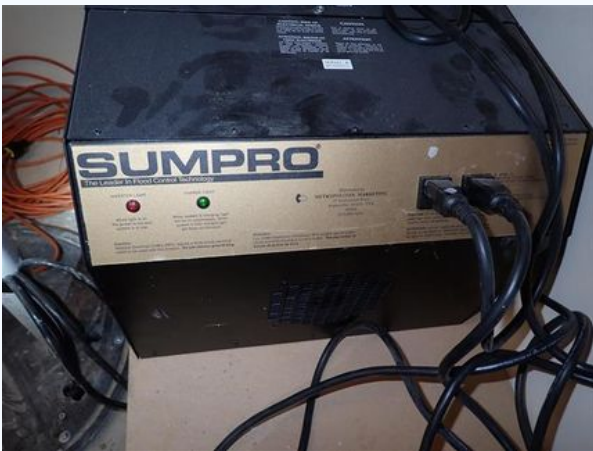
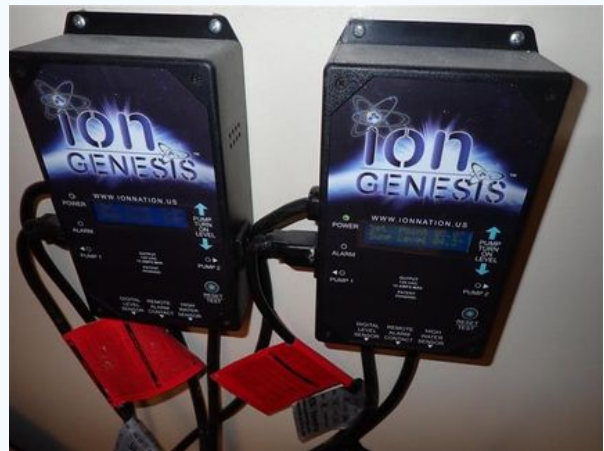
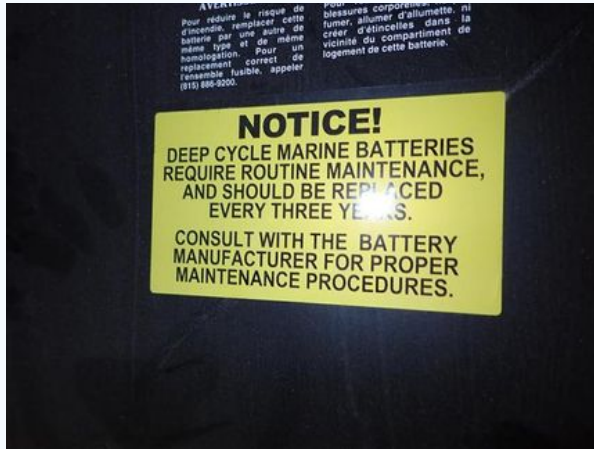
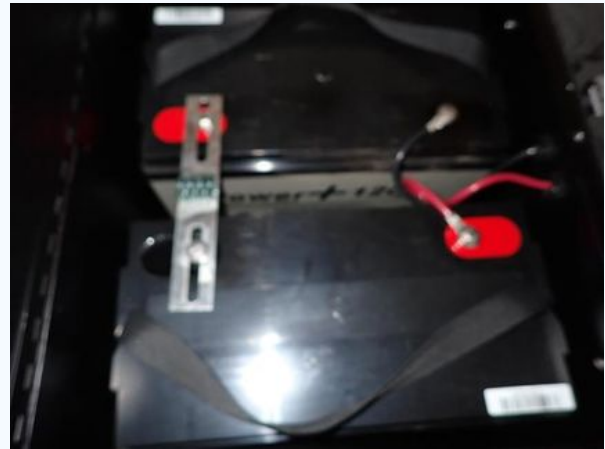
Q (IMAES-11) **Due Diligence:** The structure has a battery back-up system for the sump pump. This system utilizes an internal battery that has a limited life-span and the effectiveness of the battery may diminish over time. Given that the age of the system is unknown, in order to reduce the potential for flooding from failure of the back-up system, it is recommended that the system be evaluated and potentially serviced by a qualified basement waterproofing contractor.

Battery Back-up System for Sump Pump

Back-up System Controllers

Label on Back-up System

Batteries Inside Unit

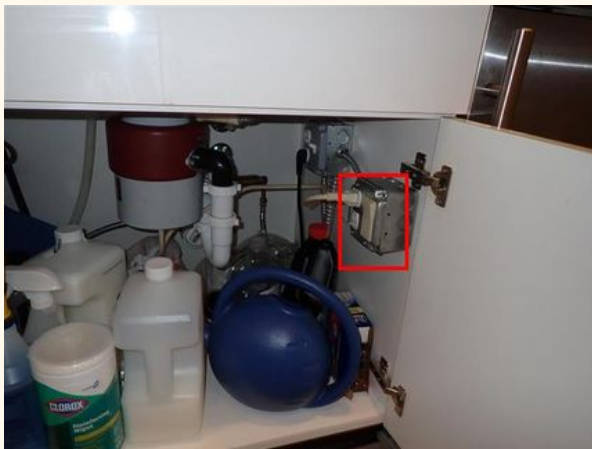
🔧 (IMAES-12) Repair: The switch for the food waste disposer is located beneath the kitchen sink. In order to reduce the potential for electric shock when using the disposal with wet hands and for the sake of convenience, the switch for the food waste disposer should be changed to an air activated switch located on the countertop near the sink housing.

Switch for Disposer in Upper Level Kitchen

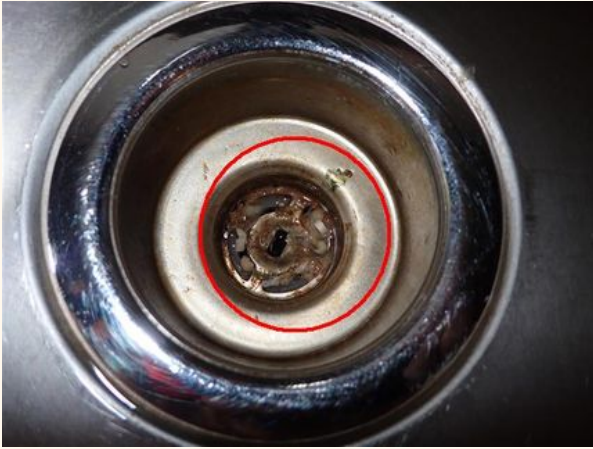
🔧 (IMAES-13) Repair: Standing water was observed in one of the sinks in the ladies restroom in the upper level. In order to be able to use the sink, repair by a qualified plumber is recommended. Also, the sink in the lower level breakroom was slow to drain and it appears the grate was clogged with food particles and just needs to be cleaned to drain properly.

Food Waste Clogging Drain

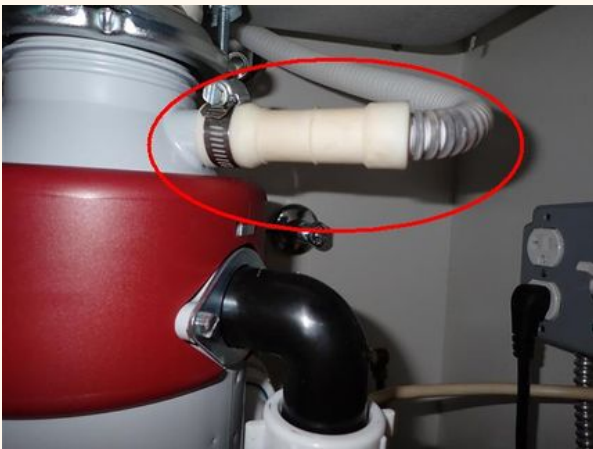
🔧 (IMAES-14) Repair: Connecting the dishwasher drain hose to the food waste disposer is prohibited by the Illinois State Plumbing Code and repair by a qualified plumber is recommended. Here is the applicable portion of the plumbing code:

Section 890.770 Dishwashing Machines

a) Domestic Dishwasher (Private Residence). When a domestic dishwashing machine drain line is connected to the house side of a trap from a sink, the drain from the dishwasher shall be carried up to the underside of the spill rim of the sink. Dishwashing machines shall discharge separately into a trap or tail piece of the kitchen sink and shall not connect to the food waste disposal unit.

Dishwasher Connected to Food Waste Disposer

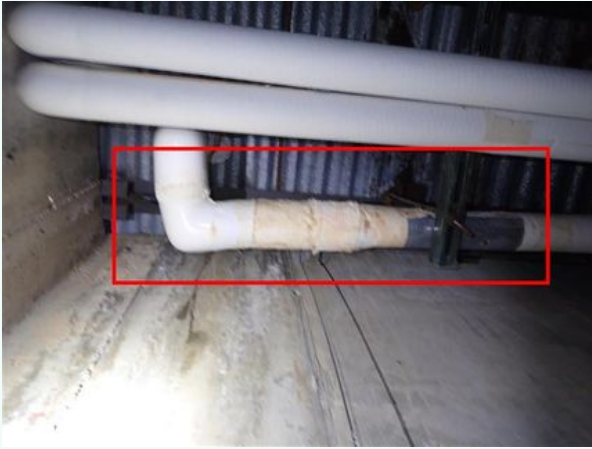
👁️ (IMAES-15) Monitor: Incipient leakage staining were noted on several areas of drain piping in the structure however no active leakage was noted at the time of the inspection. If active leakage is noted at some point in the future, repair by a qualified plumber is recommended.

Leakage Stains on Pipe in Ceiling of Elevator Mechanical Closet

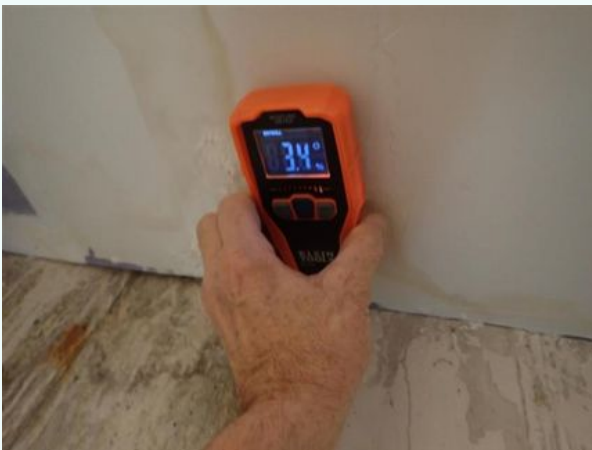
No Moisture by Wall Stain Below Pipe

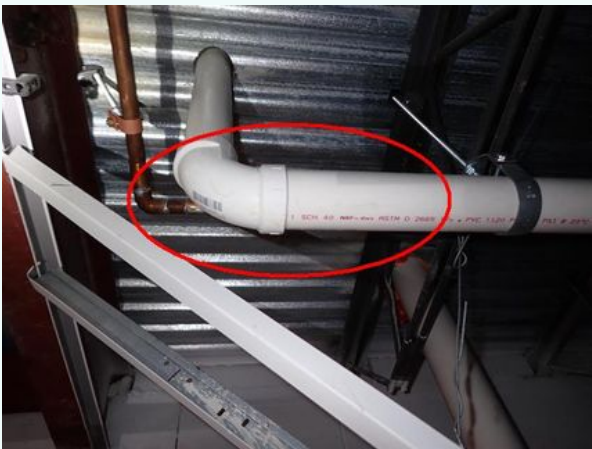
Stains on Piping Above Stained Tiles

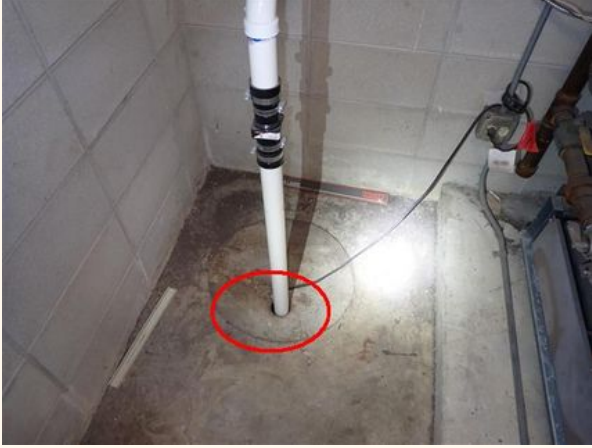
🔧 (IMAES-16) Repair: The sump pit in the mechanical closets containing the boilers is unsealed. In order to reduce the risk for excess water vapor, radon gas, pests, etc. to enter the structure from the open sump pit, it is strongly recommended that a properly sealed sump pit cover be furnished and installed by a qualified contractor or handyman.

Unsealed Sump Pit

NOTE: Prior to sealing the sump pit it should be cleaned and the pump equipment should be evaluated and serviced or replaced if needed. The typical service life of a sump pump is approximately 7 to 10 years and if no battery back-up system is present, it is advisable to install a moisture detection device above the pump and below the lid that may be able to provide an alert regarding an elevated water level that could occur in the event of pump failure.

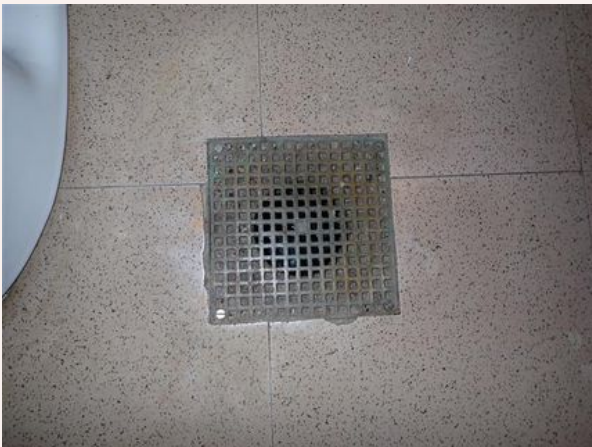
🔧 (IMAES-17) **Recommended Maintenance: FYI:** Traps on floor drains without a continuous source of moisture can dry out and should be regularly monitored and re-filled with water as needed to prevent the migration of sewer gas into the home. **The application of several drops of mineral oil can retard the evaporation of the water 'plug' in the floor drain trap.**

Open Floor Drains in Every Bathroom

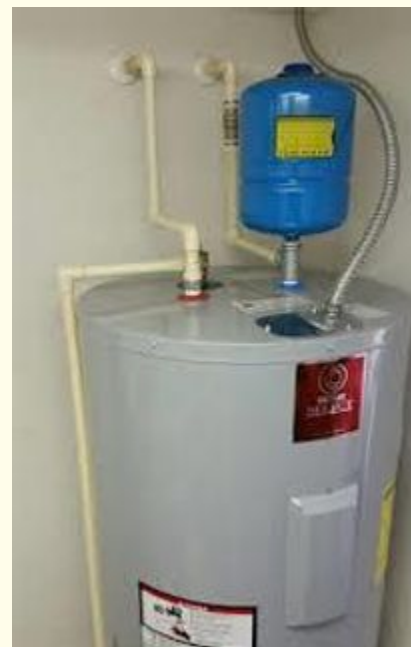
NOTE: When the water heater is replaced consideration should be given to installing an expansion tank. This feature can be critical for absorbing the pressure from water that expands as it is heated thereby prolonging the life by reducing the stress on the water heater and other plumbing components.

Water Heater Expansion Tank

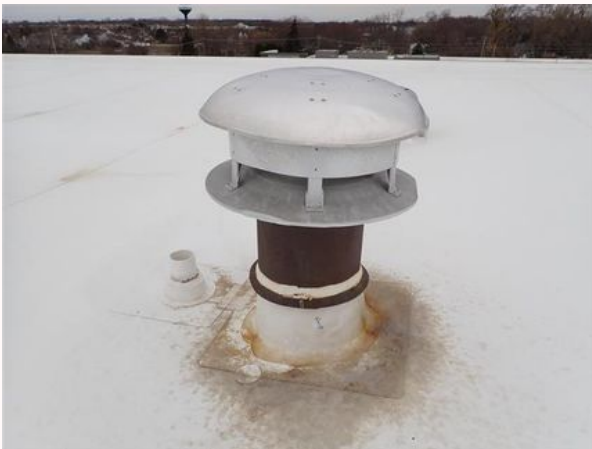
⚠️ **(IMAES-19) Major Concern:** Corrosion and moisture related staining was noted on the vent pipe for the boilers both on the roof and in the mechanical closet and was excessively present on one of the two boilers. The massive boilers in the basement appear to have insufficient access to combustion/dilution air which can reduce the ability for the boilers to vent properly resulting in the formation of condensation in the vent piping. These boilers were installed in 2011 which suggests that the existing boilers were only in service for 21 years. Cast iron boilers can last for more than 35 years if maintained properly and in order to reduce the risk of equipment damage, inefficient combustion and infiltration of carbon monoxide into the structure, a controlled intake ventilation damper system that draws intake air from the outside of the structure should be installed by a qualified HVAC or mechanical contractor.

Moisture Stains Around Boiler Vent Pipe

Also, as a part of the transfer of ownership of the property all of the HVAC equipment should be cleaned, serviced and certified as properly operational by a qualified mechanical contractor.

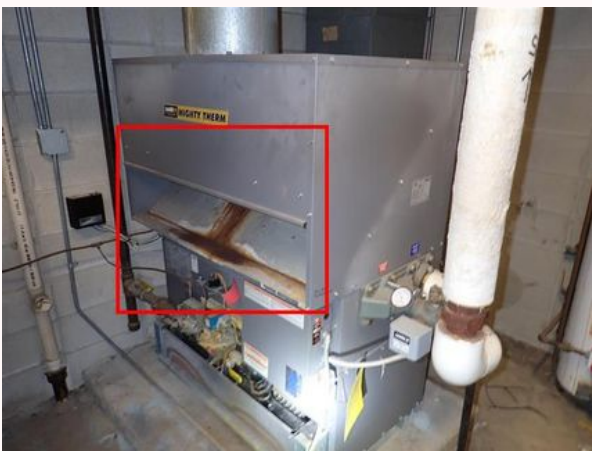
Corrosion on Boiler

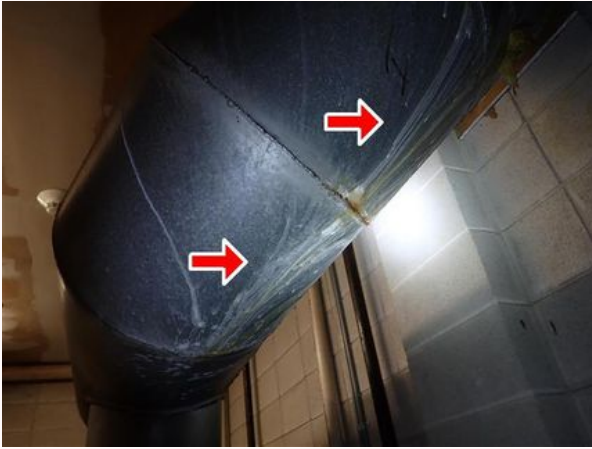
Moisture Stains and Corrosion on Vent Pipe

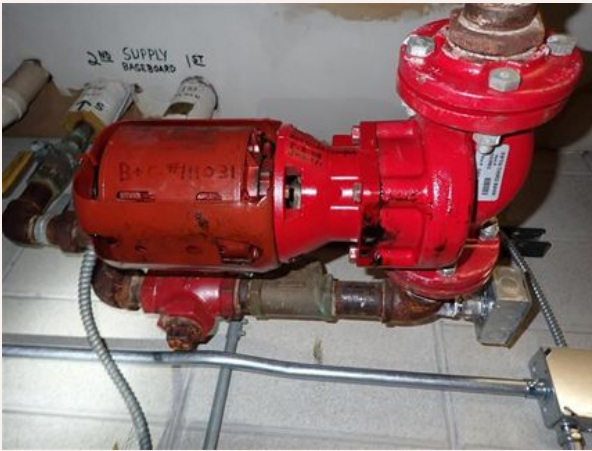
✂️ (IMAES-20) **Recommended Maintenance:** The circulating pump for the hot water heating system was covered with oil at the time of the inspection and oil was observed on the floor below the unit. It appears that the unit is being oiled too frequently which can reduce the performance of the pump and possibly result in binding of the unit. In order to reduce the potential for pre-mature failure of the pump, the oiling schedule should be adjusted and comply with the manufacturers specifications.

Excessive Oil on Circulating Pump

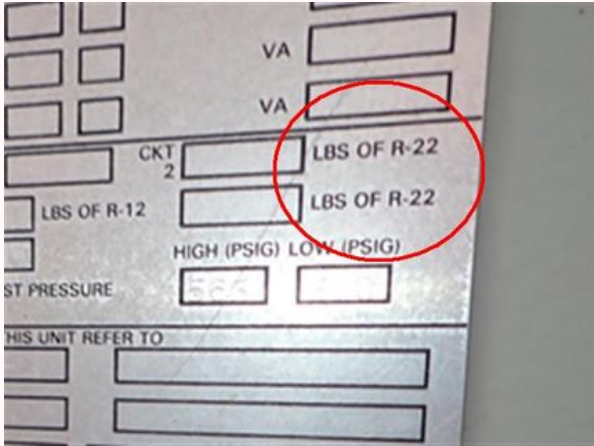
⚠️ (IMAES-21) **Major Concern:** The A/C condenser is well beyond the end of the expected service life and although the system was not tested at the time of the inspection, cooling levels may be inadequate in the near future. The R-22 refrigerant that is used in the unit is being phased out and no new or imported R-22 is allowed in the U.S. and technicians will only be able to use recycled, reclaimed, or previously produced R-22 to service equipment. Therefore it will become more expensive to service the unit in the future.

The cost to retrofit the HVAC system to use the new R-410 A replacement refrigerant is expensive and involves replacing the evaporator coils in the air handling unit.

R-22 Refrigerant Used in AC Condenser

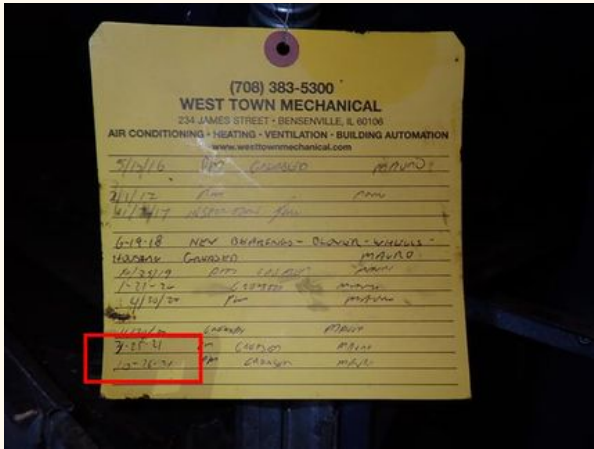
NOTE: The air handlers appear to be receiving fairly regular servicing, however, some older service dates were observed on some tags. Also, the schedules for the filter replacements should be determined.

Tags Noting Servicing in 2021

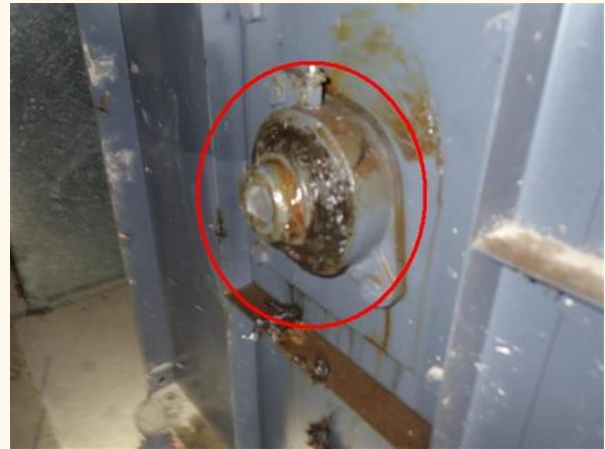
Grease Build-up on Bearings

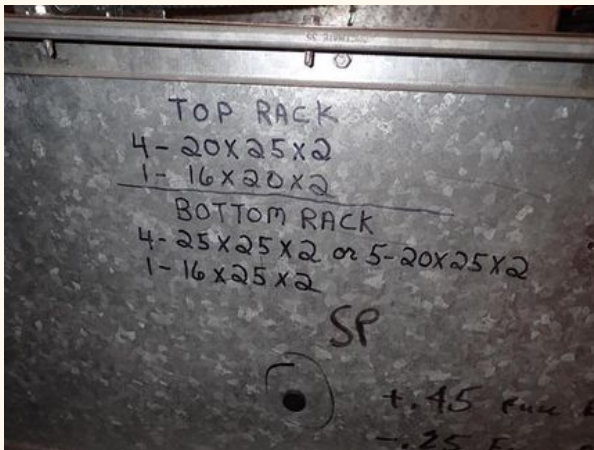
Filters in Unit

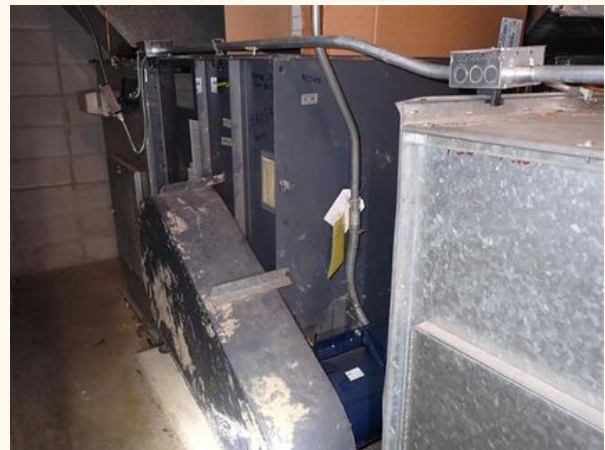
🔧 (IMAES-22) Repair: An open gap in the casing was observed on one of the air handlers in the mechanical room and significant air leakage was occurring at the time of the inspection. A comprehensive evaluation of the HVAC system was not a part of this commercial inspection and in order to ensure the systems are operating properly, it is highly recommended that a thorough evaluation of the systems be conducted by a qualified HVAC service technician.

One of Two Air Handlers in Mechanical

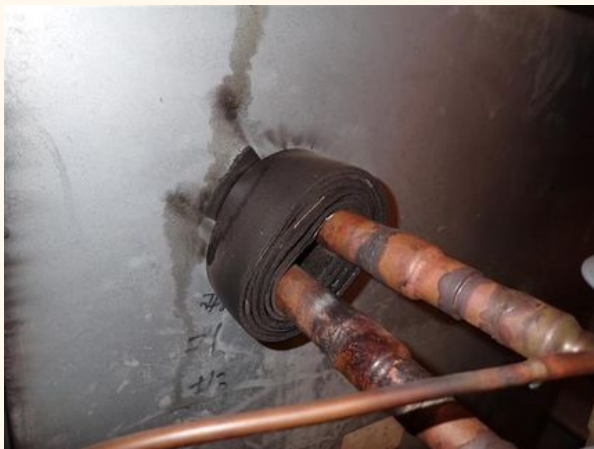
Leakage by Evaporator Coil Casing Penetrations

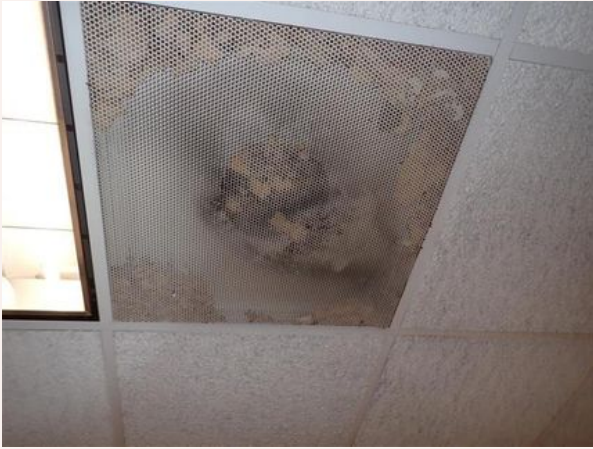
✂ (IMAES-23) Recommended Maintenance: Heavy dust build up was noted on numerous HVAC diffusers in the ceiling which limits the effectiveness of the air movement in the structure and places an added burden on the air handler blower motors. In order to achieve proper airflow and prolong the life of the HVAC equipment, the diffusers should be removed

and cleaned and/or replaced as needed.

Heavy Dust Build-up on Diffusers

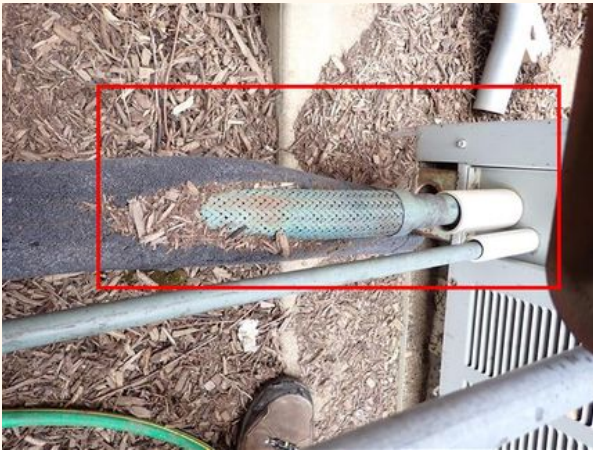
🔧 (IMAES-24) Repair: The deteriorated/missing insulation on the A/C refrigerant lines can result in energy losses that promote the formation of condensation. In order to reduce the potential for moisture related damage and to reduce energy losses and maximize efficiency, the insulation should be replaced by a qualified HVAC contractor.

Insulation Missing on Refrigerant Lines

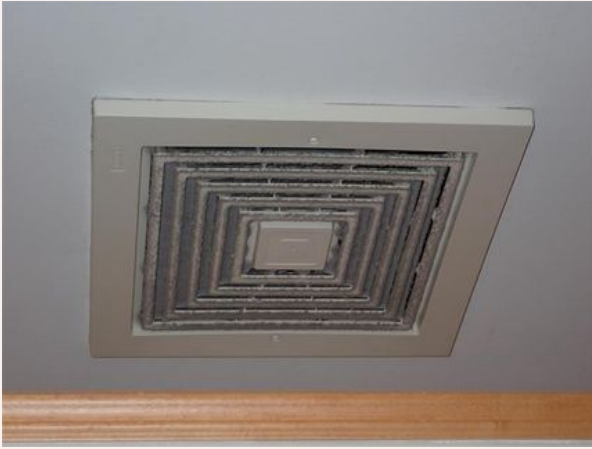
🔧 (IMAES-25) Recommended Maintenance: The bathroom ventilation fan is clogged with dust. This affects its ability to exhaust moisture and odors from the living space which, in turn, can lead to mold growth and moisture damage. A thorough cleaning of the vent cover and the accessible interior fan components is recommended.

Clogged Vent Fan in Upper Level Bathroom

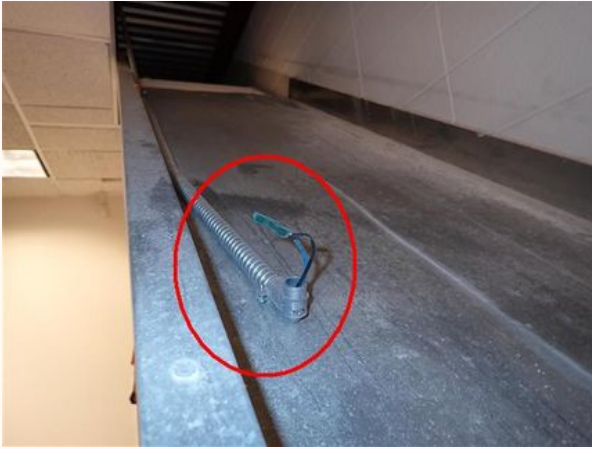
⚠ **(IMAES-27) Major Concern:** Live abandoned electrical wiring was found in at least one location and in order to reduce the risk for electrical shock and fire, all of the abandoned wiring in the structure should be located and removed or capped off and enclosed inside metal junction boxes by a qualified electrician.

Live Wiring by Former Mail Chute

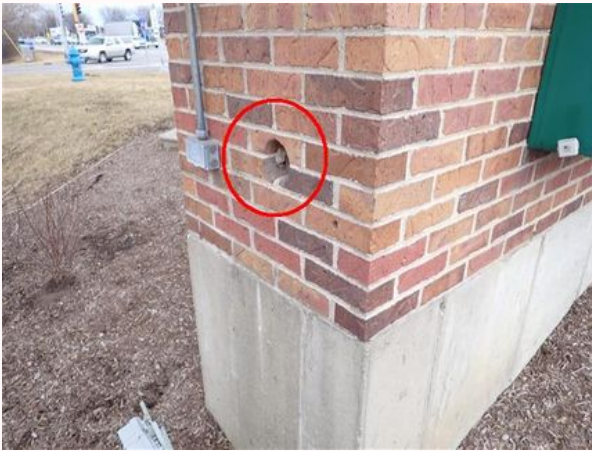
⚠ (IMAES-28) **Major Concern:** Exposed wiring was observed on the north side of the masonry sign in front of the structure. In order to reduce the risk for electrical shock from inadvertent contact with exposed current carrying equipment and in order to contain molten copper created by high temperature arcing and sparking of energized wiring, it is recommended that all electrical connections be concealed inside covered metal junction boxes by a qualified electrician.

Open Hole on Sign

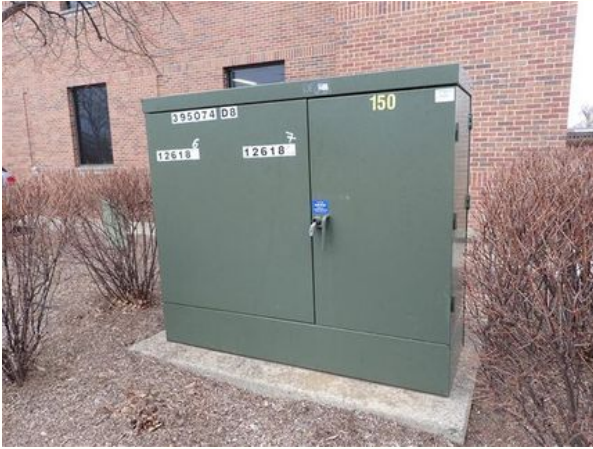
✦ (IMAES-29) **Note:** Moisture related staining and damage was noted in a document storage room in the lower level in the southeast corner of the building. The lower 2 feet of drywall in the room has been removed and corrosion was observed on some of the steel wall framing in the room. It appears that moisture had entered the room via a conduit from the external electrical transformer and **according to an answer in the questionnaire that was sent to the current owner, the flooding occurred as a result of localized flooding from a sump pump back-up.** In order to reduce the potential for moisture related damage and to prevent colder external air from entering the building and condensing on warmer interior piping, the feeder conduits from the transformer should be sealed by a qualified electrician.

Transformer on East Side of Structure

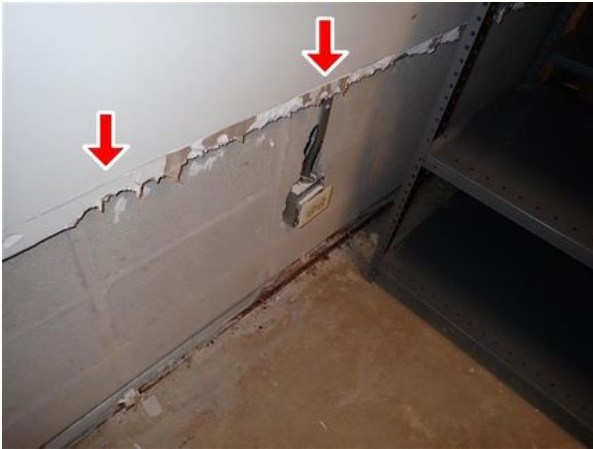
Drywall Removed

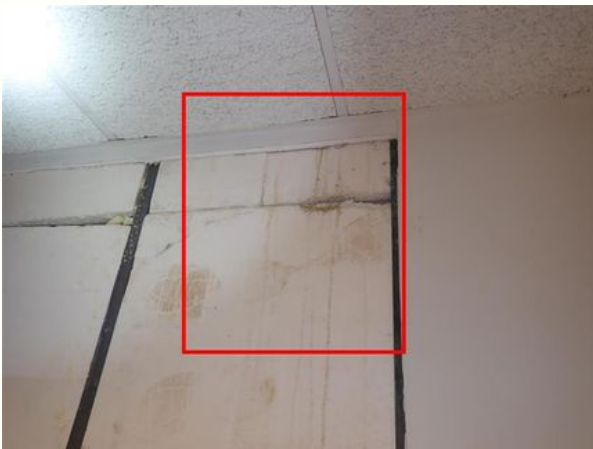
Leakage Stains on Walls

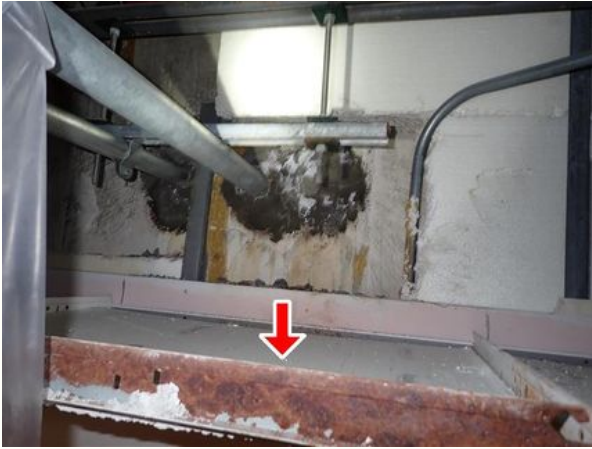
Corrosion on Ceiling Grid

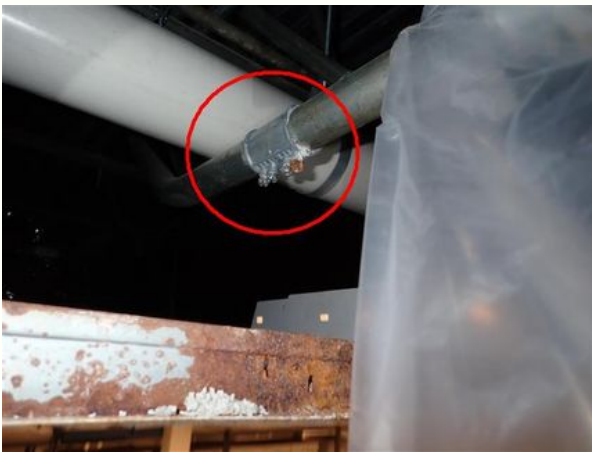
Corrosion on Conduits Connected to Junction Box

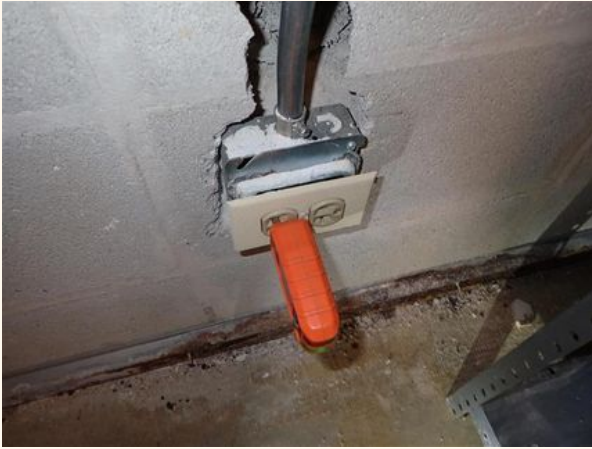
🔧 (IMAES-30) Repair: The receptacles in the lower level document storage area were secured to wall coverings that appear to have been removed because of flood damage. In order to reduce the potential for electric shock and fire, the receptacles should be secured by a qualified electrician when the wall coverings are replaced

Loose Receptacles in Document Storage Room

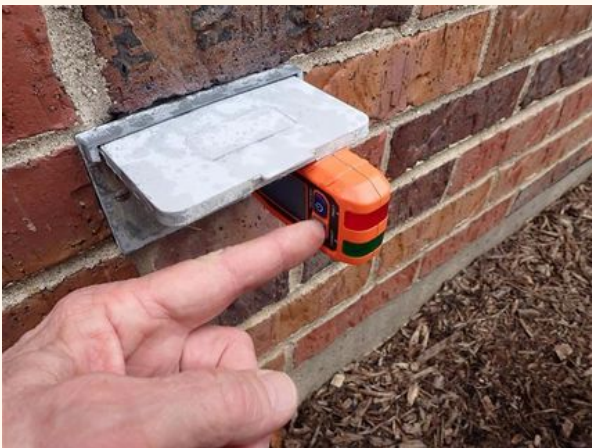
🔧 (IMAES-31) Repair: Several of the GFCI electrical receptacles were not functioning properly and will not provide protection from electrical shock as they are designed to do. All of the GFCI receptacles in the residence should be evaluated and replaced as needed by a qualified electrician

Non-GFCI Receptacles on Exterior of Structure

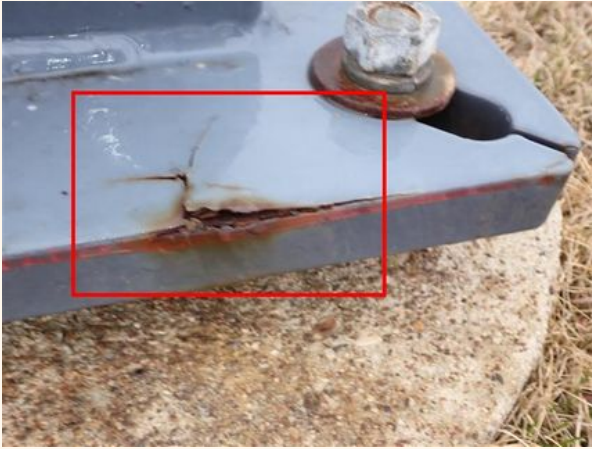
Corrosion on Light Pole Base

🔧 (IMAES-32) Repair: Several of the light poles in the parking lot had corrosion and damage to the powder coat finish. In order to reduce the potential for continued moisture related damage, It is recommended that the corrosion be removed and the poles re-coated by a qualified painting specialist, possibly someone that can perform on-site powder coating.

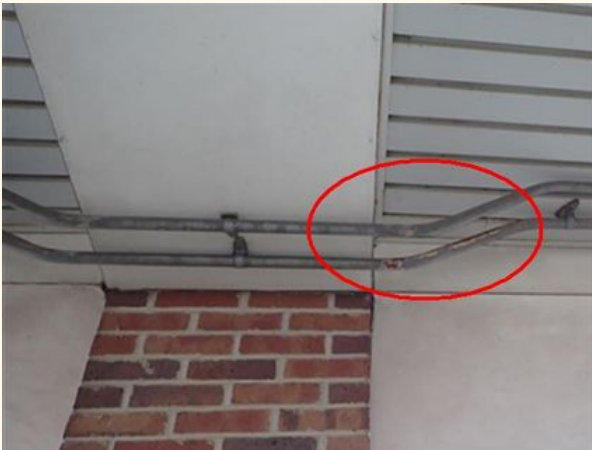
Corrosion on Conduits

⚠ (IMAES-33) Repair: Corrosion and staining was observed on several exterior conduits by the drive-thru and the configuration of the pipes and possible non-weatherproofed pipe fittings may be allowing moisture to become trapped in the pipes. For proper operation of the electrical system fed by the conduits, repair by a qualified electrician is recommended.

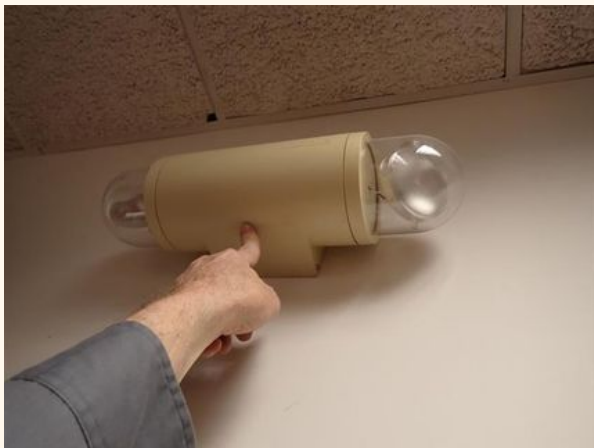
Non-functional Emergency Lighting in Former Unoccupied Mail Area

🔧 (IMAES-35) Repair: A spot check of the battery operated emergency lighting system/s revealed one or more non-functioning units. It is strongly recommended that these critical life safety devices be regularly evaluated and repaired as needed by a qualified electrician.

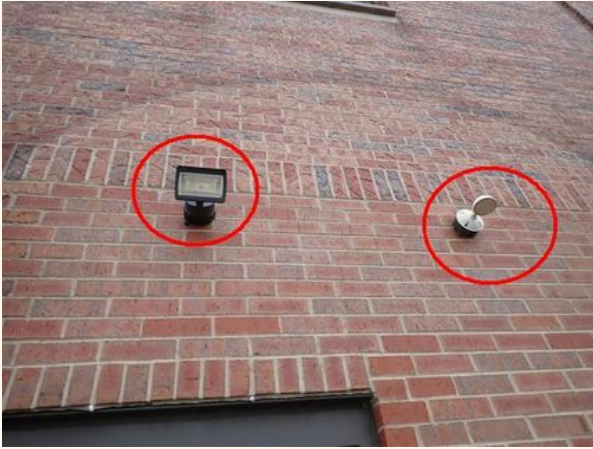
Extinguished Bulbs on Exterior

🔧 (IMAES-36) Repair: Extinguished or otherwise inoperative luminaires (light bulbs) were noted during the inspection. All of the lighting in the structure should be made fully operational for the final walk-through so that the proper operation of all the lighting can be verified and differentiated from defective switches, fixtures, etc.

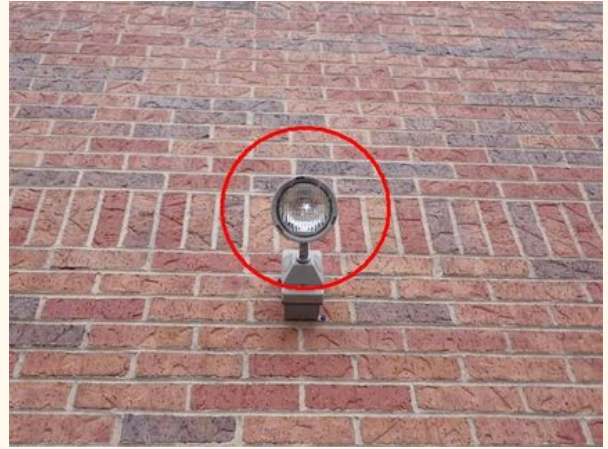
Extinguished Bulb on Exterior

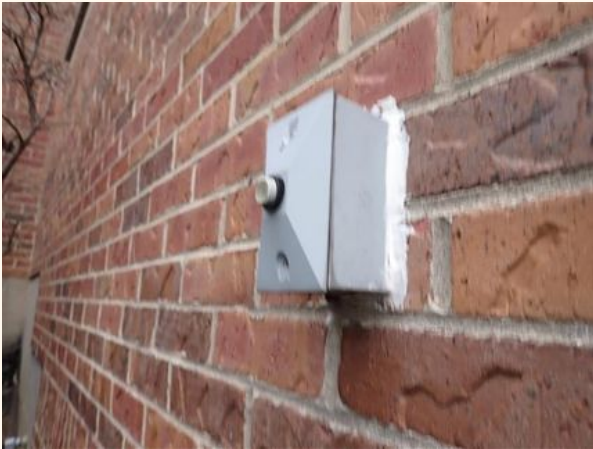
Extinguished Bulb on Exterior Wall

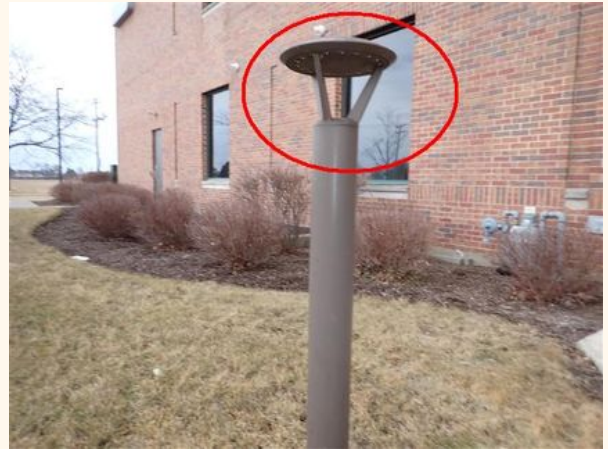
Extinguished Light by Rear Entrance

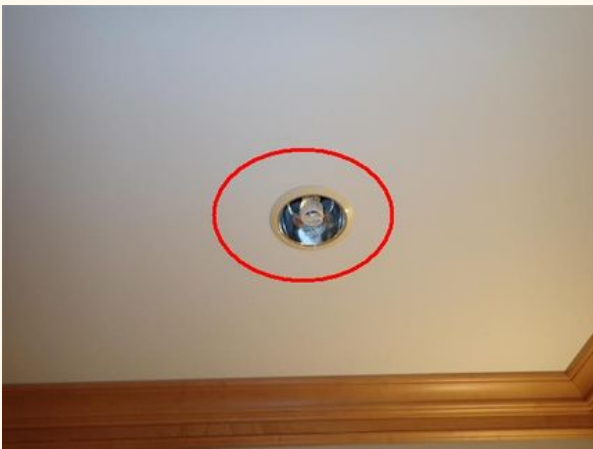
Extinguished Bulbs in Bathrooms

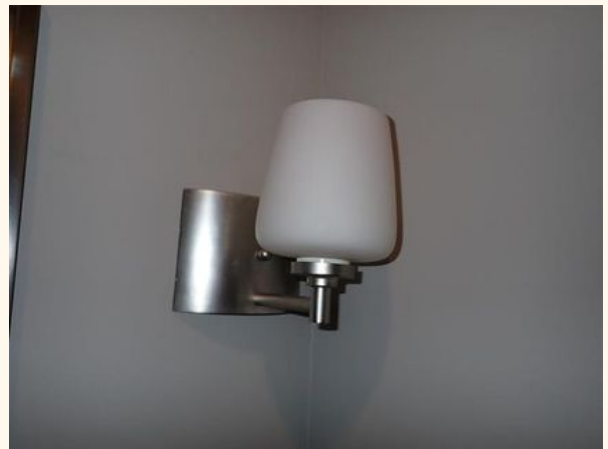
Extinguished Bulbs on Wall Fixtures

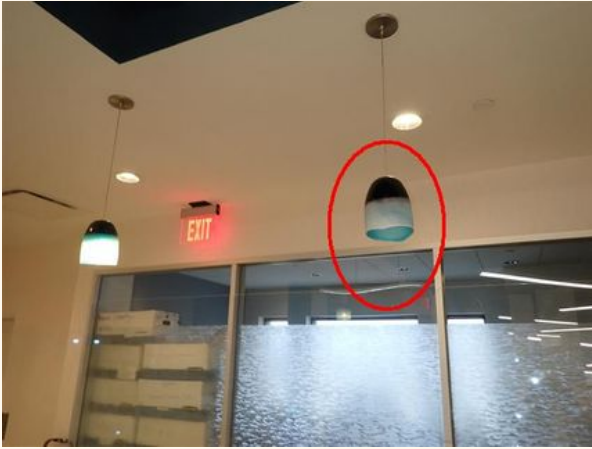
Extinguished Bulb in Light Fixture

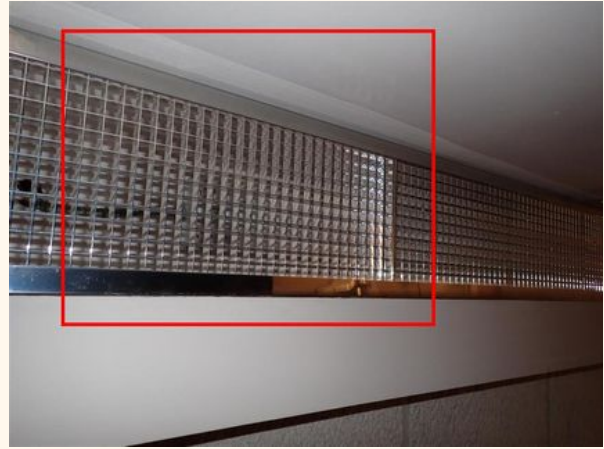
Extinguished Bulbs in Upper Level Bathrooms

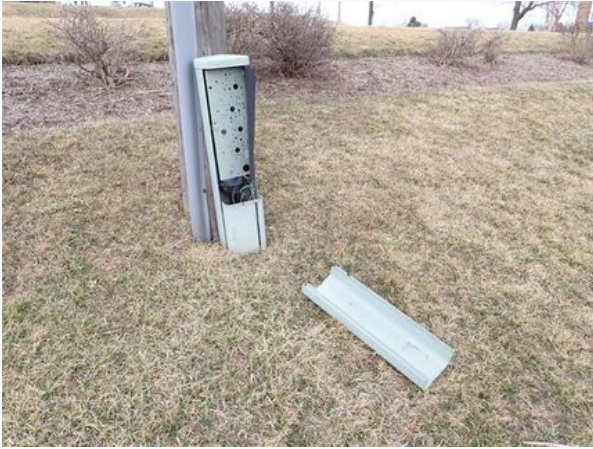
Loose Cover on Communication Pedestal in Front of Property

🔍 **(IMAES-37) Due Diligence:** The evaluation of the low-voltage equipment in the structure: alarm, communication, audiovisual, etc., is beyond the scope of this commercial inspection and should be performed by qualified low-voltage electrical contractor/s. In order to reduce the potential for confusion and to reduce clutter around the structure, any wiring, panels, cabinets, etc. for any equipment that is no longer in use should be removed.

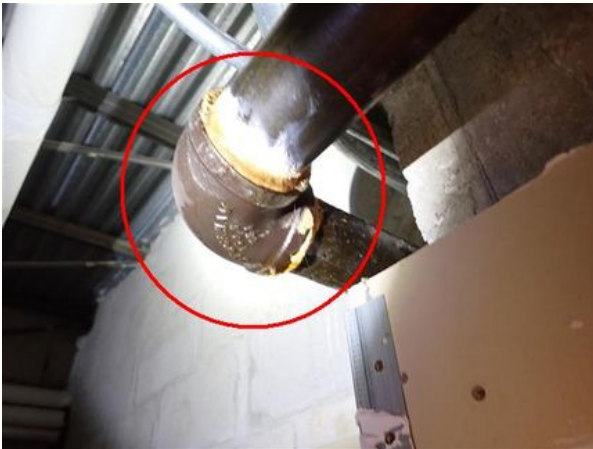
✦ **(IMAES-38) Note:** Elevator inspections require highly specialized expertise and are outside the scope of this commercial inspection. However it was noted that one of the oil supply lines for the elevator was leaking into a ceiling tile near the elevator and it appears that repairs were performed on this unit in 2012.

Oil Observed on Pipe by Elevator

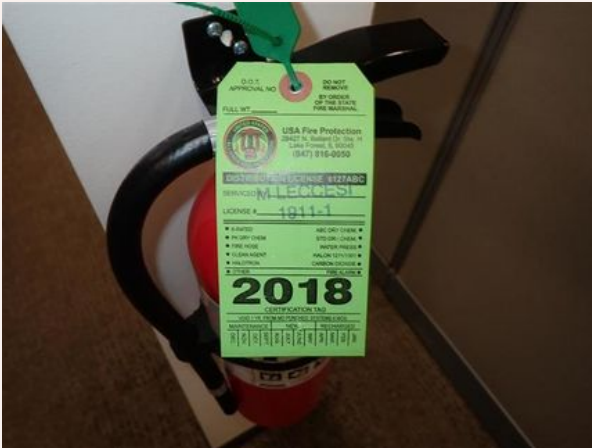
**(VFP-4) Recommended Maintenance:** Fire extinguishers with expired tags were noted in the unoccupied areas of the structure. Typically these devices are inspected and potentially serviced annually and it is recommended that a qualified fire safety service technician evaluate and service all of the fire extinguishers in the structure as well as any other related devices like exit signs and/or emergency lighting.

Expired Extinguishers

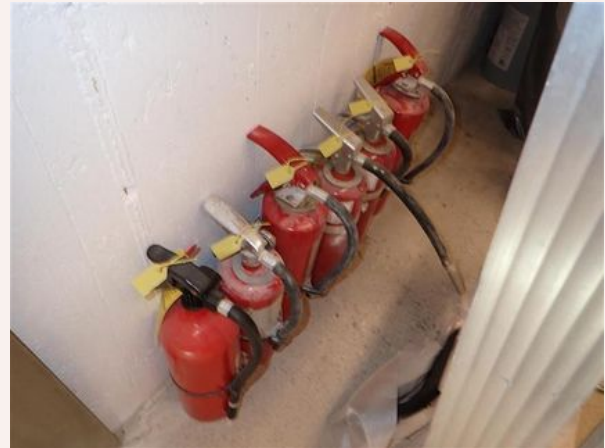
Stored Extinguishers in Bank Vault

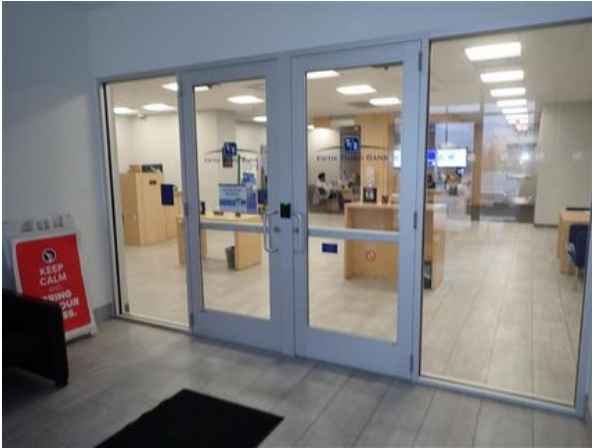
✦ **(VIET-1) Note:** Access to many of the tenant areas was not available at the time of the inspection, it can be presumed that many of the conditions observed in the common areas are present in the tenant spaces as well.

No Access to Bank Areas

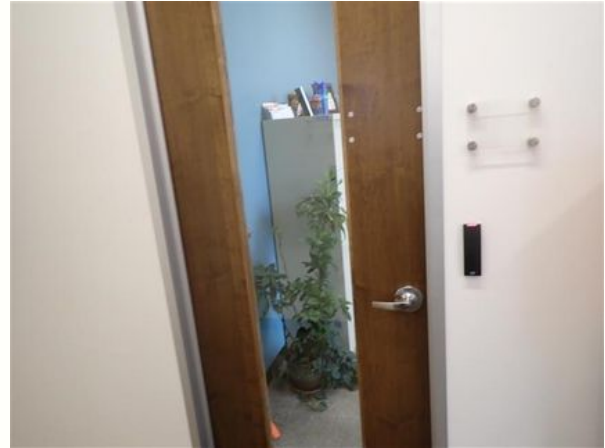
No Access to Insurance Office

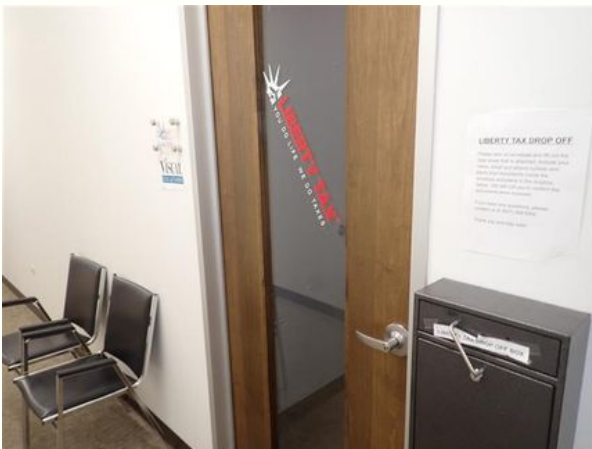
No Access to Tax Office

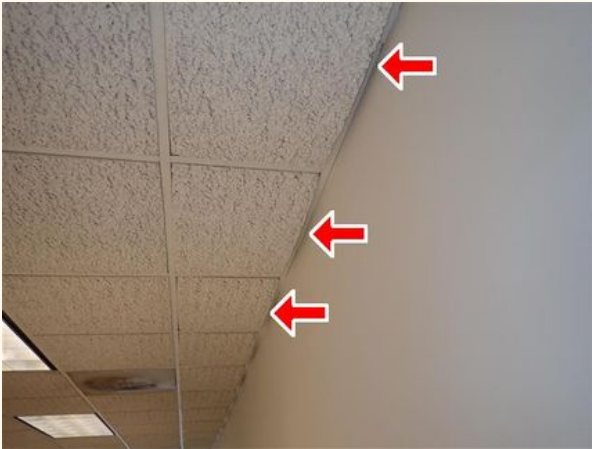
🔧 (VCAI-1) Repair: Sagging was observed on many of the partial ceiling tiles and it appears they lack support along the cut edges. For proper appearance the ceiling tiles should be evaluated and repaired or replaced as needed by a qualified ceiling tile installation contractor.

Sags in Ceiling Tiles

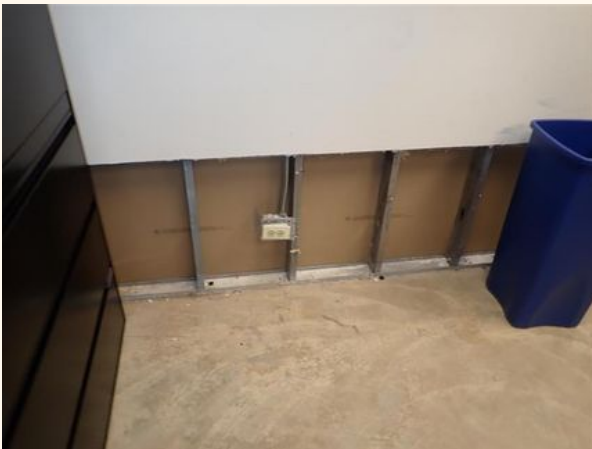
🔧 (VCAI-2) Repair: The damaged areas in the lower level document storage room that occurred as a result of leakage from a sump pump malfunction should be repaired by a qualified carpenter and/or drywall finishing contractor.

Walls Removed in Storage Area

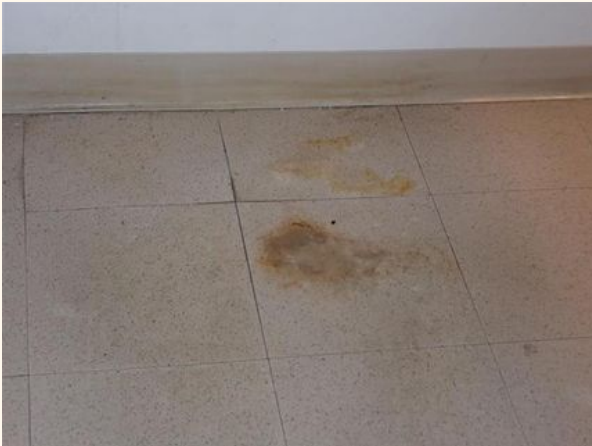
🔧 (VCAI-3) Repair: The interior finishes have some minor blemishes and in order for the interior to conform to accepted appearance standards, some repairs, re-finishing, drywall touch ups and repainting may be needed.

Stains and Warped Tile in Bathroom Tiles Below Urinal

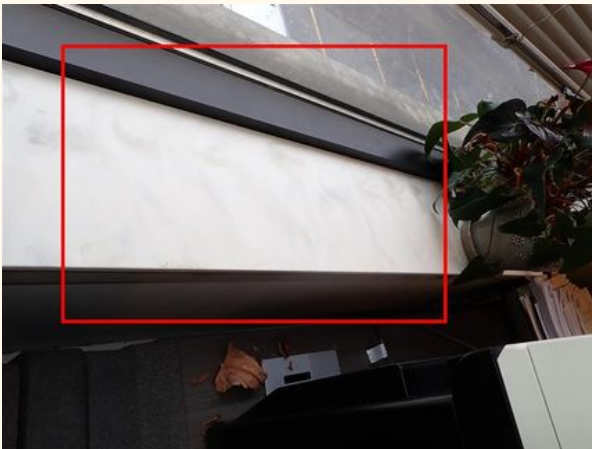
Stains on Window Ledges

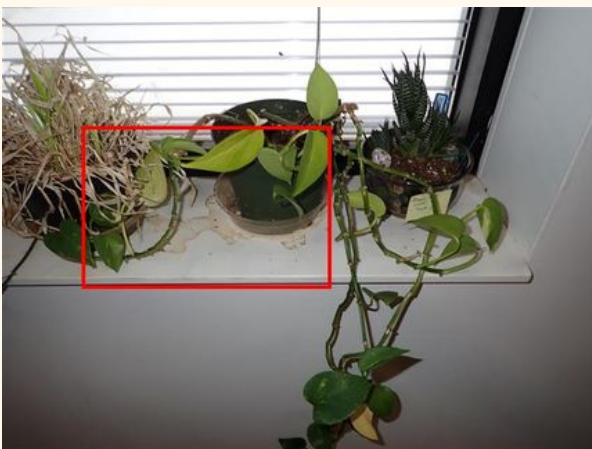
Water Stains on Window Sills from Plants

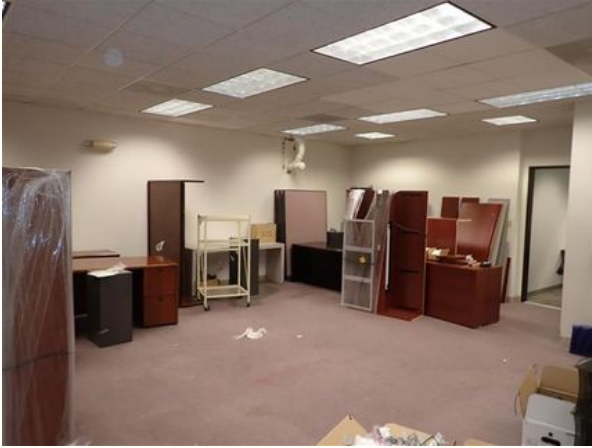
📌 **(VCAI-4) Note:** The amount of stored items present in some areas prevented a full

Stored Items in Rooms

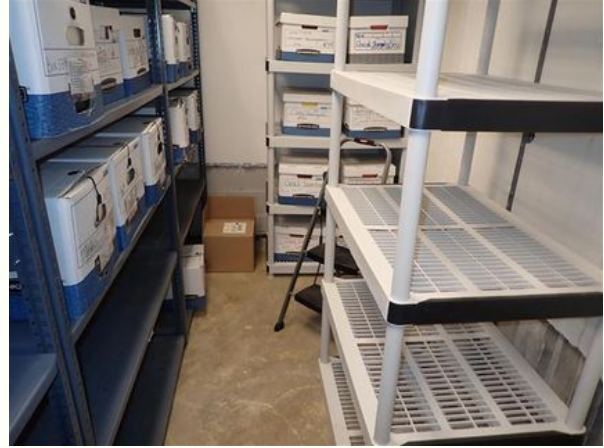
Stored Items in Areas

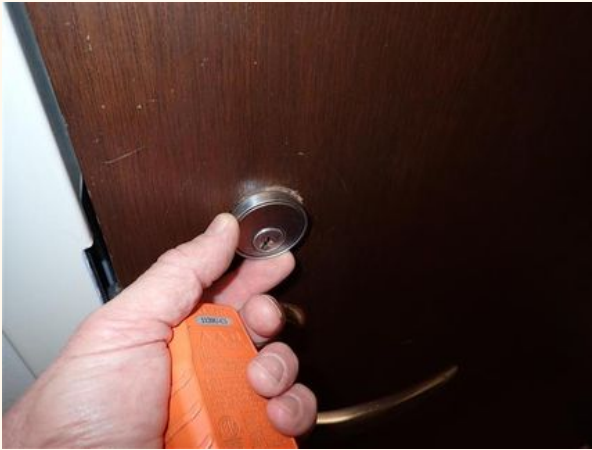
🔧 (VCAI-5) Repair: Several of the doors in the structure failed to close or latch properly. For proper operation it is recommended that any non-functional doors be repaired or adjusted by a qualified carpenter or handyman.

Loose Lock Mechanism on Basement Closet
