This report is prepared exclusively for **Some Customer**
Inspected On: **2022-11-25**

Domicile Consulting LLC
847.712.7874

This property was a mid sized commercial structure that was nearly 30 years old. There was some deferred maintenance on the exterior and the HVAC systems need replacement and significant attention in the not too distant future. It is highly recommended that the buyer read the report carefully, especially with regards to the future costs that may be incurred.

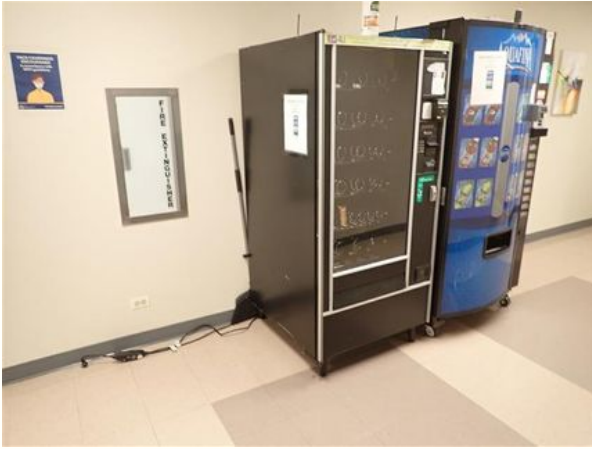
📌 (VCAI-6) Note: Vending machines were noted in the basement. These units belong to an outside vendor and according to the property owner their removal is imminent.

Unplugged Vending Machines in Basement

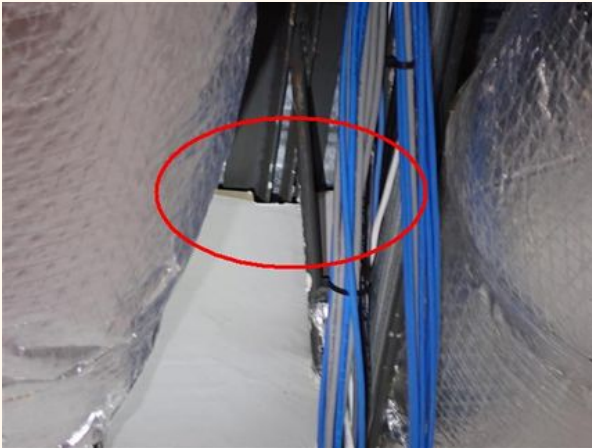
🔧 (VCAI-7) Repair: A concerted effort at air-sealing/fire-proofing all of the rooms in the structure should be made so that in the event of a fire in one of the rooms, smoke, carbon monoxide, and superheated gases are not able to readily pass between rooms. Some of the typical areas that require air-sealing/fire-proofing include: pipe chases (both vertical and horizontal).

Holes in Walls of Server Room

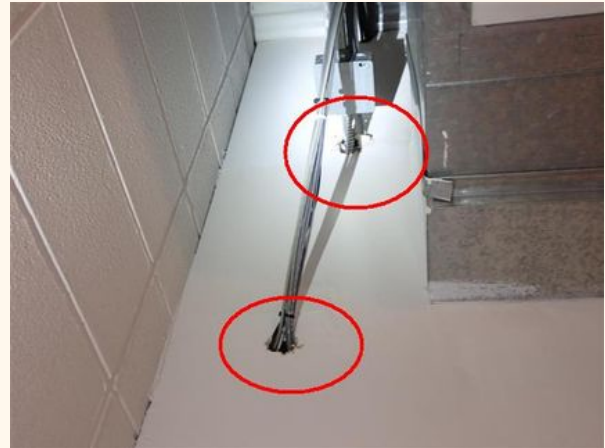
Holes in Wall of Server Room
