This report is prepared exclusively for **Large Commercial Office Building**
Inspected On: **2022-11-08**

This was an inspection of a large multi-story office building. The structure was built approximately 12 years ago and there were several ongoing concerns, mostly related to moisture that were damaging portions of the structure. Please read the report carefully in order to gain an understanding of the concerns regarding the property.

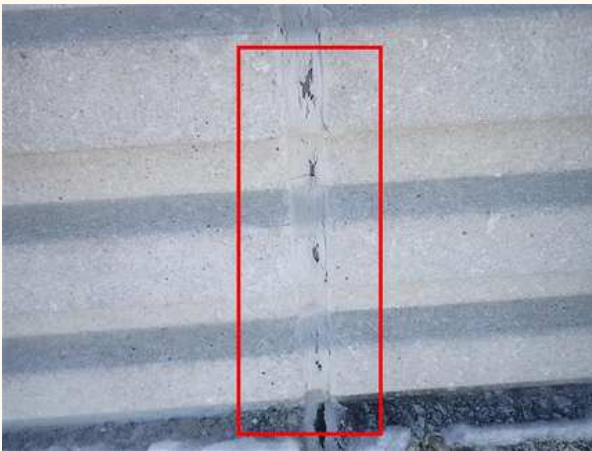
Deteriorated Caulk Between Pre-cast Cladding Panels

All caulk joints should then be inspected annually and be repaired as needed. ALL exterior wall penetrations such as: piping, conduit, vent caps, exterior light fixtures and receptacles should be sealed against moisture intrusion through the use of the appropriate caulking methods and materials. An intentional opening/gap at the base of electrical fixtures should remain open to allow any moisture penetration an avenue of escape.

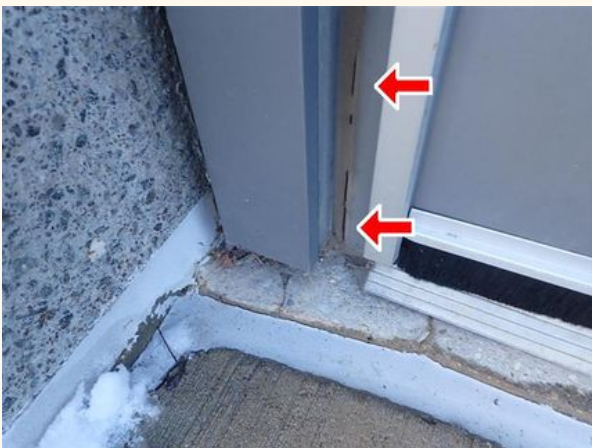
Gaps in Caulking Noted Around Windows

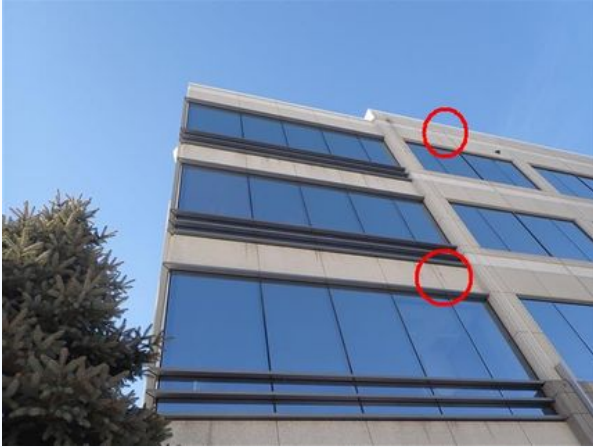
🔍 (EWGCE-3) Due Diligence: Corrosion stains were noted on several of the pre-cast concrete cladding panels on the East façade. In order to reduce the potential for further deterioration

Corrosion Noted on Pre-cast Panels

and potential detachment of the panels, the pre-cast manufacturer should be contacted in order to assess what could be corroding, if this was a manufacturing defect that would be under warranty, if repair options are viable and the cost and availability of replacement panels if needed.

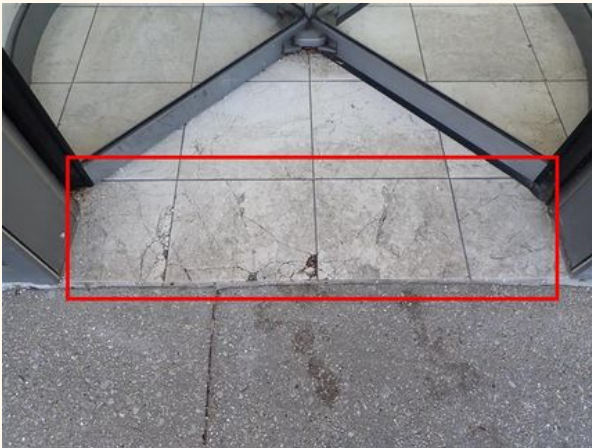
🔧 (EWGCE-5) Repair: The tile at the main entrance by the revolving door is cracked and deteriorated and further deterioration may result in a trip hazard or tile pieces that come loose and interfere with the operation of the revolving door. In order to reduce the potential for injury and proper door operation, alternate transitional materials that are more suited to the freeze thaw and heavy traffic conditions found at this door should be considered.

Cracked Tile by Front Entrance

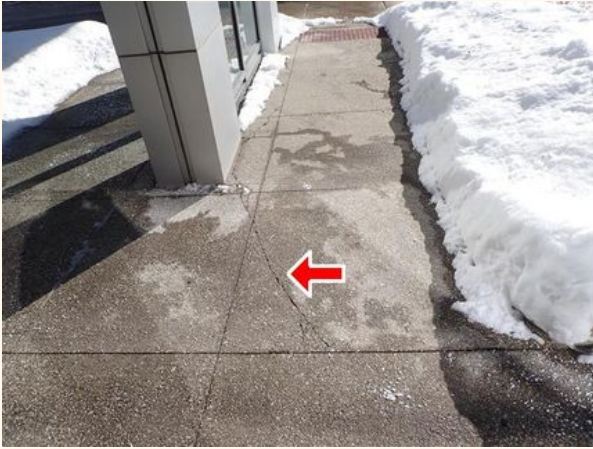
🔧 (EWGCE-6) Repair: The exterior concrete walks have cracks which can allow moisture penetration that creates the potential for further damage from freeze/thaw cycles. In order to reduce the potential for moisture related damage, the cracks should be sealed by a qualified concrete repair contractor.

Cracks Noted in Exterior Walks

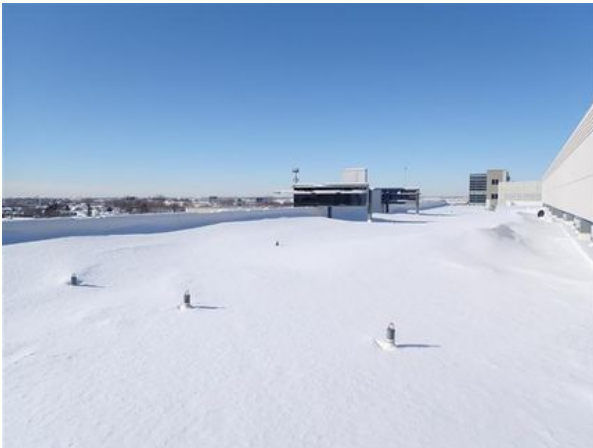
⚠️ **(RCFRD-1) Note:** Much of the roof was covered with snow and it's condition could not be assessed at the time of the inspection. Once weather permits the roof should be closely evaluate by a qualified roofing contractor.

Roof Covered With Snow

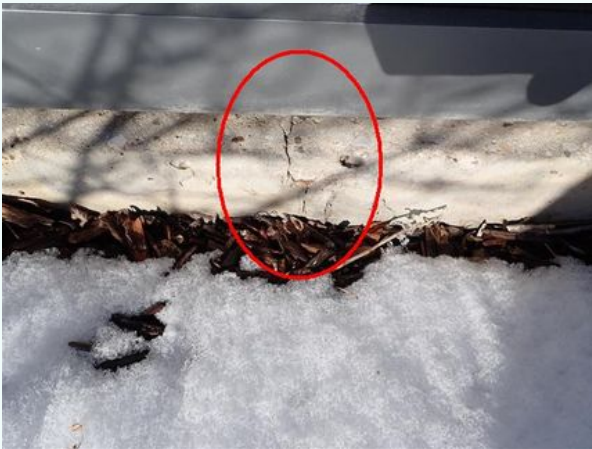
🕒 **(SAF-1) Monitor:** Minor cracking was noted along the outside edge of the foundation on the exterior of the structure. There did not appear to be any uneven gaps around windows or in the exterior cladding joints that would suggest unusual or extreme settlement on the structure. If such gaps are noted at some point in the future, evaluation and remediation by a qualified foundation repair contractor would be recommended.

Minor Cracks Noted on Exterior of Foundation

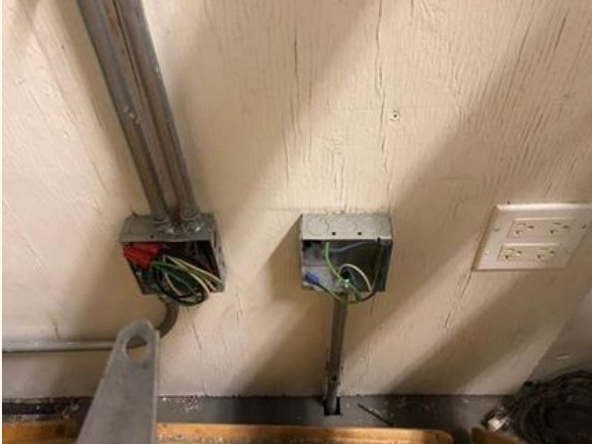
Uncovered Junction Boxes in Telecom Electric Room

🔧 (ESGCDAF-1) Repair: In order to reduce the risk for electrical shock from inadvertent contact with exposed current carrying equipment and in order to contain molten copper created by high temperature arcing and sparking of energized wiring, it is recommended that all electrical connections be concealed inside covered metal junction boxes by a qualified electrician. Also all service terminations should be evaluated and repaired as needed.

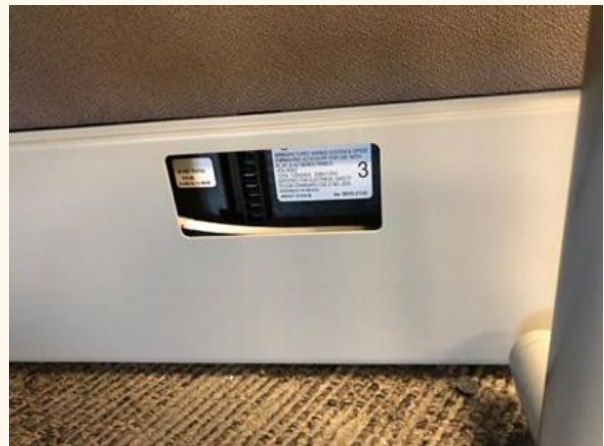
Open Power Bar in Cubicle in Room 290

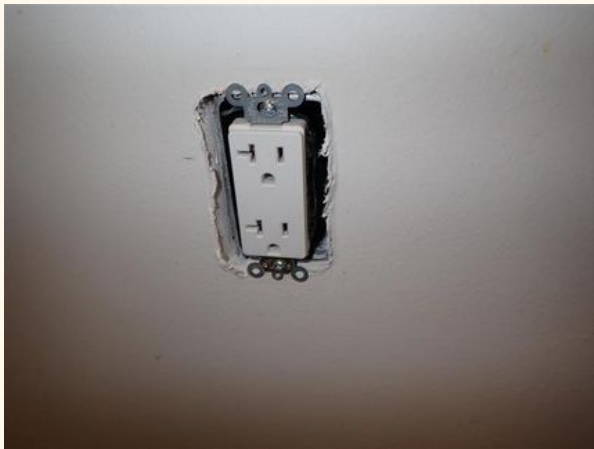
Receptacles Missing Covers

⚠️ (ESGDAF-2) Repair: Uncovered, ungrounded, inoperative, loose and/or mis-wired electrical receptacles were noted in various areas of the structure. All of these conditions represent significant electrical safety defects. All of the electrical receptacles in the building should be evaluated and repaired or replaced as necessary by a licensed and competent electrical contractor.

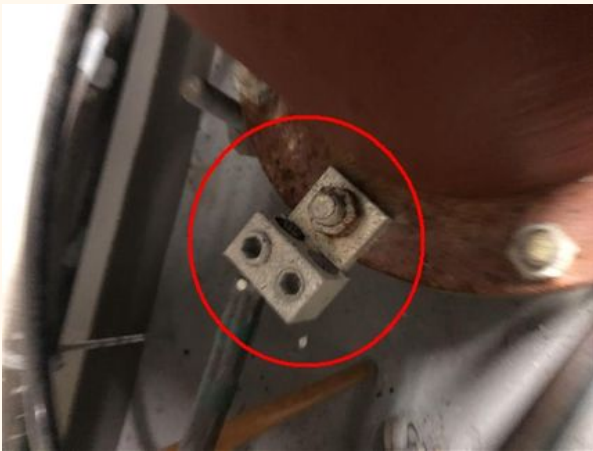
Missing Tag and Jumper Wire on Water Service Ground Connection

🔧 (ESGCDAF-5) Repair: The grounding connection to the water supply does not have a certification tag or jumper wire. Also, no driven ground rods were located and there was a bare conductor on the bus bar that did not go to earth or grounding. In order to ensure proper grounding of the building it is recommended that the grounding system be evaluated and repaired as needed by a qualified electrician.

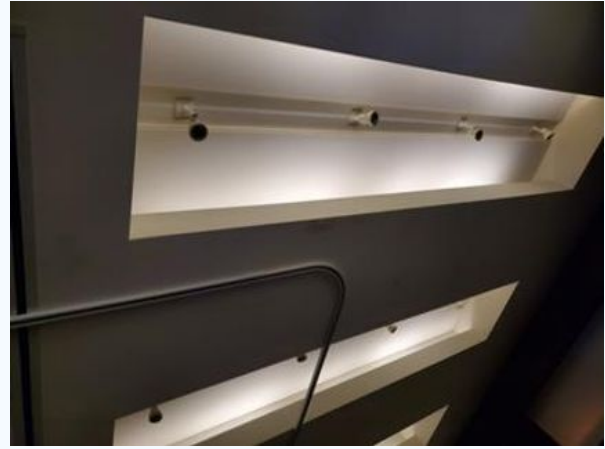
Non-functional Track Lighting

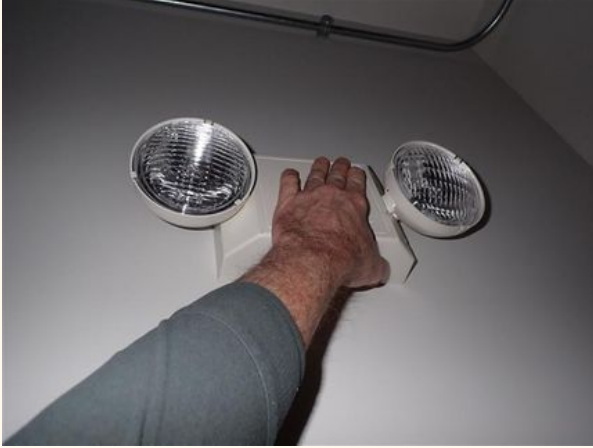
🔧 (ESGDAF-9) Repair: A spot check of the battery operated emergency lighting system

Non-functional Emergency Lights Noted

revealed one or more non-functioning units. It is strongly recommended that these critical life safety devices be regularly evaluated and repaired as needed by a qualified electrician.

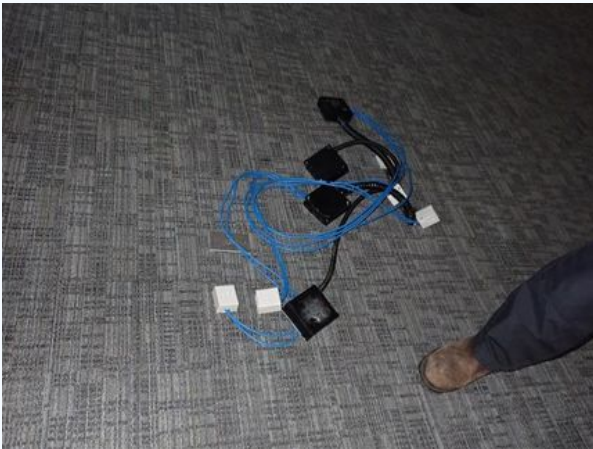
Numerous Abandoned Low Voltage Communication Wiring

🔍 **(ESGCDAF-10) Due Diligence:** The evaluation of the low-voltage equipment in the structure - alarm, communication, audiovisual, etc., is beyond the scope of the building inspection and should be performed by a qualified low-voltage electrical contractor. In order to reduce the potential for confusion and to reduce clutter around the structure, any wiring, panels, cabinets, etc. for any equipment that is no longer in use should be removed.

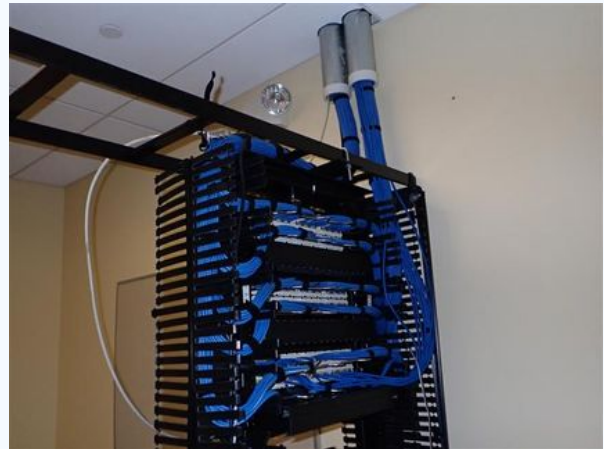
Abandoned Wiring and Racks

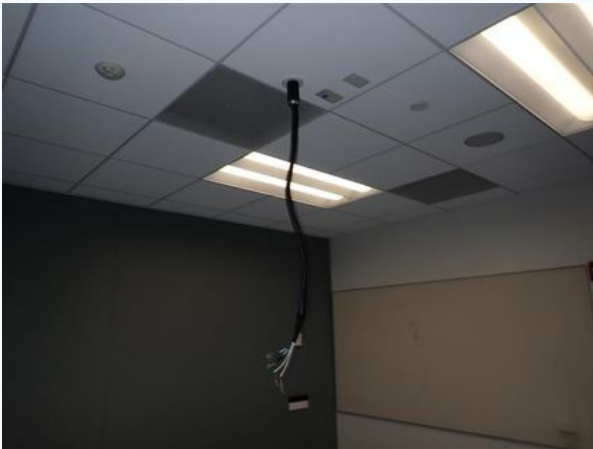
Low Voltage Cables Dangling From Ceiling

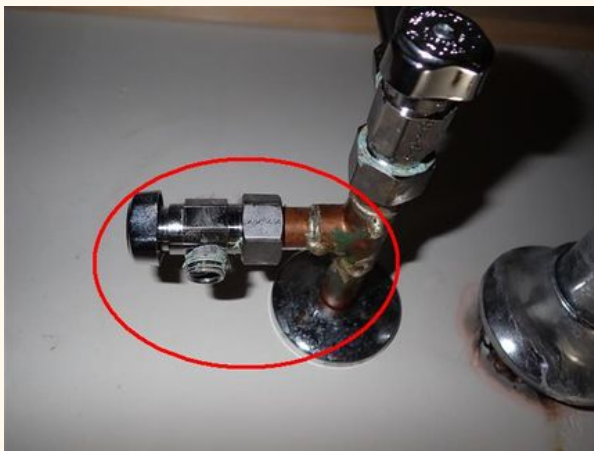
Active Leakage From Abandoned Valve

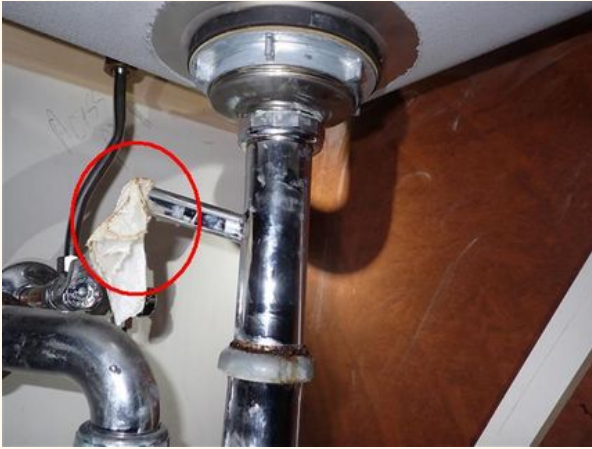
Leakage Noted From Improperly Abandoned Dishwasher Drain

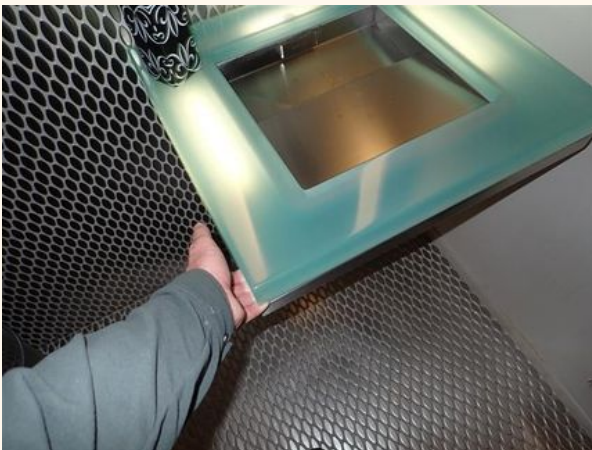
Loose Counter on Bathroom Sink

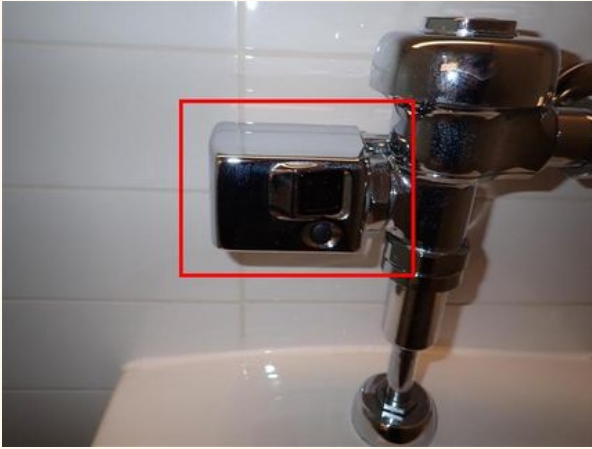
*Non-functional Self Flushing Mechanisms
Noted*

🔧 (PSDFAV-2) Repair: The subject building currently has limited use and while the automatic non-touch fixtures are being maintained, non-responsive fixtures were noted and most likely battery replacements are needed. As a part of occupancy of the building, all plumbing fixtures should be tested and serviced as needed.

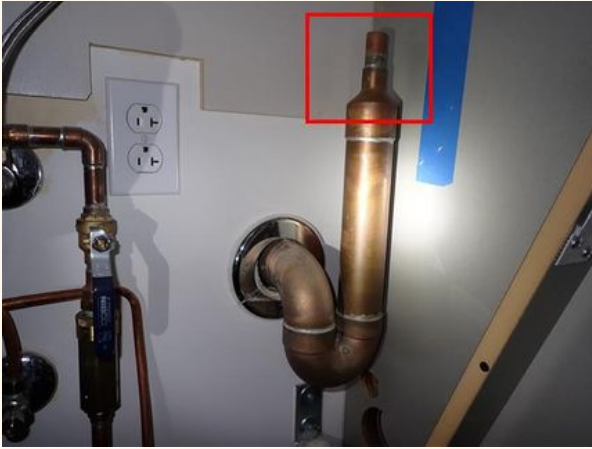
Uncapped Dishwasher Drain

🔧 (PSDFAV-3) Repair: At least one abandoned dishwasher connection was noted. If the existing finishes are going to be left in place and there is no intention of installing a dishwasher, in order to reduce the potential for sewer gases to enter the structure from a dried out trap, the drain connection for the dishwasher should be capped by a qualified plumber.

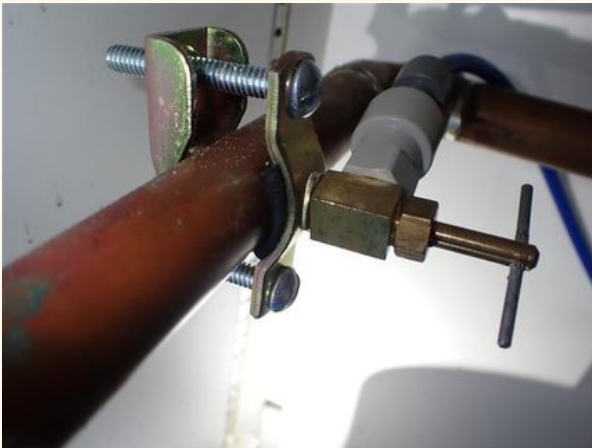
Unreliable Saddle Valve for Filter Water Supply

🔧 (PSDFAV-4) Repair: The inexpensive and unreliable saddle valve that supplies water to the sink mounted filter in one kitchen installation creates the potential for leakage. In order to reduce the potential for moisture related damage and to be able to shut off the water supply to filter, the valve should be replaced with a high-quality fixture valve.

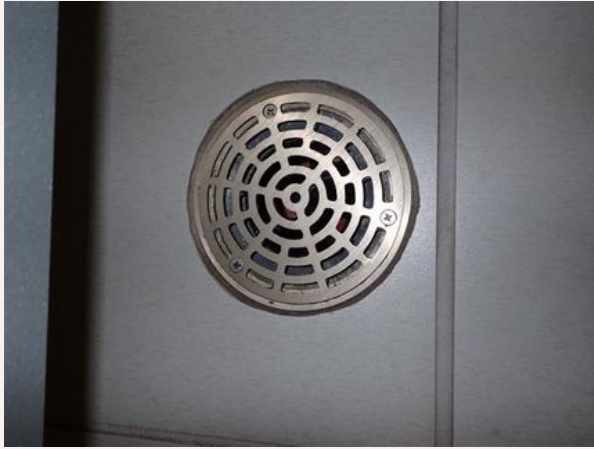
Open Floor Drains in All Bathrooms

🔧 (PSDFAV-5) Recommended Maintenance: FYI: Traps on floor drains without a continuous source of moisture can dry out and should be regularly monitored and re-filled with water as needed to prevent the migration of sewer gas into the home. **The application of several drops of mineral oil can retard the evaporation of the water 'plug' in the floor drain trap.**

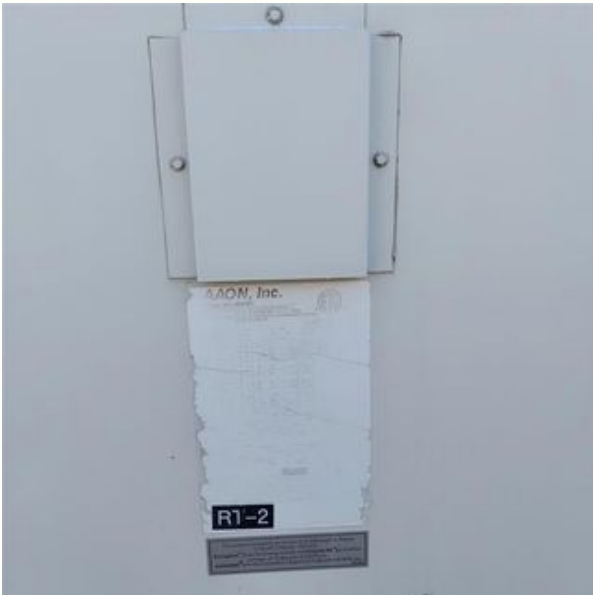
AAON Rooftop HVAC Data Plate Illegible

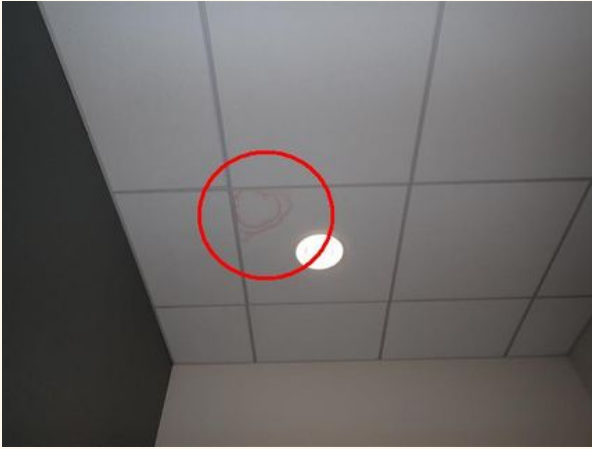
🔧 (HACVAGAS-3) Repair: Moisture related staining was noted in several ceiling areas, and all staining is directly related to leakage from ceiling fan coil units. In order to reduce the potential for moisture related damage, the leaking fan coil units should be evaluated and repaired by a qualified HVAC contractor. One of the leaking fan coil units seemed to be louder than others in the building and given the leak, it should be serviced as soon as practical.

Ceiling Stains Noted in at Least Two Locations

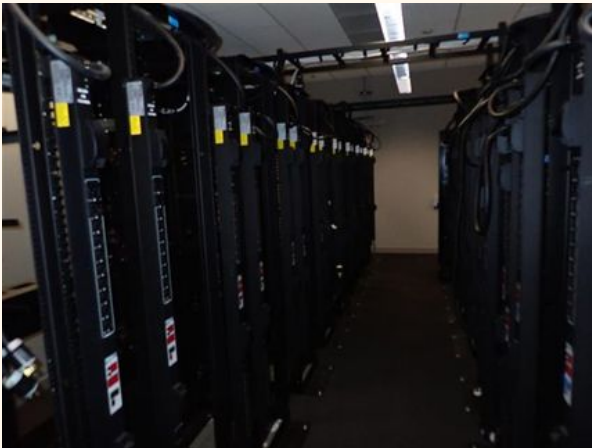
🔧 (HACVAGAS-4) Repair: There were several former server rooms that had massive stand-alone air conditioning units installed specifically to keep these rooms at the temperatures needed to keep thermal runaway from occurring while the servers were running. It is doubtful that these systems would be needed and the systems should be removed.

Former Server Racks

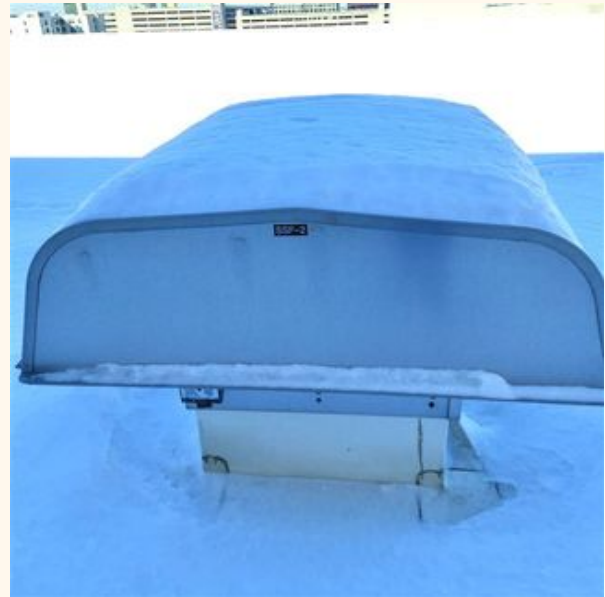
🔧 (HACVAGAS-8) Repair: The two stairwell pressurization fans were not operated at time of inspection, inspection of this equipment is beyond the scope of a commercial building inspection. A qualified specialty contractor services should be engaged to evaluate, operate and insure these critical life safety units perform as intended.

Stairwell Pressurization Fan

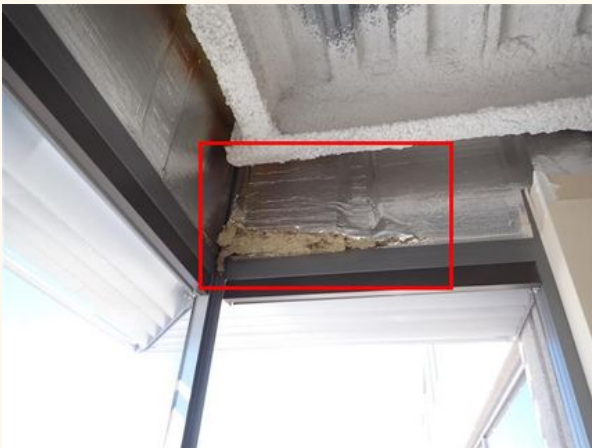
🔧 (IVAE-1) Repair: Potential moisture related staining was noted on the interior metal trim around some windows. The areas above the windows where the pre-cast façade panels are attached are insulated with what appears to be mineral wool batts. These batts are then "sealed" or held in place via adhesive reflective material that has now become loose in some areas. The insulation did not appear to completely fill the cavities and the open, un-insulated voids adjacent to exterior areas may also have potential air leakage. Other areas prone to air leakage and lack of insulation are the metal trim window dividers and potential leakage stains were also noted on those.

The colder temperatures in these areas have the potential to react with warmer interior temperatures that could result in the formation of condensation. It appeared that the condensation was less pronounced in areas of the building that were exposed to more sunlight, however, conversely, areas of the building that experienced less sunlight had more condensation formation. In order to reduce the potential for moisture related damage it is recommended that the mineral batt insulation be removed and an equivalent depth of closed cell foam insulation be applied in these cavity areas by a qualified insulation specialist. For more information on the role air leakage plays on interior condensation, here is a link to an interactive webpage from the Department of Energy that can shed light on this and many other insulation concerns: [Moisture Control](#)

Loose Insulation Above Window

NOTE: It had been reported by building maintenance personnel that water from the window washers may be responsible for some of the staining and before extensive corrective actions are explored or developed, some simple testing with overly sloppy window cleaning should be conducted.

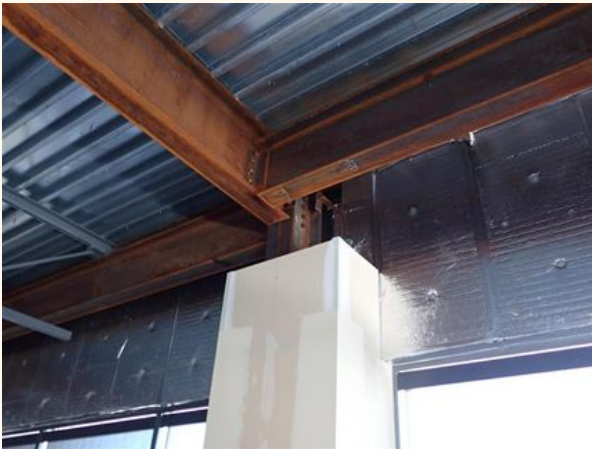
🔍 (IVAE-2) Repair: An infra-red examination of open ceiling areas on the fourth floor revealed a potential lack of insulation around the column to roof connections. In order to reduce the potential for moisture related damage related to condensation, these areas should be evaluated by a qualified insulation specialist in order to see if they can be insulated with closed cell spray foam insulation.

Column to Beam Connection on Fourth Floor

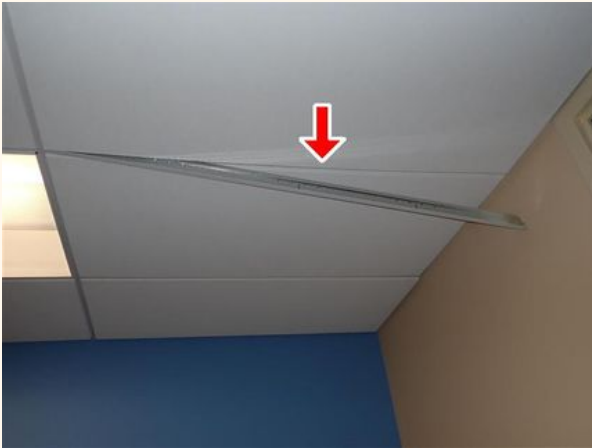
🔑 (IAF-1) Repair: The building has numerous built out spaces that were in a variety of states when they were abandoned. If use of any of the existing interiors is desired, some drywall touch-ups, re-painting and other repairs may be needed.

Loose Ceiling Tile Grid Members

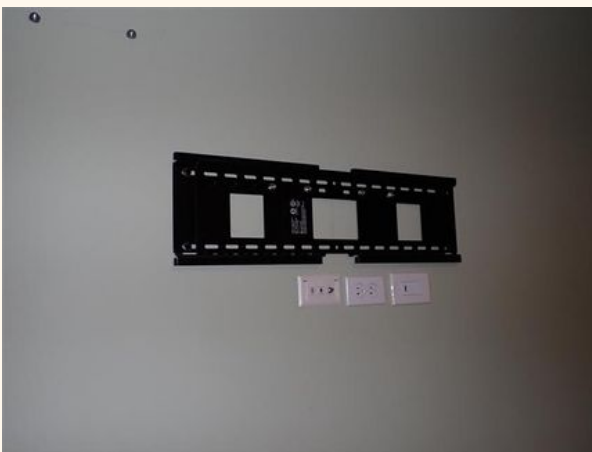
Numerous Wall Mounts Noted

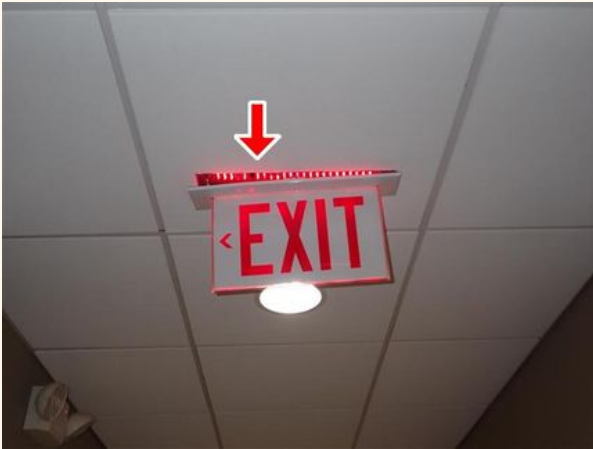
Loose Exit Sign

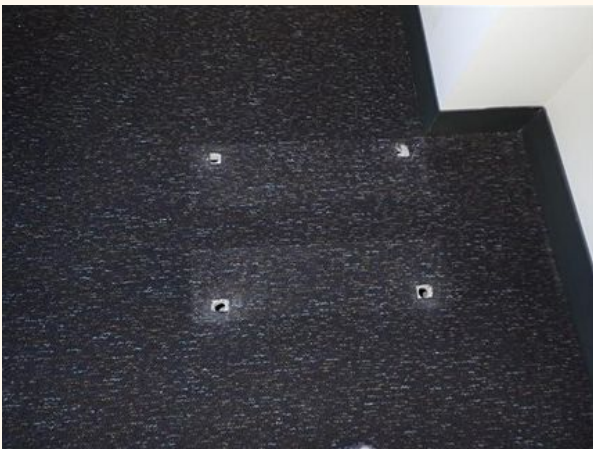
Holes in Floor

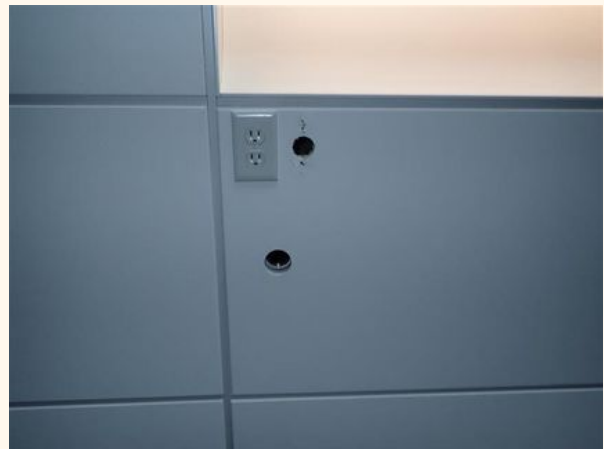
Holes in Wall

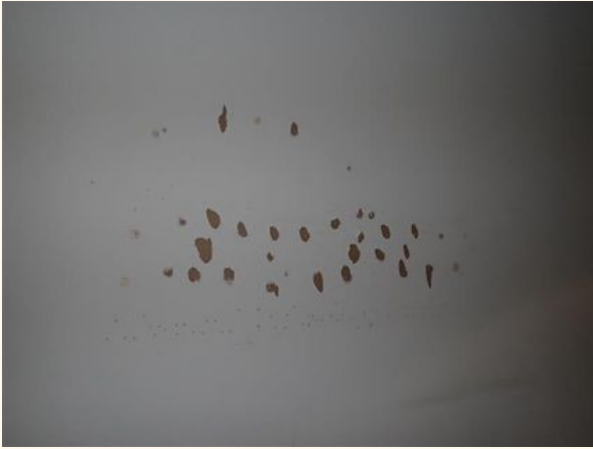
Damaged Wall Finishes

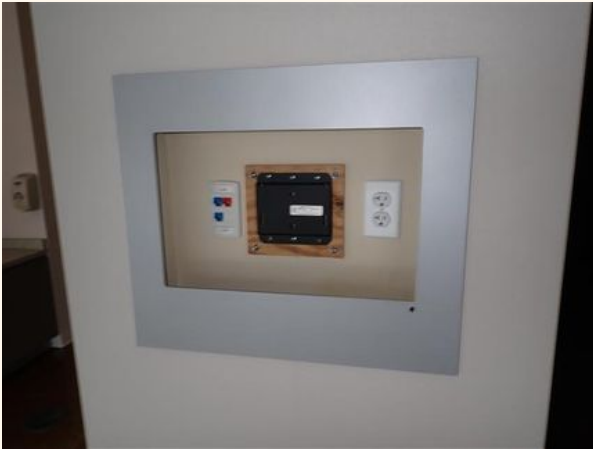
Numerous Abandoned Wall Mounts

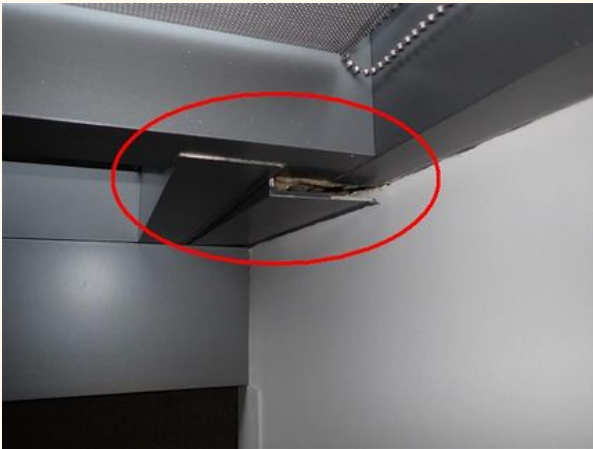
Loose Window Trim

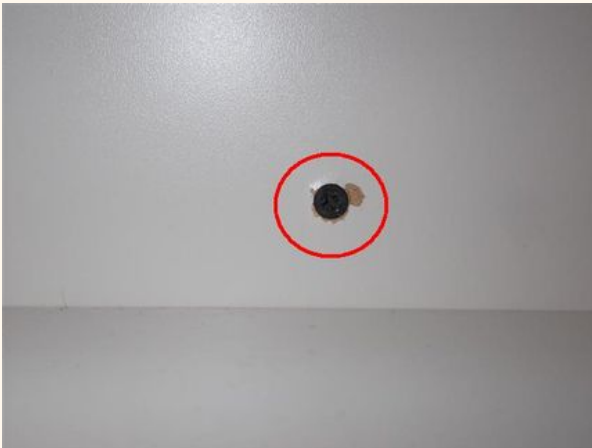
Drywall Screws Used to Secure Some Cabinets

Cabinet Screws

🔧 (IAF-2) Repair: The screws used to fasten some of the cabinets to the wall framing are not the recommended washer head screws. In order to reduce the risk of the cabinets pulling through the existing fasteners and loosening or becoming detached, the existing screws should be removed and replaced.

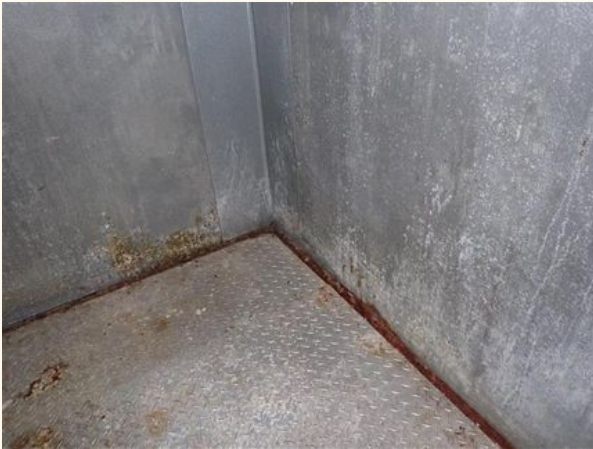
Corrosion Noted on Interior of Fridge

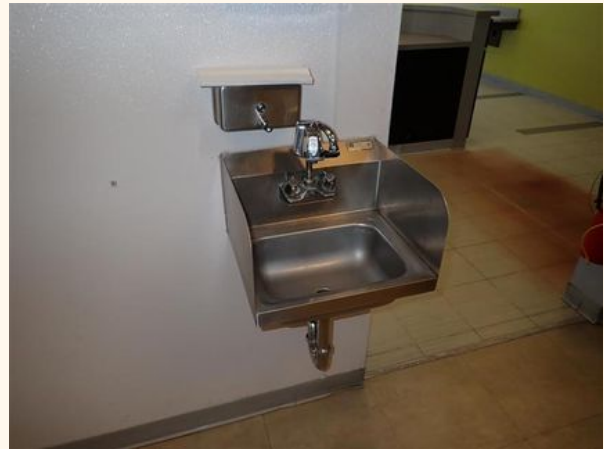
Non-functional Hand Washing Sinks

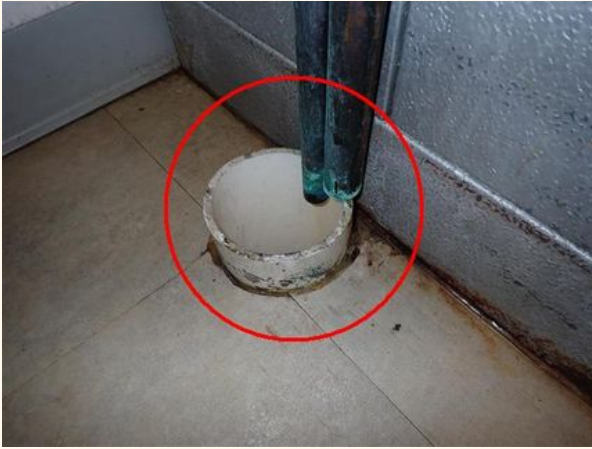
Fridge Drain Line Discharging Outside of Floor Drain

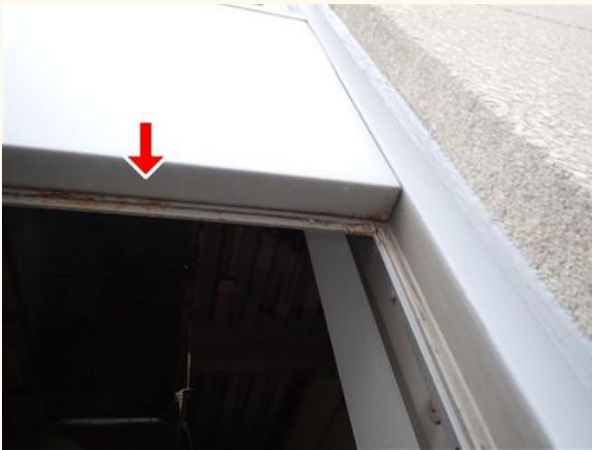
The exterior doors have some corrosion and damage, most likely related to salt use by the entrances. For proper appearance and operation some painting, repair and replacement of door features may be needed

Corrosion and Deterioration Around Door Seals

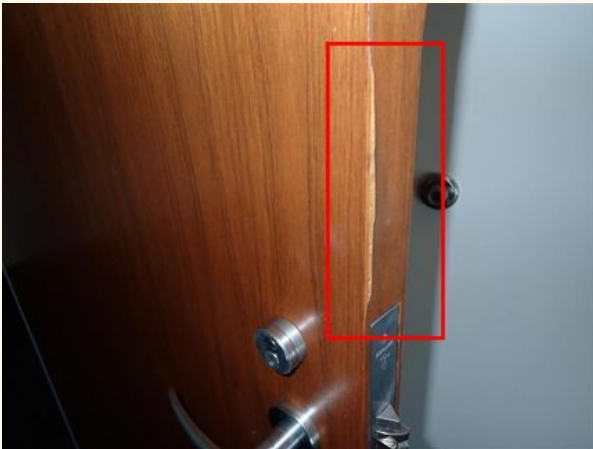
Peeling Veneer on Several Doors Noted

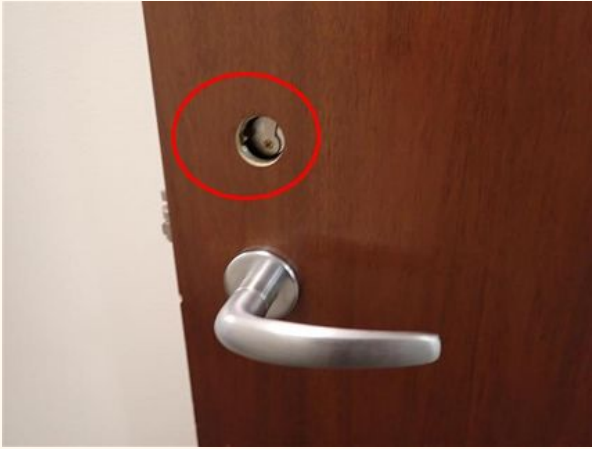
Missing Hardware on Doors

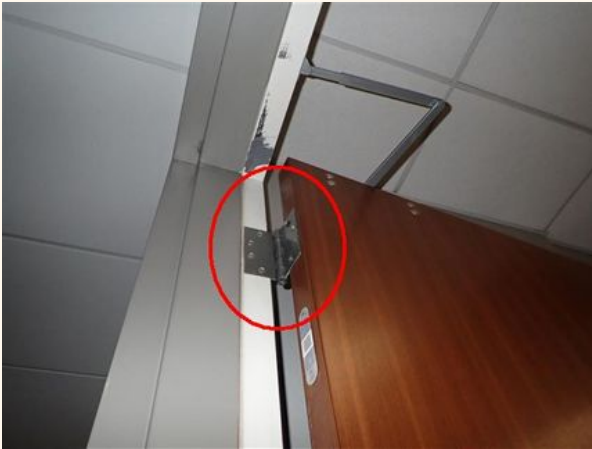
Unstable Hinge on Door

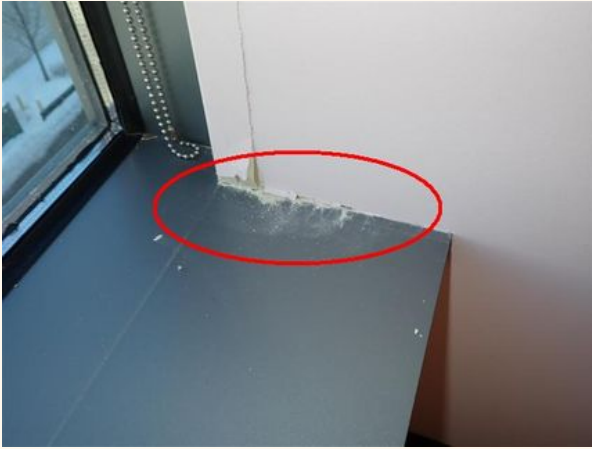
🔧 (WDS-4) Repair: Large exterior windows with aluminum frames are prone to the transmission of cold exterior temperatures that can result in the formation of condensation on interior metal surfaces and the adjacent drywall finishes are capable of wicking moisture which promotes mold growth. In order to reduce the potential for moisture related damage and fungi growth at these locations, a caulked capillary break should be provided between the metal finishes in contact with the exterior and the adjacent drywall finishes.

Potential Moisture Related Damage Noted on Numerous Wall Surfaces

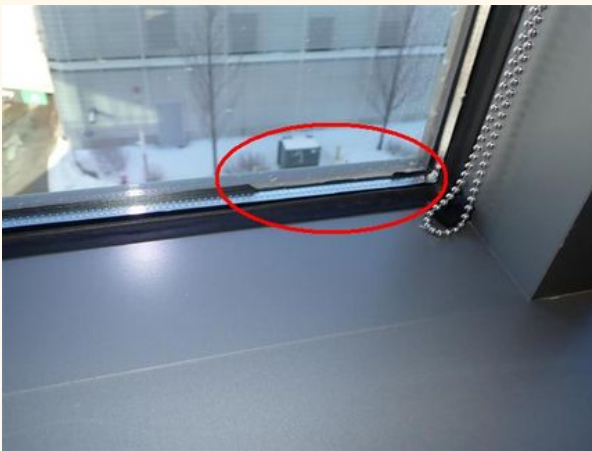
🔧 (WDS-5) Repair: Some irregularities with regards to sealant installation was noted on several windows. No apparent signs of leakage were noted on these windows, however, they should be monitored and if leakage is noted in the future, repair by a qualified curtain-wall contractor is recommended.

Irregular Sealant Installation

If desired water testing using pressurized exterior flow with an interior observer may be utilized to pinpoint leaks - removal of some interior cladding features may need to be removed to clearly view leak location.

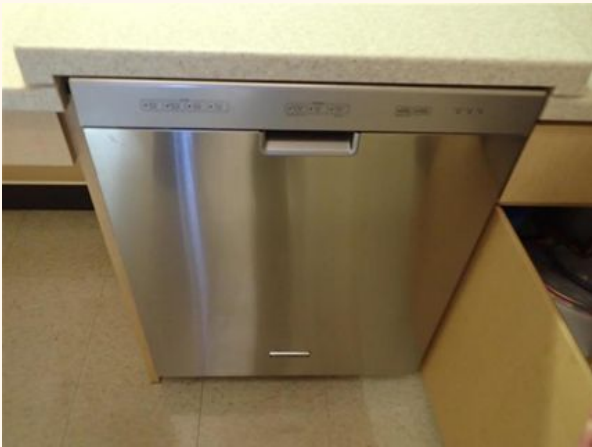
🔧 (IA-1) Repair: The dishwasher in the fourth floor kitchen does not have a switched disconnect as required for electrical safety. In order to reduce the potential for electric shock, it is recommended that a qualified electrician install a 'kill switch' within sight of the dishwasher.

Shut-off Switch Missing on Dishwasher

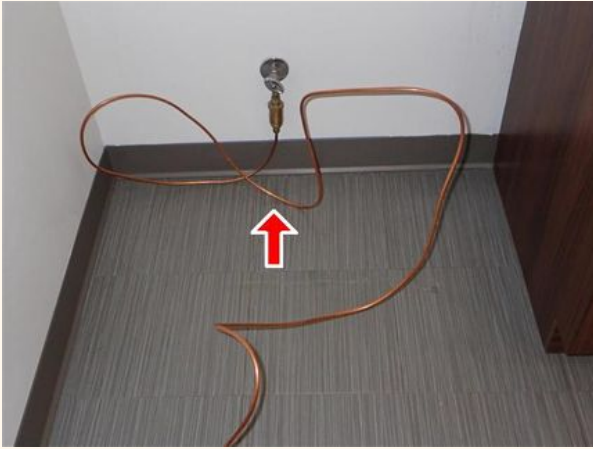
🔧 (IA-2) Repair: A refrigerator that was removed had a copper water supply line that is flexible and easily damaged. For optimal resistance against leakage and water related damage to the surrounding finishes, the copper water supply tubing should be replaced with braided stainless steel tubing if a new refrigerator is installed.

Copper Water Supply Utilized for Removed Refrigerator

Fridge Tubing

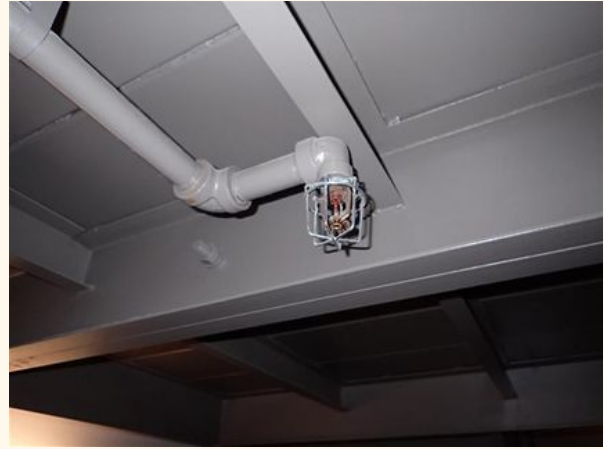
Protective Cover on Sprinkler Head

In order to reduce the potential for accidental activation of the sprinkler heads, any exposed heads that are accessible should have protective covers installed.

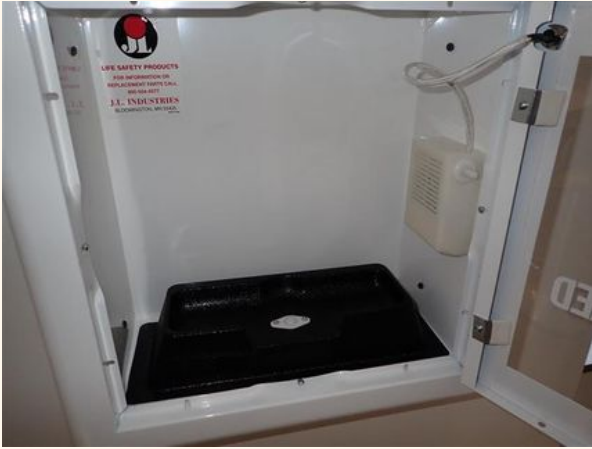
Missing Extinguishers in Some Enclosures

🔧 (O-2) Repair: There were numerous fire extinguishers noted throughout the building. Many of the extinguishers appear to have been regularly maintained, however, some expired extinguishers were noted. All equipment that is part of the sale of the property that is required for use in the structure should be evaluated and serviced as needed for re-certification.

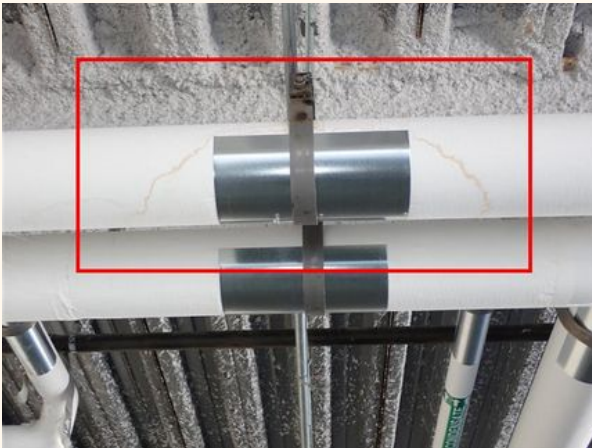
Potential Moisture Stains on Insulation for Suppression System Piping

🔧 (O-3) Repair: The building has a fire suppression system that most likely has components that require annual inspections and/or servicing and as agreed to with the client was not evaluated as a part of this inspection. In order to ensure proper operation of the fire suppression system, it is recommended that the buyer review the past service records and make arrangements for regular servicing.

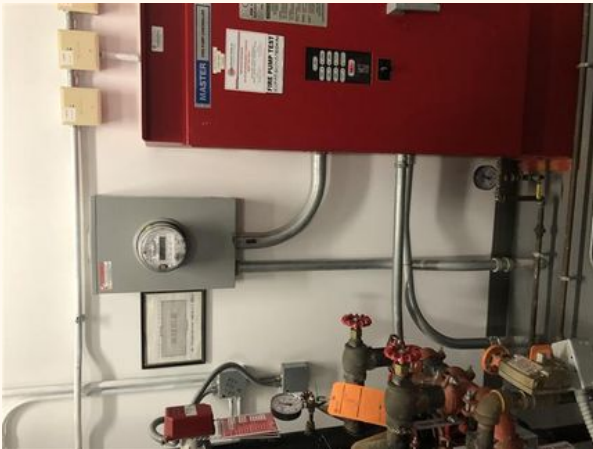
No Grounding Observed on Fire Pumping System

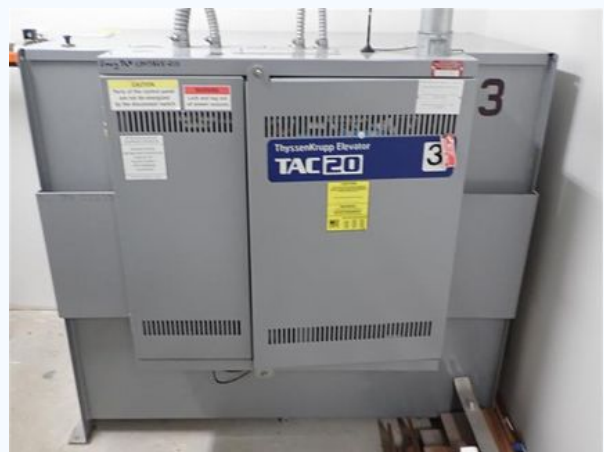
Hydraulic Elevator Units

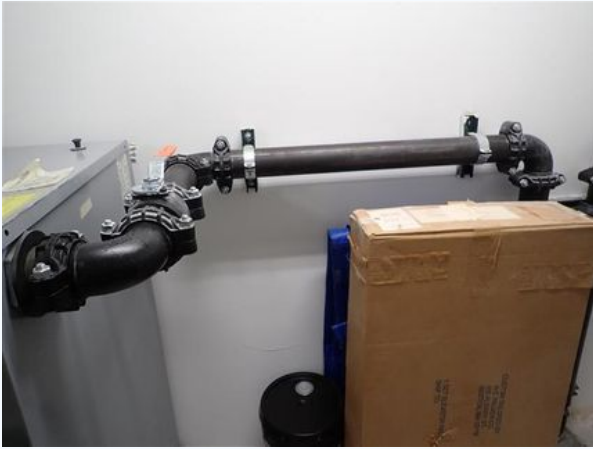
*No Leakage Observed on Visible Elevator
Piping*
