This report is prepared exclusively for **Any Client**  
Inspected On: **2022-12-06**

This inspection was a Property Condition Assessment of a 15 year old 40 unit condominium building. There have been a number of problems occurring since the building was built and there have been significant expenditures to rectify some of the problems. The building is at a critical juncture as the reserve funds are low and there are still a number of concerning issues to address. This PCA will be used to drive a Reserve Study that will look at upcoming expenditure needs and the need to adjust the monthly assessment to cover the needed upcoming improvements.

# The Scope and Purpose of a Property Condition Assessment

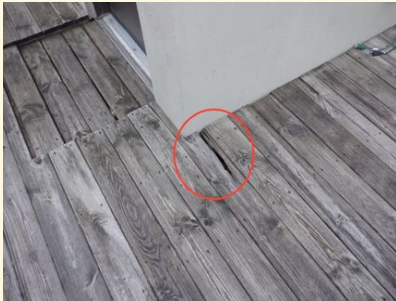
**🔧 (EWGCE-1) Repair:** The existing wooden roof deck is weathered and deteriorating. In many cases there are rugs or other objects on the roof that are trapping moisture against the deck and deteriorating the existing deck boards. There are also planters that are deteriorating and the dirt from the planters is spilling onto the deck boards and getting into the roof deck and drainage piping. **Since the deck needs to be removed to replace the roof, it is vitally important that the deck and roof membrane be on the same replacement cycle.** In order to extend the service life of the deck materials, all materials that trap moisture should be removed from the deck and be banned from future use. If planters are desired, they should be appropriately designed and installed in a manner that does not affect deck surfaces, like wall mounted planters. Once the deck is clear the exterior wooden deck surfaces should be professionally cleaned and sealed against weather. Any deteriorated boards should be replaced prior to the sealing.

*Deteriorated Deck Board*

**NOTE:** Because of the rooftop exposure and maintenance costs of a wood deck, when the deck is replaced, consideration should be given to using composite decking materials. These materials are not affected by moisture like wood is and the reduced maintenance costs and extended life will typically offset the higher initial purchase cost of the composite materials.

**FINAL NOTE:** When the deck is replaced the level of the deck should meet the rooftop door access thresholds. The existing sloped transitions should be avoided as they present trip hazards that can result in injury and drive moisture into the door openings.

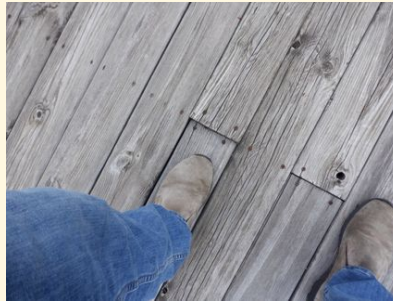
*Protruding and Weathered Deck Boards*

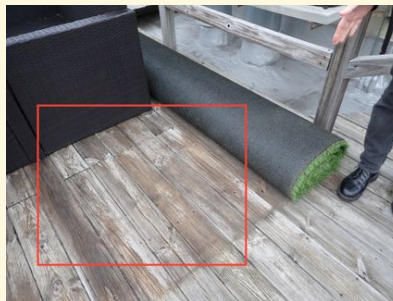
*Carpeting Trapping Moisture and Damaging Deck*

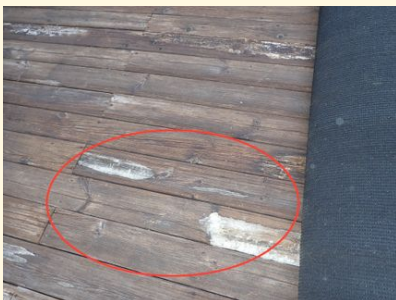
*Wood Rot on Deck Areas Below Carpet*

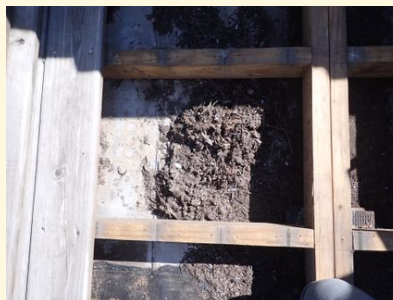
*Dirt and Debris Beneath Deck*

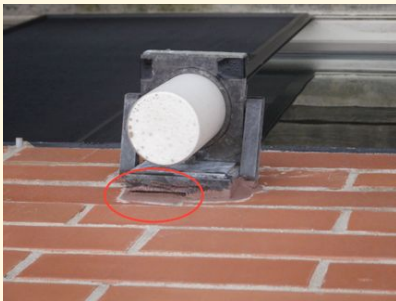
**🔧 (EWGCE-2) Repair:** The existing caulking around the perimeter of the structure is missing,

cracked and sloppy and/or improper. Exterior sealant performance is **directly related to the joint preparation and application**. For increased service life, performance and aesthetics, the exterior of the structure should be carefully examined and old deteriorated and/or improper caulking should be removed and the exterior of the structure caulked via appropriate means and materials. Proper joint preparation and the use of compliant exterior rated sealants of good quality is recommended .

*Unsealed Edge on Balcony Light*

All caulk joints should then be inspected annually and be repaired as needed. **ALL** exterior wall penetrations such as: piping, conduit, vent caps, exterior light fixtures and receptacles should be sealed against moisture intrusion through the use of the appropriate caulking methods and materials. An intentional opening/gap at the base of electrical fixtures should remain open to allow any moisture penetration an avenue of escape.

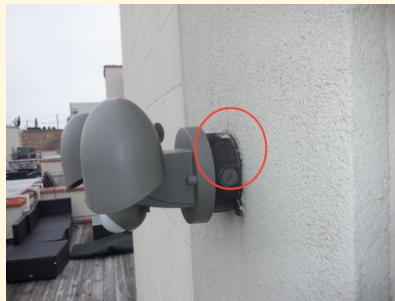
*Unsealed Junction Box on Upper Deck Light*

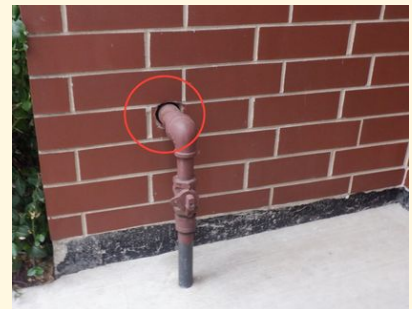
*Unsealed Wall Penetrations*

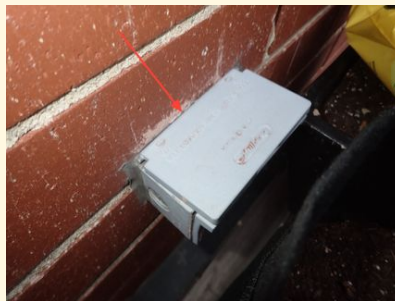
*Unsealed Wall Penetrations*

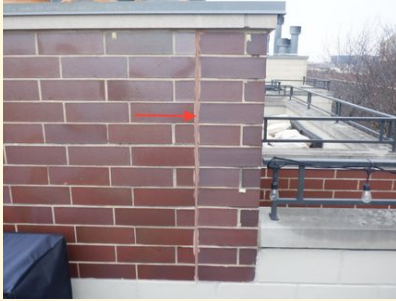
*Failing Caulk Joints Noted*

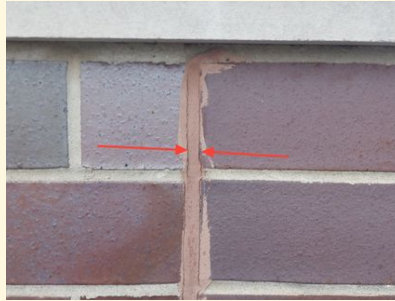
*Cracks Noted on Sides of Caulk Joint*

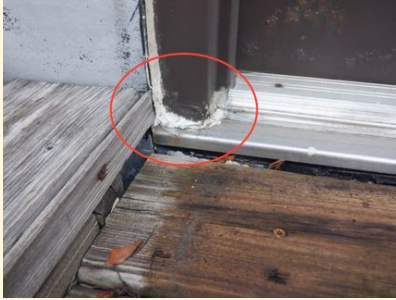
**NOTE:** The cracked and open caulk joints by many of the doors exacerbates runoff entering the joints and deteriorating the metal and the caulk joints should be replaced as noted elsewhere in this report.

*Sloppy Caulk by Doorframes*

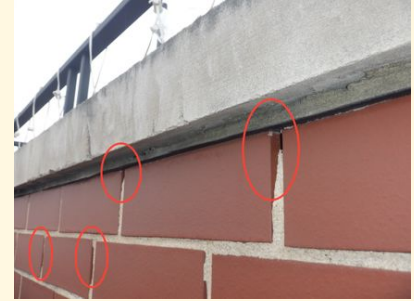
**🔧 (EWGCE-3) Repair:** Some of the masonry joints on this relatively new structure are poorly formed, especially at the head joint. Proper masonry installation requires a skilled brick layer that can properly fill and finish the head joints on each course of masonry and failure to achieve this results in openings that may allow excessive moisture to enter the structure. In order to reduce the potential for moisture related damage, it is recommended that a qualified masonry contractor evaluate the entire structure and re-point the joints as needed.

*Numerous Poorly Formed Joints*

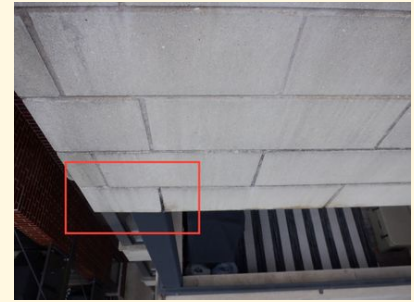
*Displaced Blocks by Steel Framing*

**NOTE:** Displaced block was observed in several locations which suggests that moisture entered into the spaces behind the block and frozen conditions pushed the blocks outward. These blocks cannot simply be re-pointed and it will be necessary to remove the affected blocks, evaluate the space behind the blocks for additional concerns and replace the blocks so they are flush with the exterior face.

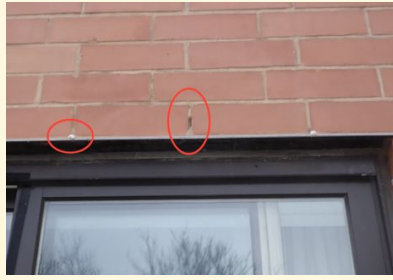
**🔧 (EWGCE-4) Repair:** Some of the exterior window lintels have been sealed and can no longer drain moisture which increases the potential for corrosion of the lintels. Over time the corroding steel will expand which can damage the adjacent masonry walls and allow moisture to penetrate to the interior of the living space. In some cases inappropriate or improper weep ropes have been installed, if these are to be utilized they should be proper weep tubes that extend back into the wall cavity. In order to reduce the potential for moisture related damage, the lintel drainage space should be repaired by a qualified masonry restoration contractor.

*Blocked Weep Hole and Potentially Improper Weep Ropes*

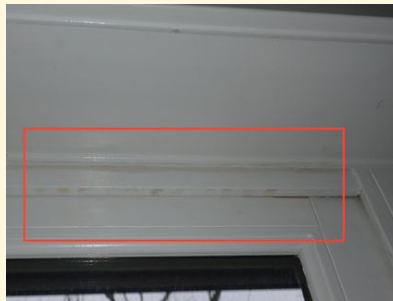
*Moisture Stains Noted in Trim Above Sliding Door in Upper Level Unit*

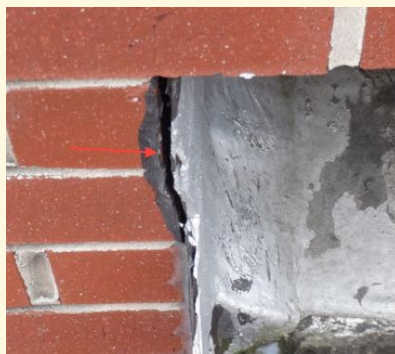
**🔧 (EWGCE-6) Repair:** The through-wall drainage scupper details are improperly configured and are prone to allowing moisture penetration and damage to take place. The installations conform with neither the National Roofing Contractors Association (NRCA) standards nor those of the Sheet-Metal and Air-Conditioning Contractors National Association (SMACNA). In order to reduce the risk for moisture penetration, saturation and freeze/thaw damage, it is strongly recommended that the through-wall scupper openings be repaired by a qualified sheet-metal contractor. Also, debris was found in several of the scuppers that could reduce or block flow. In order to reduce the potential for moisture related damage It is recommended that debris screens be added to the scuppers and they be checked and cleaned regularly

*Close-up of Large Open Gaps on Scuppers*

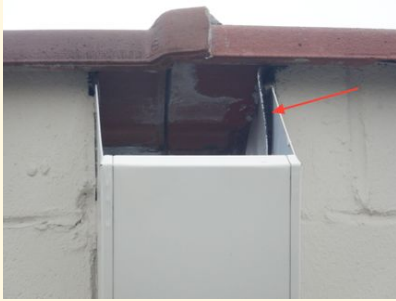
*Unsealed Roof Edge on Side of Scupper*

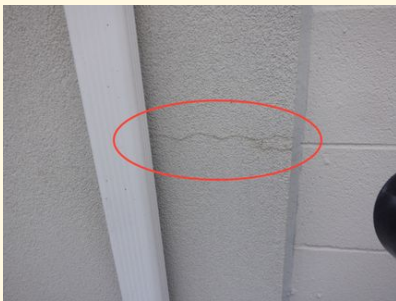
**🔧 (EWGCE-7) Repair:** This structure has an exterior cladding of EIFS (Exterior Insulation and Finishing Systems) and cracks were observed in the exterior walls. This wall cladding system may allow unseen moisture penetration, rot and damage to occur and progress to critical levels before being noticed. No representation is made in this report regarding the suitability or performance of this product. Obvious defects will be noted but a final determination on the existing condition of the EIFS system should be made by a licensed and competent contractor specializing in the review and repair of these systems.

*Cracks in EIFS*

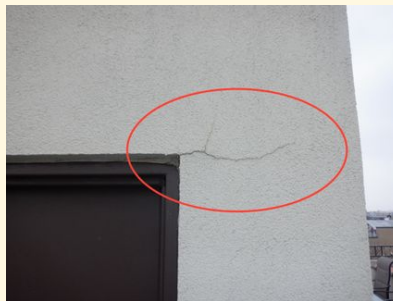
*Cracks in EIFS*

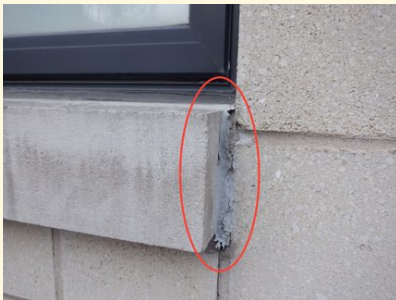
**🔧 (EWGCE-10) Repair:** Caulk appears to have been smeared over the joints between the stone copings and/or sills and cracks were noted on the sides of the caulked joints. All of the exterior caulk joints should be configured and applied according to appropriate standards. A thin smear of caulk over a brittle substrate such as cement mortar, does not constitute an appropriate caulk or sealant joint. In order to reduce the risk for moisture penetration, drafts and energy losses, it is recommended that all of the exterior caulking on the building be evaluated and repaired or replaced as needed by a qualified handyman or masonry restoration contractor.

*Caulk Smeared Joint on Stone Sill*

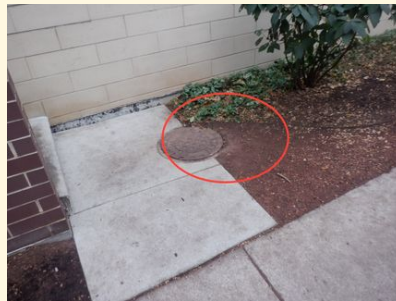
**🔧 (EWGCE-12) Repair:** Settlement of some of the front walk areas was noted and the rainwater runoff may further exacerbate settlement of the walk and stairs. There was also potential settlement of at least one of the stairs and walls. It's highly likely that these areas were adjacent to the large excavation needed for the foundation of the structure. Typically this void is backfilled with material that is difficult to compact and there may be some settlement over time. In some cases the slabs can be raised via various methods, however, some of the slabs are cracked and eventual replacement may be needed as it appears to have already been done on several other walk areas. Also, the grade adjacent to the front steps and walks does not drain away from the structure and ponding areas were noted adjacent to some of the walks that further exacerbates the walk settlement. All areas adjacent to the structure should drain away from the structure and once the walks are raised or replaced the landscape areas should be re-graded by a qualified landscaping contractor.

*Areas of Ponding Water*

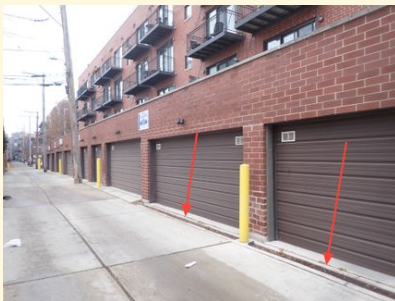
**🔧 (EWGCE-14) Repair:** There were several trench drains on the property, a large one is present by the main underground garage entrance and there are several by the garages on the rear of the property. These drains appeared to be clogged with debris that would affect their ability to provide critical drainage and reduce the potential for water to enter the garages. In order to reduce the potential for moisture related damage It is recommended that the drains be regularly cleaned and maintained.

*Trench Drains by Garages*

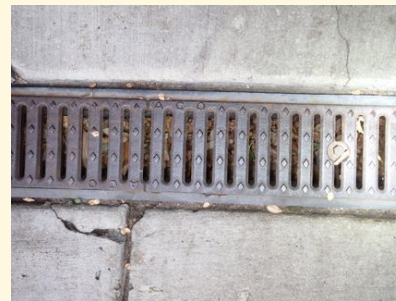
*Trench Drain Clogged with Leaves*

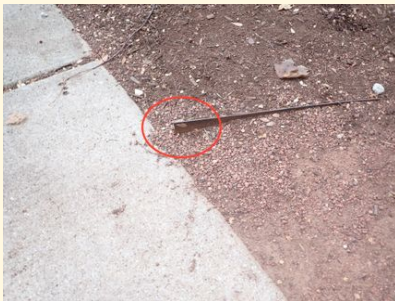
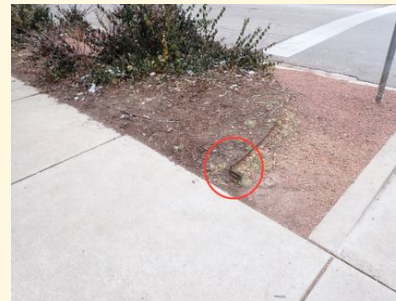
**🔧 (EWGCE-16) Repair:** There were metal planter edgings in several locations and there are sharp exposed edges that create potential trip and/or injury hazards. In order to reduce the potential for injury, it is recommended that a qualified landscaping contractor evaluate and remove or repair the edging as needed.

*Exposed Metal Edging*

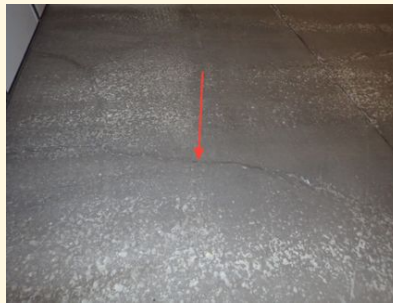
**🔧 (GAO-1) Repair:** The concrete floor in interior the parking garage is cracked spalled and uncoated. Concrete typically contains reinforcement in order to provide the needed strength, however, this reinforcement is extremely susceptible to deterioration from exposure to moisture and de-icing salts. Over time this exposure can result in deterioration of the concrete resulting in costly replacement of the parking garage concrete. Unless a waterproofing membrane system was

*Cracks in Driveway*

installed as a part of the initial construction, the parking deck surface may be unprotected. In order to reduce the potential for moisture related damage, It is recommended that a qualified waterproofing contractor clean the floor and apply an appropriate waterproofing membrane that is suitable for vehicular traffic.

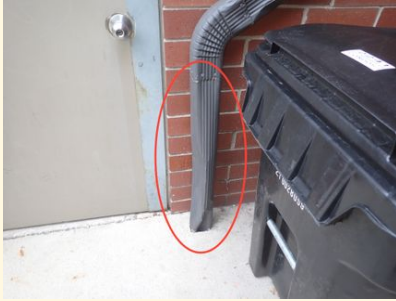
**🔧 (RCRFRD-5) Repair:** The lower portions of the relatively thin and weak aluminum downspouts should be protected against impact damage by the use of cast-iron transition pieces or the equivalent. In order to allow for proper control of roof runoff, repair by a qualified gutter installation contractor or handyman is recommended.

*Damaged Downspout  
Surrounded by Sidewalk*

Also, the downspout termination should take place above grade and the hub of the downspout-to-subsurface drain connection should be clearly visible and accessible. In order to reduce the risk for soil washout, repair of the subsurface drain system by a qualified plumber, handyman or gutter installation contractor is recommended.

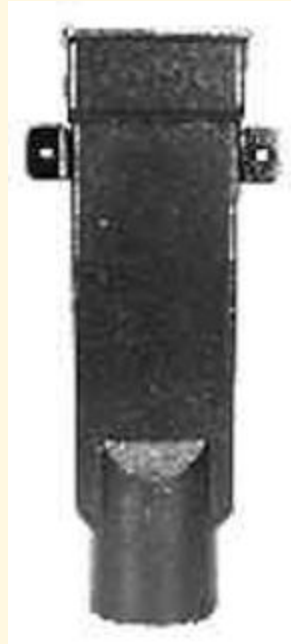
*Cast Iron Downspout Connection*

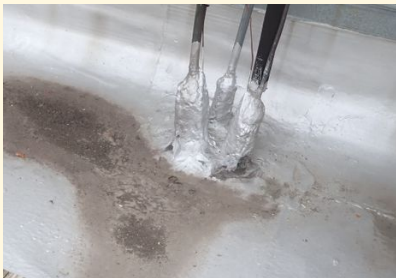
**⚠️ (RCFRD-6) Repair:** The penetrations through the modified bitumen roof covering are sealed with caulk and/or roofing tar which is a high maintenance, unapproved, high risk means of sealing a hole in the roof. When the roof is replaced, in order to reduce the potential for damaging and mold causing moisture to enter the structure, the installation of rubber boots flashings or pitch pocket flashings by a qualified roofing contractor is recommended.

*Multiple Layers of Sealant  
Materials on Rooftop  
Penetrations*

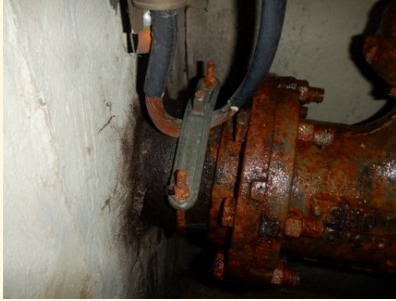
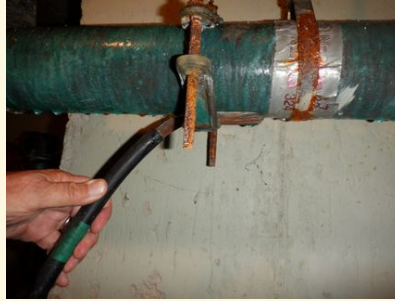
🔧 (ESGCDAF-2) Repair: The grounding electrode conductor is not properly secured to the water piping system and grounding clamp. The stranded copper grounding conductor has been squeezed between the clamp and the piping which is not allowed and is unsafe since it makes the clamp prone to loosening. This can reduce the safety and effectiveness of the bonding and grounding system and the existing clamp should be replaced with one that can properly secure the grounding electrode conductor into a screw terminal. Further evaluation and repair by a licensed and competent electrical contractor is recommended.

*Loose and Improperly Clamped Bonding Wire*

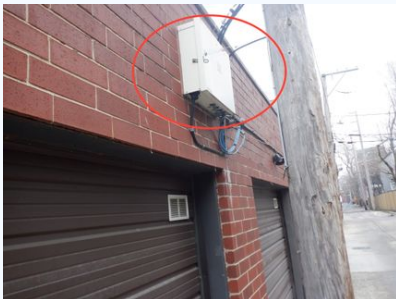
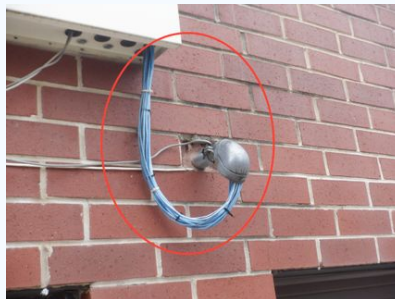
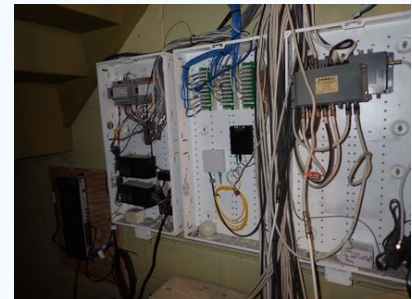
**🔍 (ESGCDAF-4) Due Diligence:** The evaluation of the low-voltage equipment in the home: alarm, communication, audiovisual, etc., is beyond the scope of the home inspection and should be performed by a qualified low-voltage electrical contractor. In order to reduce the potential for confusion and to reduce clutter around the home, any wiring, panels, cabinets, etc. for any equipment that is no longer in use should be removed.

*Low Voltage Communication Equipment*

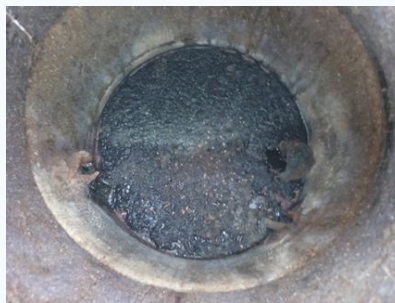
🔍 (PSDFAV-1) **Due Diligence: A video camera sewer scope is recommended.** An evaluation of the sewer line below the ground was attempted at two locations in the parking garage. One was near the NW corner of the garage and the other was by parking space G41. The pipe near the NW corner went underwater at about 12 feet and the camera was pushed to 40 feet before it wouldn't go further and was under water continuously. The pipe near space G41 hit an obstruction at about 9 feet and the camera could not be pushed further. Both pipes were full of sludge which made televising more challenging and blockage may be responsible for the back-up in the one pipe. It should be noted that there are numerous rooftop planters and significant quantities of debris were noted beneath the rooftop deck and much of the debris and dirt could be flowing into the sewers via the rooftop drainage scuppers and has the potential to be the source of the blockage. There are two sanitary manholes on the north side of the structure, one had a significant quantity of sludge that should most likely be removed. The other was full of debris, however, it was clear that drainage was occurring in the bottom of the structure. Also, it appears that leakage has been occurring by one of the clean-out covers in the garage. In order to provide proper sanitary drainage for the structure and to ensure the condition of the drainage pipes, the manholes should be cleaned out by a qualified sewer cleaning company. Also, any accessible sanitary/drain pipes should be flushed and televised by a qualified sewer cleaning company.

*Manhole Full of Sludge*

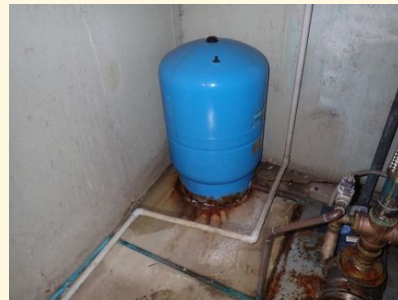
**🔧 (PSDFAV-2) Repair:** A booster pump system has been installed on this multi-story structure. At the time of the inspection it was noted that the pump system was running constantly and that the pressure tank was completely full of water. Based on the number of units in the structure, the tank for this building would appear to be grossly undersized. These systems are typically required to be installed in order to ensure that there is adequate water pressure to upper level units and the pump will typically pressurize the holding tank and then shut off until the pressure is depleted. In this case the bladder in the pressure tank may have been compromised resulting in continuous operation of the pump. In order to reduce the potential for pressure loss to the upper level units, it is recommended that a qualified plumber evaluate the tank and repair the system as needed. Here is a link to an article that discusses quiet options for booster pump replacements: [Which Water Booster Pumps are the most silent?](#)

*Small and Waterlogged Pressure Tank*

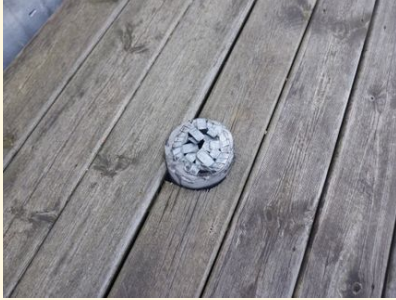
**🔧 (PSDFAV-3) Repair:** The plumbing vent pipes on the roof are flush with the roof deck. This can allow occupants of the rooftop decks to be exposed to noxious sewer gases. Residential building codes require these vent pipes to extend at least seven feet above the deck. In order to reduce the potential for sewer gases to affect rooftop residents, the vent pipes should be extended and properly supported.

Also, at least one of the narrower diameter plumbing vent pipes has material stuffed into the pipe that was most likely intended to eliminate the potential to drop objects into the pipes, however, they can restrict airflow. During extreme freezing temperatures in the winter this restriction can allow venting air to freeze and hoar frost formations can occur that can block the vent piping. Blocked

*Flush and Blocked Vent Pipes*

plumbing vent pipes increase the risk for noxious sewer gas intrusion into the occupied spaces and a qualified plumbing and/or roofing contractor should repair the vent pipes.

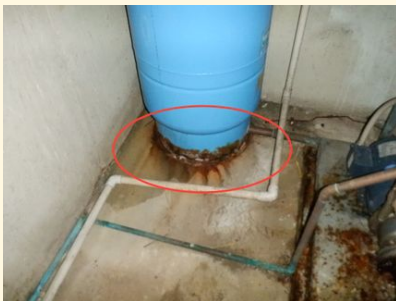
*Heavily Corroded Expansion Tank*

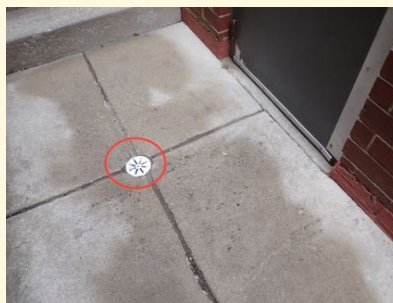
**🔧 (PSDFAV-7) Repair:** There are small drains adjacent to the lower level exterior entry doors that are easily clogged or overwhelmed by heavy rains. In order to reduce the potential for moisture related damage, it is recommended that a qualified plumber or concrete repair contractor install a larger drainage grate in the walk areas.

*Small Drains by Lower Level Entry Doors*

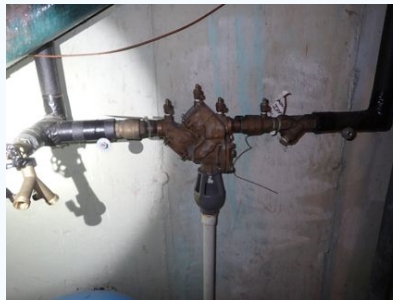
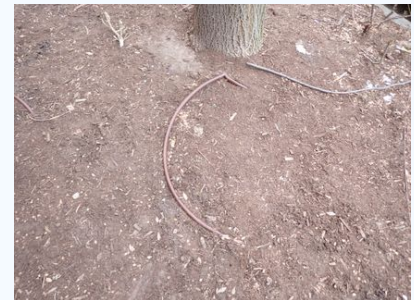
**🔍 (PSDFAV-9) Due Diligence:** There is a planter watering system that was not evaluated as part of this inspection. In order to reduce the risk for extensive frost damage, these systems must be drained of water prior to freezing winter conditions and some components require annual servicing and/or certification. Some of the components appear to be exposed and/or possibly damaged and it is unknown if these items are still actively used. Also , the backflow preventer that was found in the basement may be a part of this system and did not appear to be recently serviced and in order to continue the function of the system it should be evaluated and serviced as needed.

*Sprinkler Controls*

*RPZ (if for sprinkler) Requires Annual Servicing*

*Exposed Irrigation Components*

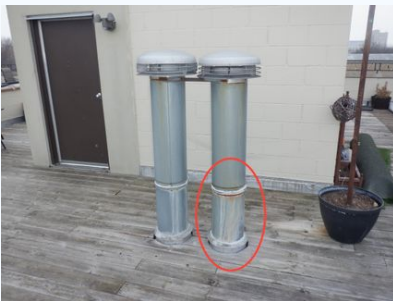
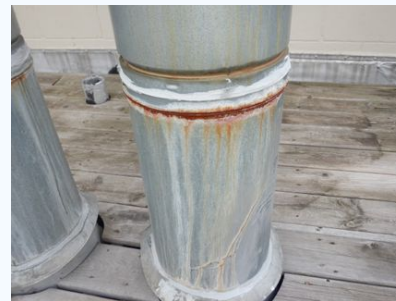
**🔍 (HACVAGAS-1) Due Diligence:** Heavy corrosion was observed on one of the vent pipes for the gas appliances in the units. This is typically an indication that there is insufficient warm exhaust gases that allow for proper ventilation of exhaust air or backdrafting of exhaust air in the vent pipe from either use of a large ventilation fan or a fireplace damper in one of the units that is left open. In order to determine the cause of this corrosion, the vent fans and fireplaces in the units served by the vent pipe should be examined to determine if one of the conditions noted above is occurring.

*Heavy Corrosion on Vent Pipe*

*Close-up of Corrosion on Vent Pipe*

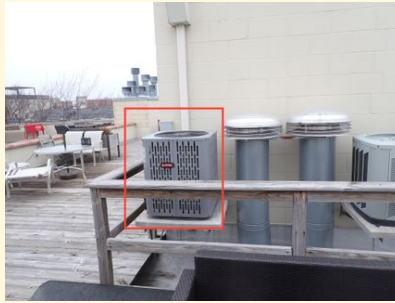
**🔧 (HACVAGAS-2) Repair:** The vents for many of the gas appliances in the units discharge adjacent to some of the A/C condensers. It was noted that nearly every A/C condenser next to a vent pipe has been replaced, while many of the A/C condensers away from the vent piping are original. It appears that the heated exhaust gases may be shortening the life of some of these A/C condensers and in order to prolong the life of these units the vent pipes should be raised an appropriate height above

*New A/C Condensers Noted in These Locations*

*Numerous Original Units Still Functioning*

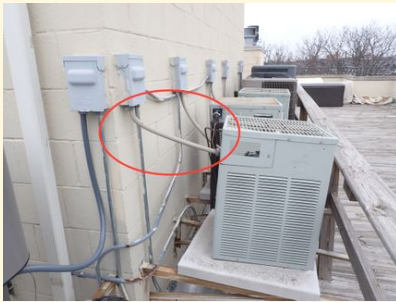
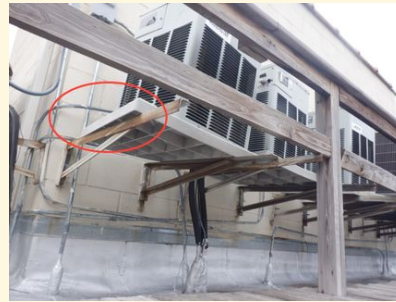
**🔧 (HACVAGAS-3) Repair:** The A/C condensers are installed on energy absorbing bases that sit on metal brackets extending from the walls. The bases are not secured and there is nothing to keep the condensers from moving. In some cases it appears the bases have slid and the A/C condenser is balanced precariously on the edge and in one case the unit is exerting pressure on the flexible conduit for the power feed to the condenser. In order to reduce the potential for damage to the A/C units, the bases should be leveled and secured to the brackets by a qualified service technician or handyman.

*Power Feed Under Tension*

*Base Balancing on Brackets*

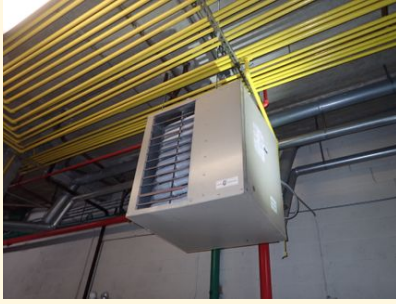
**🔧 (HACVAGAS-4) Repair:** There are two large gas fired heaters for the below ground parking garage. According to the manufacturers installation instructions the heaters should be inspected annually and the burners cleaned periodically. Given the build-up of dust on the interior of the units, it does not appear as if they have been inspected, cleaned and serviced recently if at all. For proper and continued operation of the heaters, it is recommended that a qualified service technician evaluate and service the units as needed.

*Space Heaters in Garage*

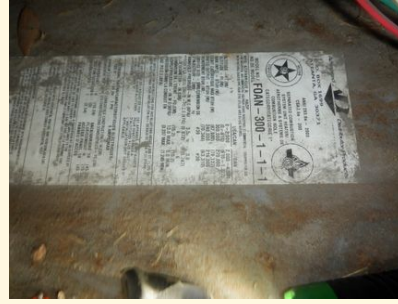
*Data Plate on Heaters*

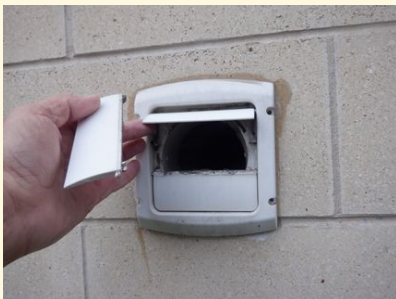
**🔧 (IVAE-2) Repair:** The existing cheap plastic vent and/or dryer dampers are warped and are open to the exterior which creates the potential for cold air to enter and condense on warmer interior components and for flying pests to enter the open dryer venting. In order to reduce the potential for corrosion and moisture related damage and unwanted visitors, all dryer and exhaust vent dampers on the exterior walls should be replaced with high-quality, gasketed, vent dampers.

*Broken Vent Damper*

**NOTE:** In order to ensure proper performance of the dryer vents, regular examination and cleaning of dryer vents is recommended.

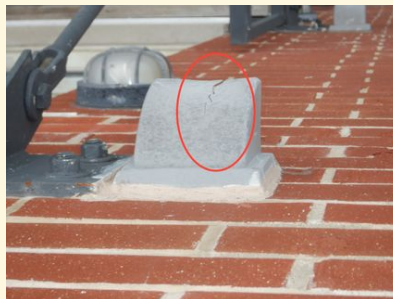
*Cracked Vent Damper*

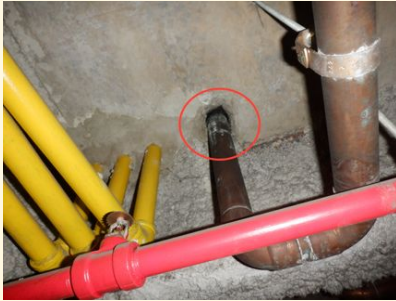
*Unsealed Pipe Penetrations*

**🔧 (IVAE-3) Repair:** Gaps and openings were noted around numerous ceiling and wall penetrations in the below grade parking garage. Significant air leakage can occur in these openings which could allow reduced indoor air quality; introduce potentially dangerous and noxious odors; allow drafts and energy losses; and, in the event of a fire; allow smoke and carbon monoxide into the living unit's in the structure. It is recommended that the subject living unit and all of the living units in the building undergo an air-sealing regime to reduce these risks and to save energy. Some of the typical areas that require air-sealing include: pipe chases (both vertical and horizontal). For suggestions on air sealing the structure, here is a link to a webpage from the US Dept of Energy with some excellent suggestions: [Air Sealing Your Home](#)

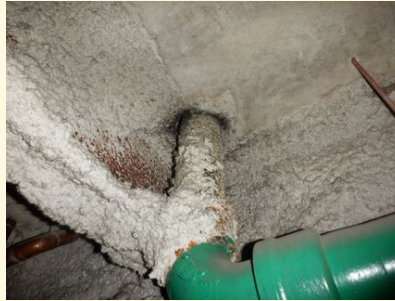
*Unsealed Pipe Penetrations*

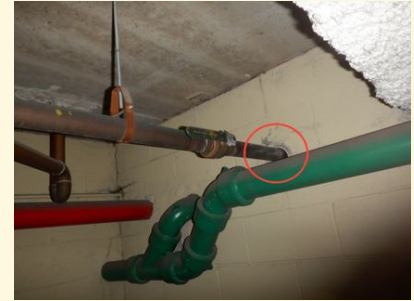
*Unsealed Pipe Penetrations*

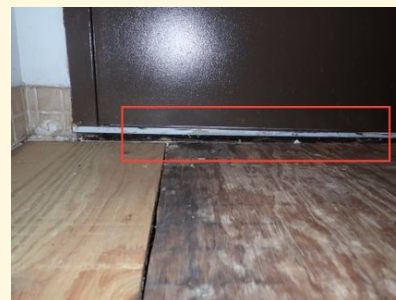
*Daylight Observed Beneath Entry Doors*

**🔧 (WDS-1) Repair:** Flooring has been removed near the threshold of several of the elevator doghouse rooftop access doors. The existing threshold at the rooftop access doors are poorly sealed. In order to reduce the potential for the entry of moisture and pests and to conserve energy, reduce cold drafts and reduce noise levels inside the living spaces, it is recommended that a improved weatherstripped thresholds be installed at the bottom of the rooftop access doors by a qualified carpenter or handyman.

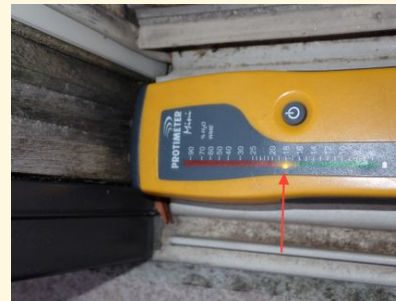
*Elevated Moisture Levels in Doorframe*

**🔧 (WDS-2) Repair:** Moisture related staining and elevated moisture levels were noted in the doorframe on the sliding door in at least one upper level unit. Given that the sliding doors are now 15 years old, the seals are beginning to become compromised and leakage is developing and will more than likely progress further. In order to reduce the potential for moisture related damage, it is recommended that consideration be given to replacing the sliding doors in the not too distant future. Some of the sliding doors that are in lower or more protected balconies may have less deterioration and replacement of those doors can wait, however, the more deteriorated ones should be replaced with doors that are made from materials that are less affected by moisture. The doorframes should be monitored and if excessive deterioration is noted, especially on the bottom portion of the doorframe, the bottom portion should be replaced with materials that are less affected by moisture like PVC lumber. For recommendations on more energy efficient sliding doors, here is a link to a webpage from the US Dept of Energy that discusses energy efficient doorframes: [ENERGY STAR Most Efficient 2022 — Sliding Glass \(Patio\) Doors](#)

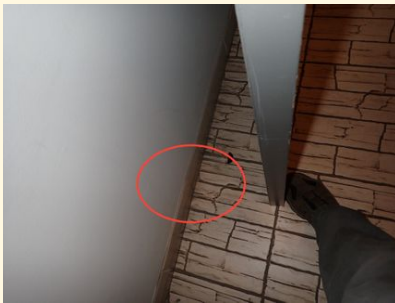
*Doorstops Missing on Some Doors*

🔧 (WDS-5) Repair: Damaged finishes were noted on the walls adjacent to many of the doors. In order to protect the adjacent finishes and components from damage, door stops (hinge mounted, floor mounted, or wall mounted) should be installed by a qualified handyman.

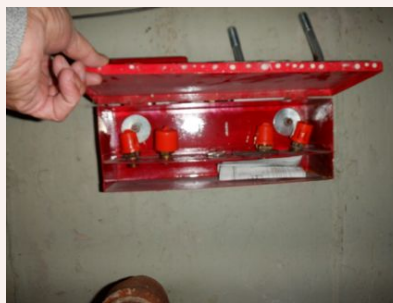
*Sprinkler Equipment Box in Mechanical Room*

(O-3) **Recommended Maintenance:** The structure has a fire suppression system that most likely has components that require annual inspections and/or servicing. In order to ensure proper operation of the fire suppression system, it is recommended that the regular servicing that appears to be occurring be continued.
