This report is prepared exclusively for **Small Commercial Property**
Inspected On: **2022-11-07**

Company Information

Domicile Consulting LLC
847.732.2503

Inspected By:

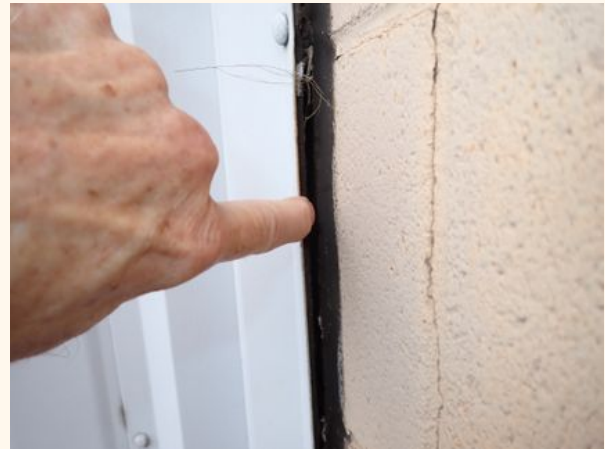
Close-up of Large Open Gap

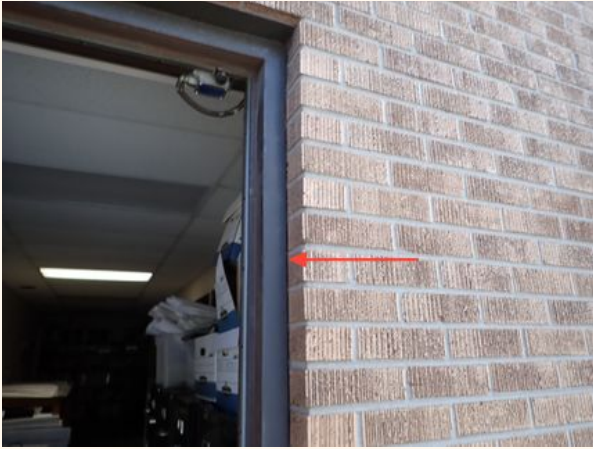
Uncaulked Edges Around Door Openings

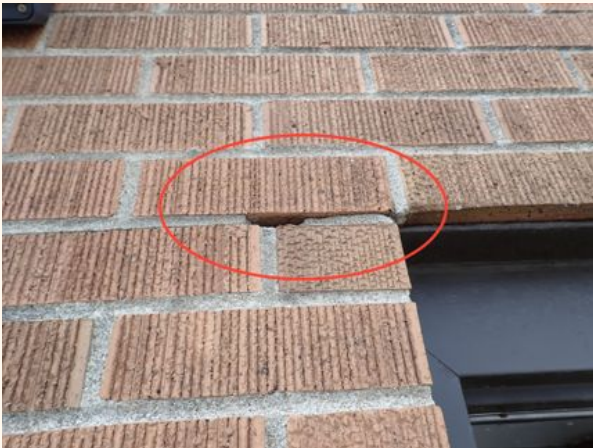
🔧 (EWGCE-4) Repair: The exterior masonry walls are in overall good condition, however, areas of deterioration and damage were noted. The property owner should budget for repairs and maintenance and the exterior walls should be evaluated by a qualified masonry restoration contractor.

Cracked and Open Mortar Joint by Lintel

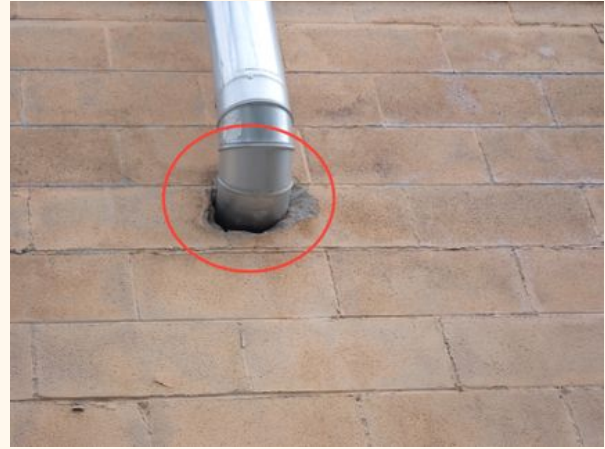
EWGCE-7 EXTERIOR WALLS< GROUNDS, CHIMNEYS. ETC: In order to reduce the potential for moisture related damage, all exterior wall penetrations such as; piping, conduit, vent caps, etc. should be sealed against moisture intrusion, drafts, and energy losses through the use of the appropriate caulking methods and materials.

Unsealed Wall Penetrations

Also, many of the openings were rough penetrations. Penetrations through the exterior masonry walls should be configured with neatly cored openings that are slightly larger than the conduit or other item passing through the wall. This allows a consistent and uniform space for caulking/sealing which reduces the risk for moisture penetration and damage. It is recommended that all such exterior openings in the masonry walls be reconfigured in this manner.

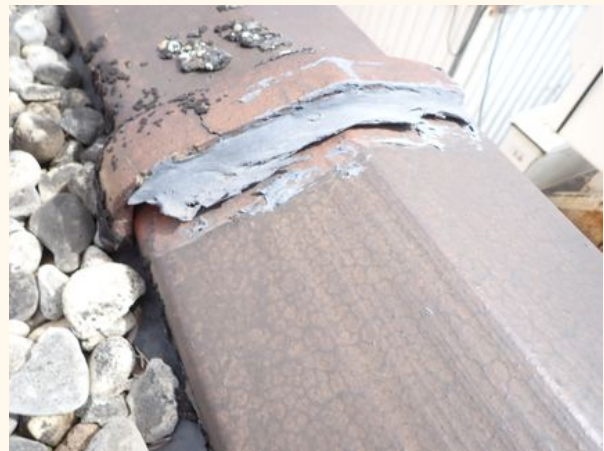
EWGCE-10 EXTERIOR WALLS< GROUNDS, CHIMNEYS. ETC: The butt joints between the individual sections of clay tile coping have been sealed with cement mortar. The mortar is cracking and the joints are open which creates a risk for moisture saturation/damage to the masonry walls below. The coping tiles serve to protect the underlying brick masonry walls

Close-up of Open Gap

from wetting/drying and freezing/thawing damage and should be neatly joined and properly sealed in order to perform this function. The coping tiles should be repaired or replaced as needed by a qualified masonry or roofing contractor. It is recommended that the individual clay tiles be removed and reinstalled using backer rod and polyurethane caulk to seal the joints.

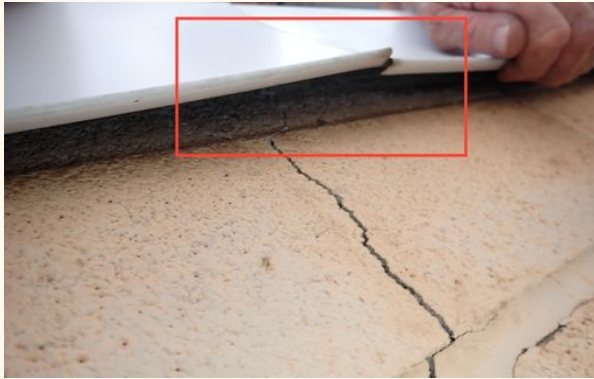
🔧 (EWGCE-11) Repair: The aluminum parapet capping at the top of the masonry parapet walls and metal building does not conform with industry standards as published by the Sheet-Metal and Air Conditioning Contractors National Association (SMACNA). The aluminum wall cap does not promptly shed moisture; does not have sleeved and gasketed overlaps; and is composed of relatively thin aluminum which will expand and contract significantly from temperature changes. These defects greatly increase the risk for moisture penetration into and through the underlying masonry walls. It is recommended that plans be made for the near-term replacement of the existing parapet wall cap with one that reflects industry standards and best practices.

No Splice on Cap Joint

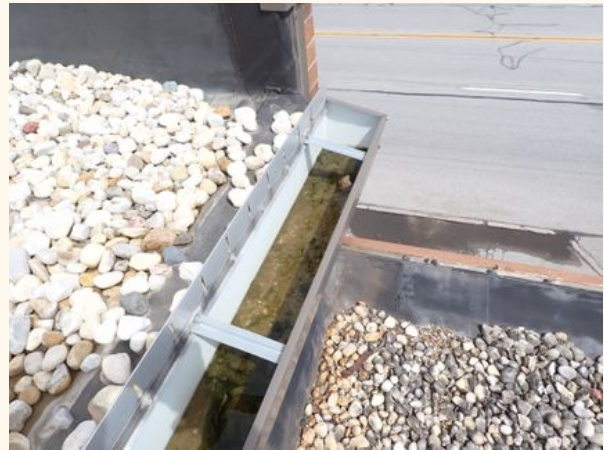
Standing Water and Debris in Gutter

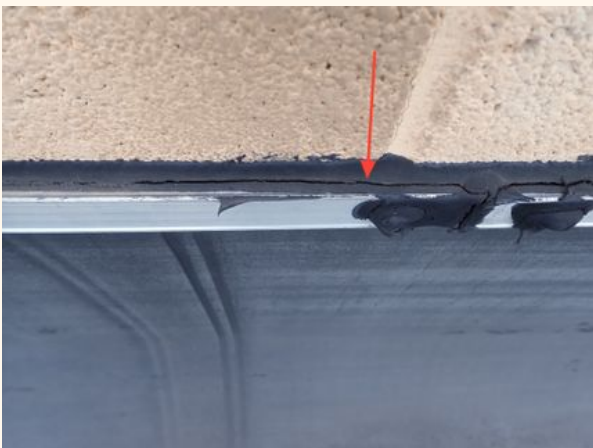
Old Cracked Sealant

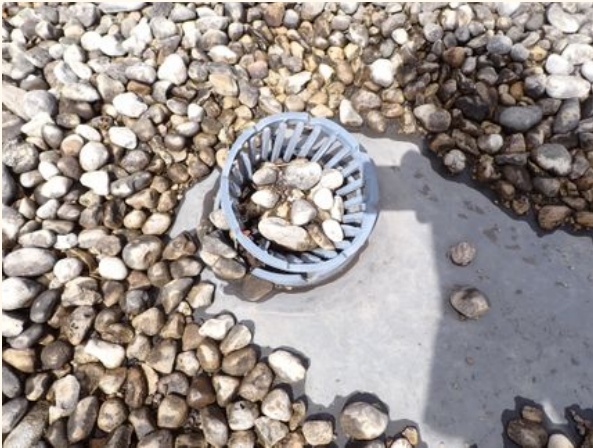
🔧 (RCRFRD-3) Repair: Roof drains are part of a drainage system that removes excess rainwater from the roof. At least one of the drains was partially blocked and should be cleaned for proper roof drainage.

Blocked Roof Drain

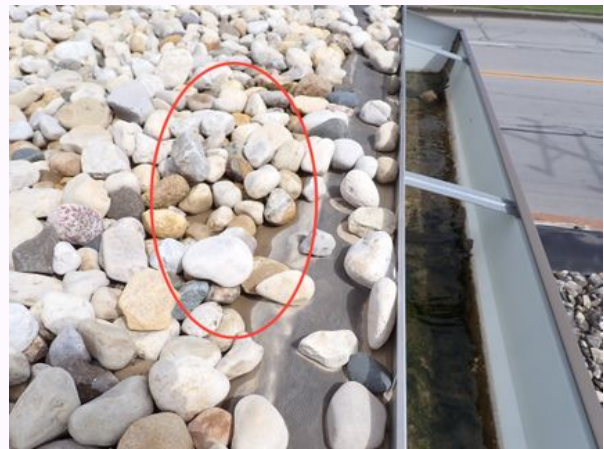
📐 (RCRFRD-4) Future Project: Ponded areas were noted on the low slope roof. Ponding accelerates the rate of roof wear/deterioration and increases the risk for leaking. When a new roof covering is installed, plans should be made to re-pitch the roof using tapered roof insulation.

Non-draining Areas Near Gutters

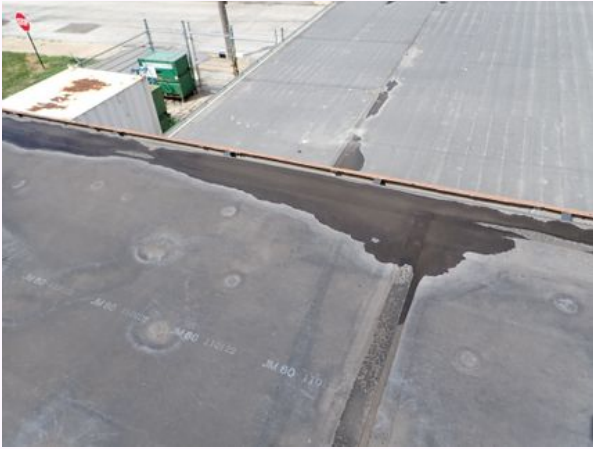
Ponding on Bare Roof Areas

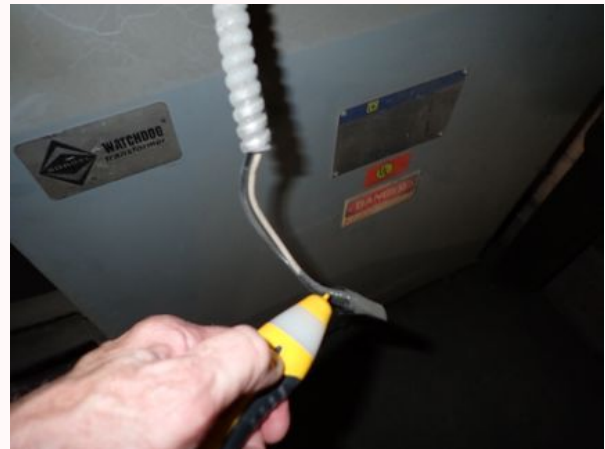
Taped Live Wires

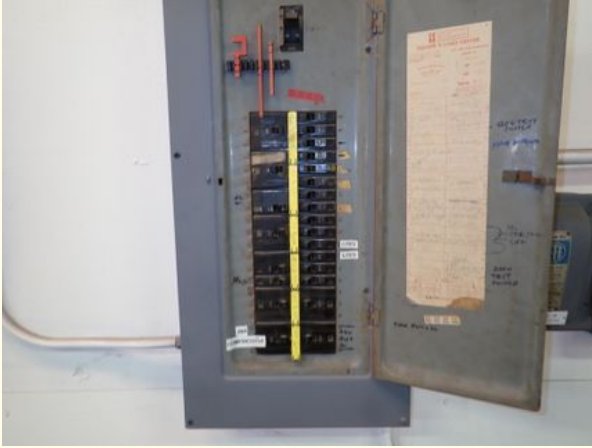
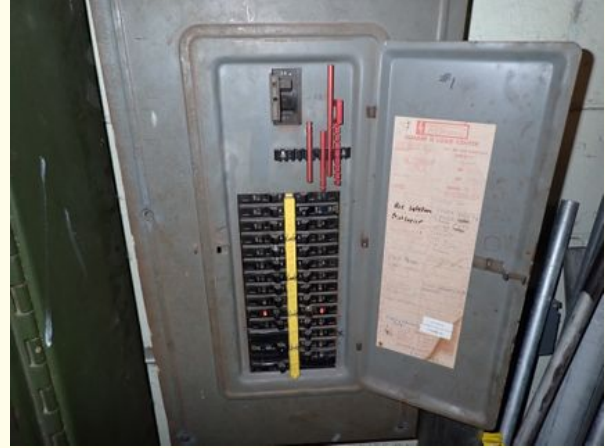
🏠 (ESGCDAF-2) **Improve:** There are no spare breaker spaces in some of the electrical service panels. Common sense and good practices call for the provision of at least 10% spare breaker spaces in a new service panel installation. In order to provide for future expansion and

Full Panels in Shop Area

unforeseen demands, it is recommended that larger service panels be installed by a qualified electrician.

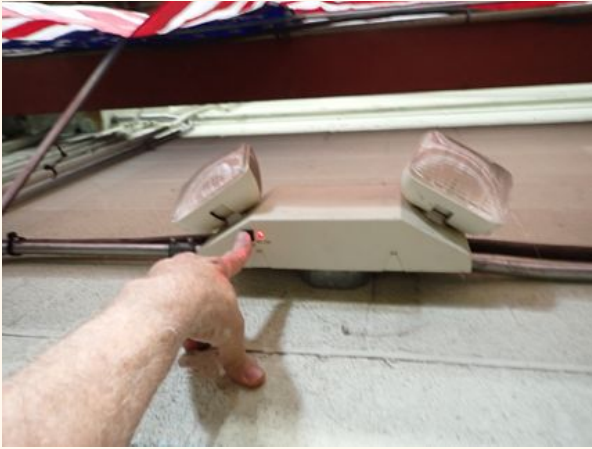
🔧 (ESGCDAF-3) Repair: A spot check of the battery operated emergency lighting system/s revealed one or more non-functioning units. It is strongly recommended that these critical life safety devices be regularly evaluated and repaired as needed by a qualified electrician.

Non-functional Lighting

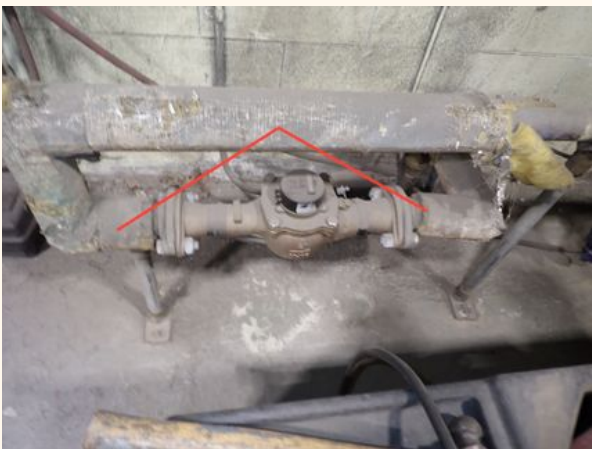
⚠️ (ESGCDAF-4) Repair: In order to help ensure the continuity of the bonding/grounding safety system, a bonding jumper should be installed across the water meter by a qualified electrician.

Jumper Missing Across Meter

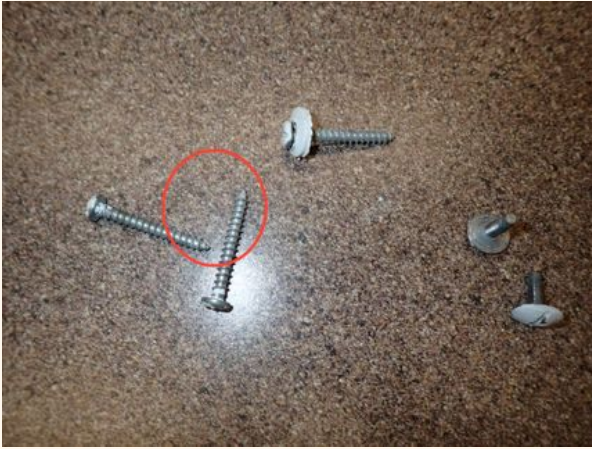
⚠️ (ESGCDAF-5) Repair: Pointed tipped screws are used to secure several of the service panel covers to the enclosure and the sharp ends have the potential to come into contact with wiring in the panel. This presents a risk for arcing/sparking, shock and fire and they should be replaced by a qualified electrician with blunt tipped screws specifically intended for use by the manufacturer of the panel.

Pointed Tipped Screws Securing Electric Service Panel

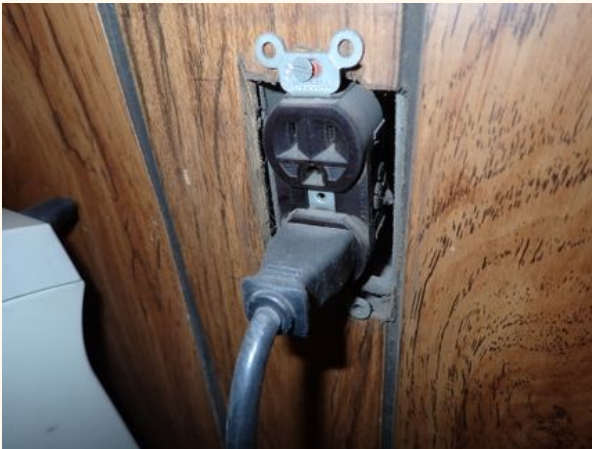
⚠️ (ESGCDAF-6) Repair: While not all of the receptacles in the structure were tested, some loose and uncovered, electrical receptacles were noted in various areas of the structure. All of these conditions represent significant electrical safety defects. All of the electrical receptacles in the structure should be evaluated and repaired or replaced as necessary by a licensed and competent electrical contractor.

Uncovered Receptacle in Office

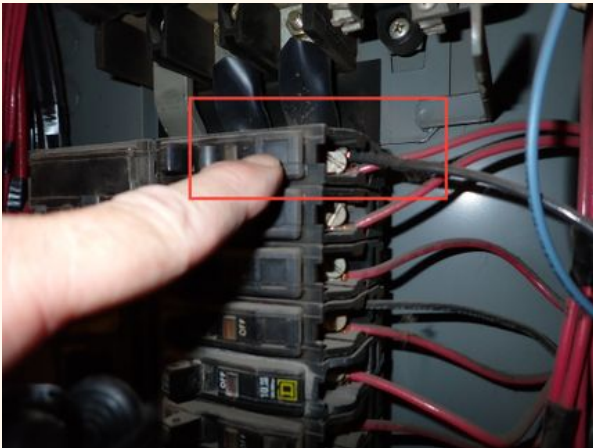
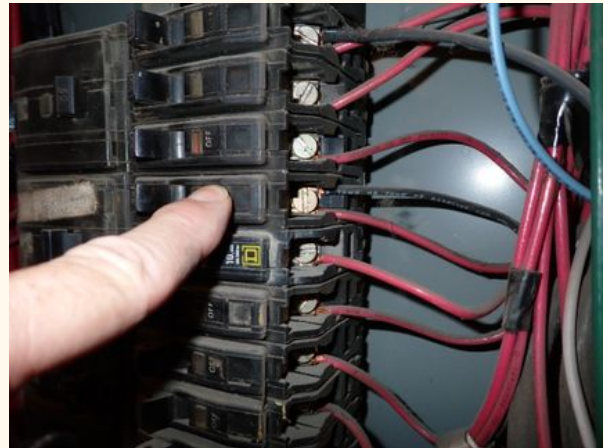
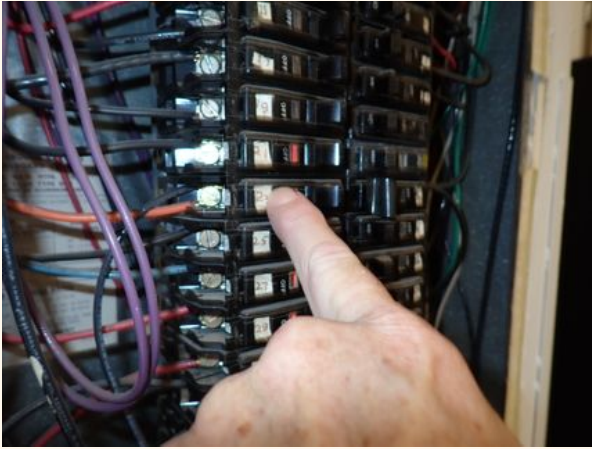
⚠️ (ESGCDAF-8) Repair: Numerous double tapped breaker terminals were noted in several of the electrical service panels that were opened for examination. Double tapping can result in overloaded circuits and can increase the risk of electrical shock and/or fire. Evaluation and repair of all of the service panels in the structure by a licensed and competent electrical contractor is recommended.

Double Tapped Breaker in Electric Service Panel in Shop

Double Tapped Breaker in Electric Service Panel in Kitchen Area

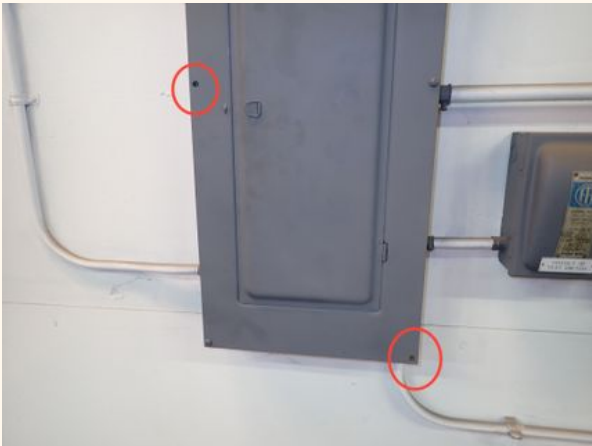
🔧 (ESGCDAF-9) Repair: At least one screw was missing from the cover for one of the electrical service panel. In order to reduce the potential for inadvertent contact with energized electric equipment, it is recommended that the missing electrical panel cover screw/s be replaced.

Missing Screws in Panel Cover

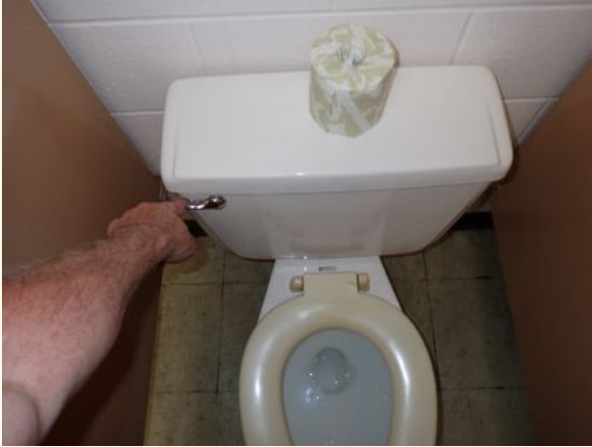
Non-flushing Toilet in Men's Room

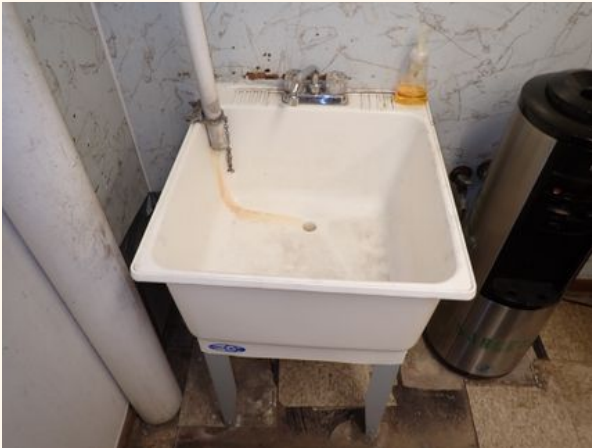
⚠️ (PSDFAV-4) Repair: The utility sink is not adequately secured in place and is subject to excess motion which can result in damage to the water supply and/or drain piping. In order to reduce the potential for moisture related damage, repair by a qualified plumber is recommended.

Loose Utility Sink

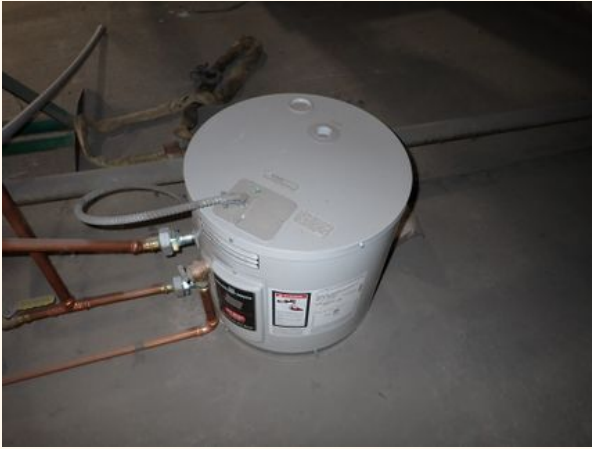
⚠️ (PSDFAV-5) Repair: The water heater on the mezzanine by the Dayton space heater is located above other improved spaces and the lack of a nearby floor drain creates the potential for moisture related damage. Since a water heater defect or failure can result in catastrophic damage it is strongly recommended that a moisture management system be furnished and installed by a qualified contractor.

Drip Pan Missing on Water Heater

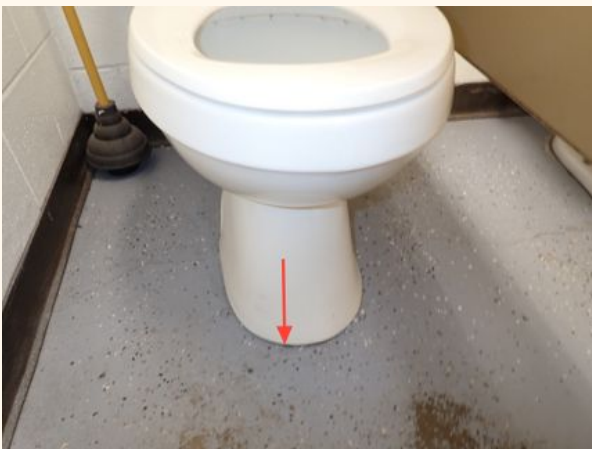
🔧 (PSDFAV-6) Repair: The gap between the toilet base and tile floors should be sealed using the appropriate materials and methods in order to reduce a "fouling area". If mop water, bathtub water or a less pleasant "bathroom liquid" gets underneath the toilet, there is no way to clean it up. In order to reduce this risk and promote proper sanitation in the bathroom, caulking around the base of the toilet is recommended.

Unsealed Toilet Base

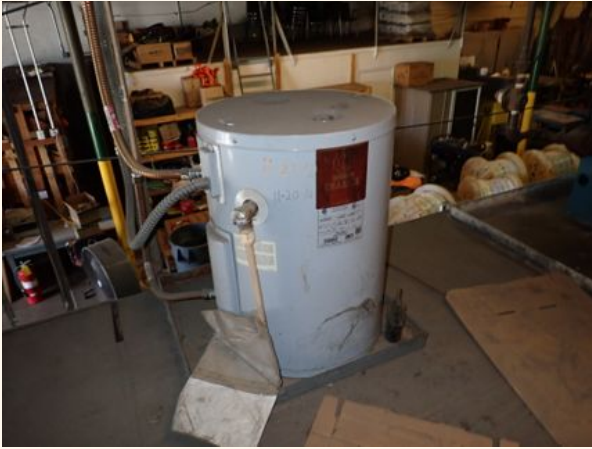
🔧 (PSDFAV-7) Repair: The water heater in the front portion of the mezzanine does not appear to have a shut-off within sight of the heater as the supply line disappears into a difficult to reach area. In order to safely isolate the water heater for servicing it is recommended that a qualified electrician install a safety switch if one is not already installed.

No Shut-off on Water Heater

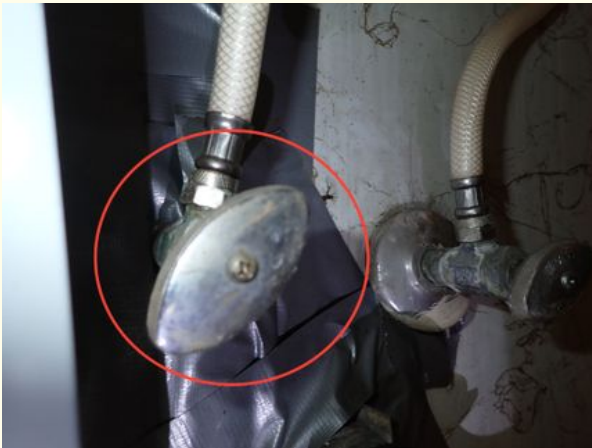
(PSDFAV-8) **Improve:** Older style gate valve shut-offs were noted on supplies to many of the plumbing fixtures in the structure. **These supplies can be prone to leakage when operated and they were not opened or closed at the time of the inspection.** In order to be able to shut off water to service plumbing fixtures in the future, the valves should be replaced with 1/4 turn ball valves by a qualified plumber.

Gate Shut-off Valves

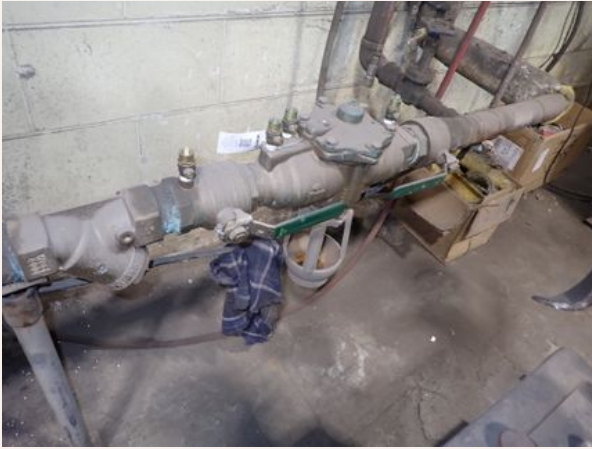
(PSDFAV-9) **Recommended Maintenance:** Backflow prevention devices typically require annual servicing. There is one such unit near the water meter on the west side of the building and it appears it was last serviced in 2019. In order to reduce the potential for backflow of undesirable materials into the water supply the unit should be evaluated and serviced as needed by a qualified service technician.

Backflow Prevention Device

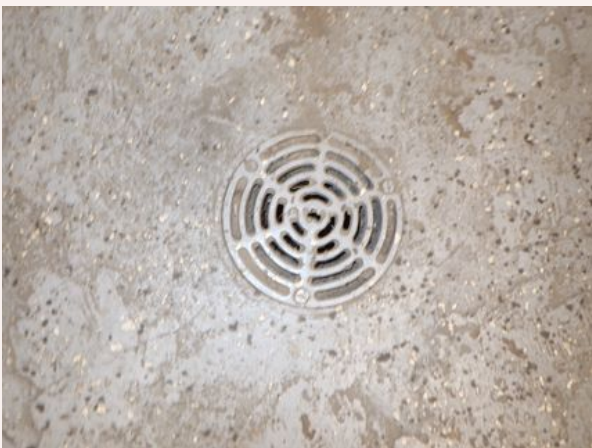
✂️ (PSDFAV-10) **Recommended Maintenance: FYI:** Traps on floor drains without a continuous source of moisture can dry out and should be regularly monitored and re-filled with water as needed to prevent the migration of sewer gas into the home. **The application of several drops of mineral oil can retard the evaporation of the water 'plug' in the floor drain trap.**

Floor Drains in Rest Rooms

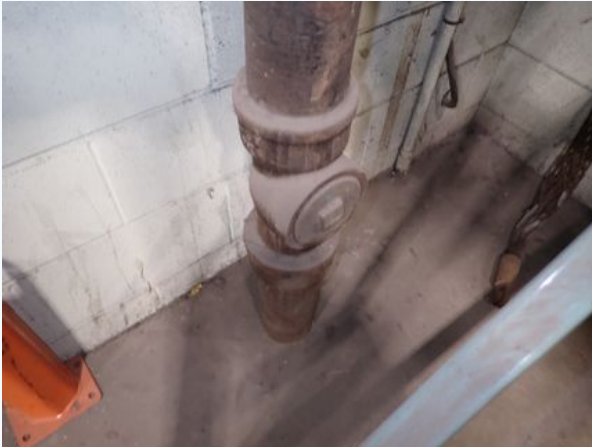
🔍 (PSDFAV-11) **Due Diligence: A video camera sewer scope is recommended.** An evaluation of the sewer line below the ground is beyond the scope of this inspection. Due to the age and location of the building, a sewer scope is recommended to further evaluate the sewer line and the below ground connections between the structure and the municipal sewer line. Sewer scopes are done using video cameras and can reveal the materials, condition and reliability of the sewer line. If that has not been done recently, I recommend having a sewer scope performed.

Clean-out in Shop Area

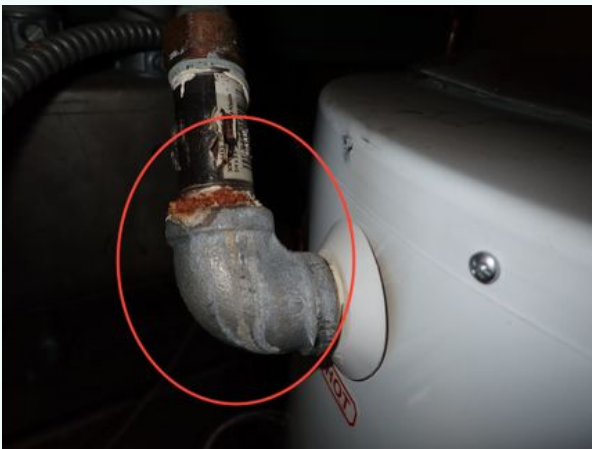
👁️ (PSDFAV-12) **Monitor:** Incipient leakage stains were noted on several water supply pipes in the structure and while no active leakage was observed at these locations at the time of the inspection, they should be monitored and repaired by a qualified plumber if leakage is noted at some point in the future or if other plumbing work is performed in the structure.

Incipient Leakage on Water Heater Piping

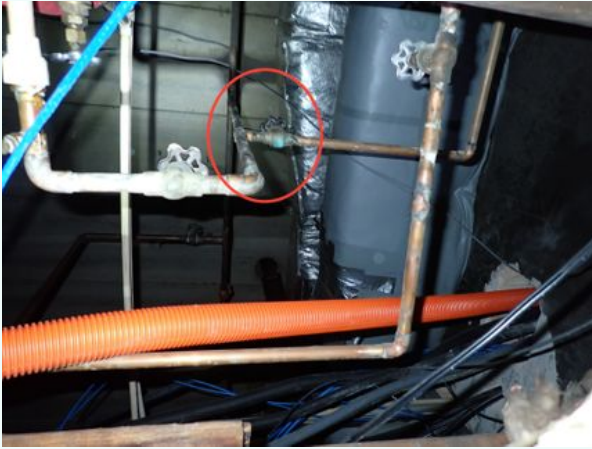
Leakage Stains on Piping

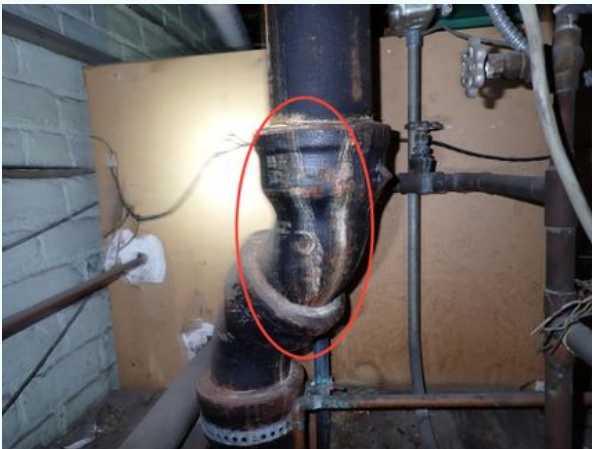
⦿ (PSDFAV-13) **Monitor:** Incipient leakage staining was noted on the drain/vent piping in the mezzanine area however no active leakage was noted at the time of the inspection. If active leakage is noted at some point in the future, repair by a qualified plumber is recommended.

Leakage on Drain/vent Piping

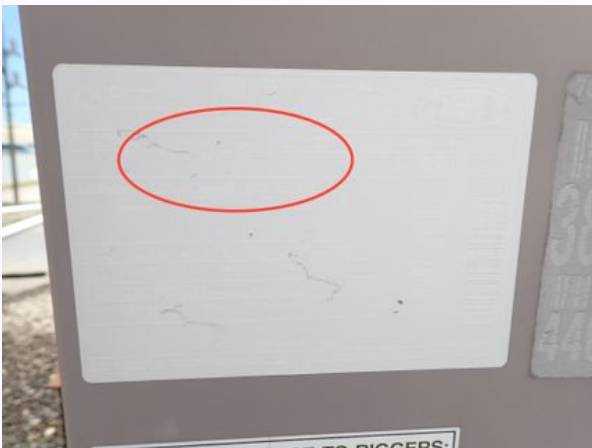
(HACVAGAS-1) Future Project: The air-conditioning condenser is close to the end of the expected service life and although the system was operational at the time of the inspection, cooling levels may be inadequate in the near future. The R-22 refrigerant that is used in the unit is being phased out and no new or imported R-22 is allowed in the U.S. and technicians will only be able to use recycled, reclaimed or previously produced R-22 to service equipment. Therefore, it will become more expensive to service the unit in the future. The cost to retrofit the HVAC system to use the new R-410 A replacement refrigerant is expensive and involves replacing the evaporator coils in the furnace.

R-22 Refrigerant Used in AC Condenser

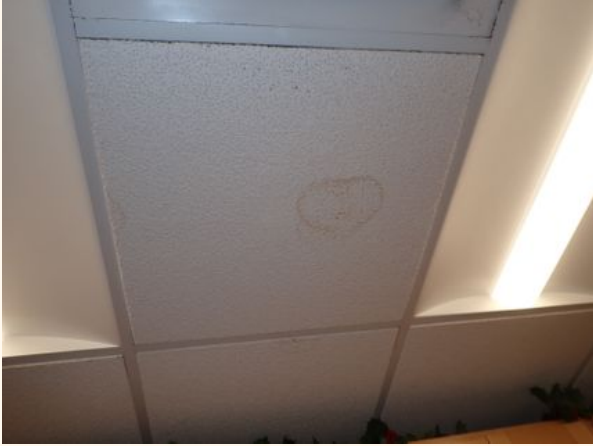
(HACVAGAS-2) Repair: Non-insulated and/or minimally insulated ductwork and/or plenums were noted in the unconditioned attic space above the office areas and there were stained ceiling tiles and signs of condensation leakage from the ductwork. The lack of insulation on this ductwork significantly reduces energy efficiency as the ducts are exposed to the extreme temperatures in the attic that the HVAC system is trying to overcome in the structure. The lack of insulation also dramatically increases the potential for the formation of condensation due to temperature differentials that would exist between the ductwork and the attic temperatures. In addition, the heat escaping from the ducts results in pre-mature melting of snow cover on the roof during winter that can result in icicle formation and subsequent ice damming. In order to reduce the potential for moisture related damage and

Stains on Ceiling Tiles in Kitchen

for improved energy efficiency, it is recommended that a qualified HVAC contractor or insulation specialist evaluate and insulate the ductwork in the attic.

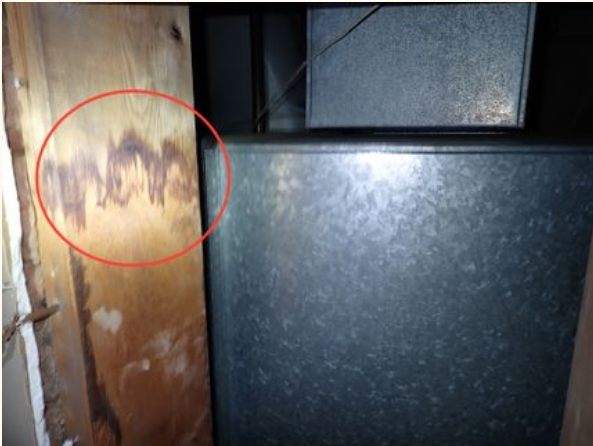
Moisture Stains on Framing Below Ductwork

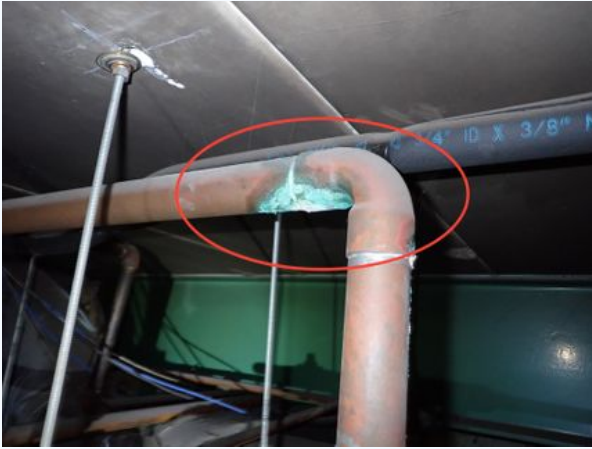
🔍 **(HACVAGAS-4) Due Diligence:** The age of the cast iron boiler in this structure could not be determined as there was not a legible data plate, however, it can provide decades of service if it is maintained properly. It is recommended that any available service records for the boiler be obtained from the seller and be compared to the manufacturer's maintenance requirements. If proper maintenance is being followed, it is recommended that the property owner continue the ongoing service schedules.

Incipient Leakage on Boiler Piping

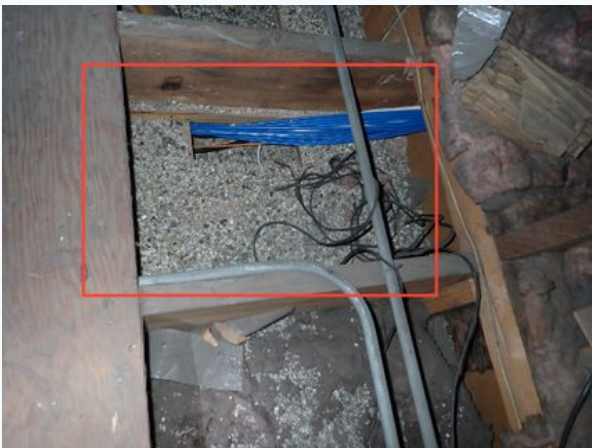
🔍 **(IVAE-1) Due Diligence:** Traces of vermiculite insulation was noted in the attic space above the office area. This insulation is a mineral that is mined from the earth. Most of this insulation comes from a mine in Libby Montana that was contaminated with asbestos. A recent class action law suit alleged that this insulation is unsafe and could expose occupants to asbestos fibers. According to the EPA, there is no safe level of exposure to asbestos. At the time of inspection it appeared as though most of this material was removed. Inquire with the sellers for more information. For more information about vermiculite insulation go to the following link: [Zonolite Attic Insulation Trust](#)

Vermiculite in Attic Area

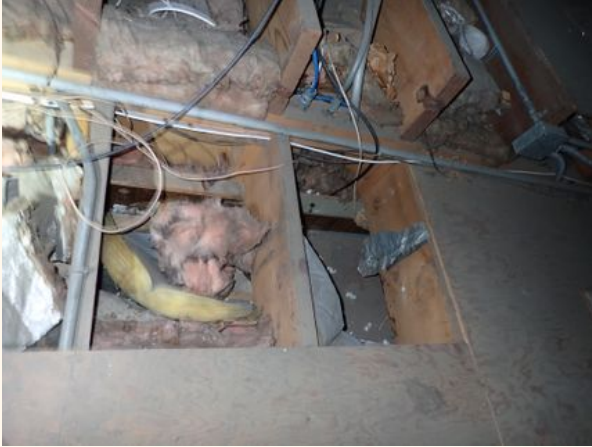
🔧 (IVAE-2) Repair: The attic insulation above the office area has minimal and missing insulation with numerous areas having no insulation at all. Energy savings can be expected by blowing in additional cellulose insulation on top of the existing fiberglass insulation up to a level of approximately R-49 and evaluation by a qualified insulation specialist is recommended.

Areas of Minimal and Missing Insulation

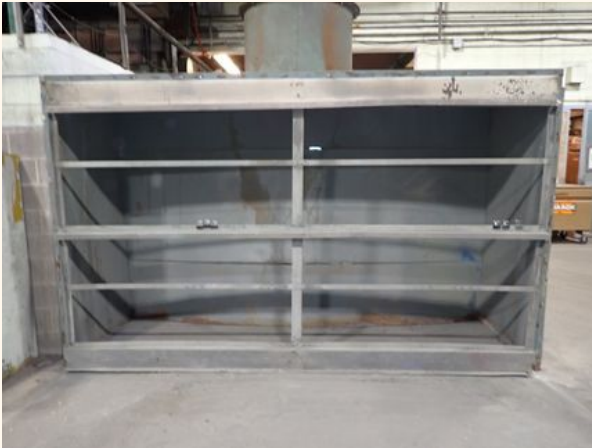
🔧 (IVAE-3) Repair: The building has several large vent openings that do not appear to have dampers or louvers which allows unconditioned air to enter the shop area. The vents may be needed for the large exhaust fan structure in the shop, however, for improved energy efficiency self-closing louvers should be added to the vent.

Massive Interior Vent Fan

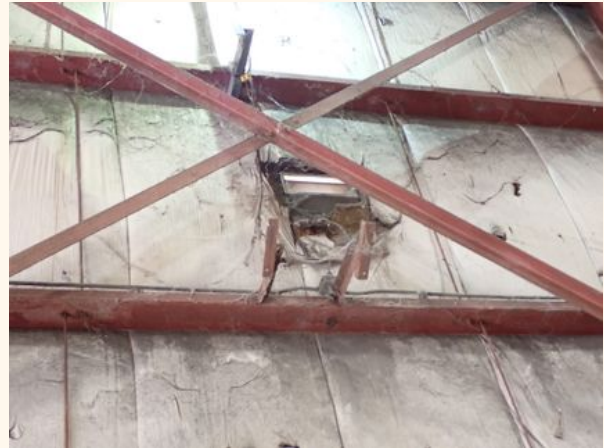
Open Vents on Interior

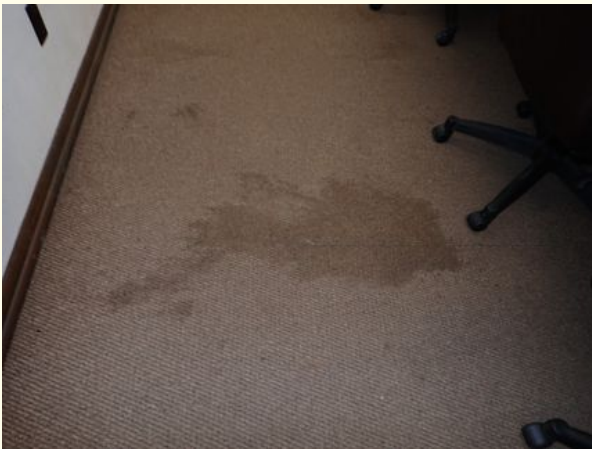
**(IAF-1) Improve:** The interior finishes have some minor blemishes and in order for the interior to conform to accepted appearance standards, some repairs, re-finishing, drywall touch ups and repainting may be needed.

Stains on Carpeting

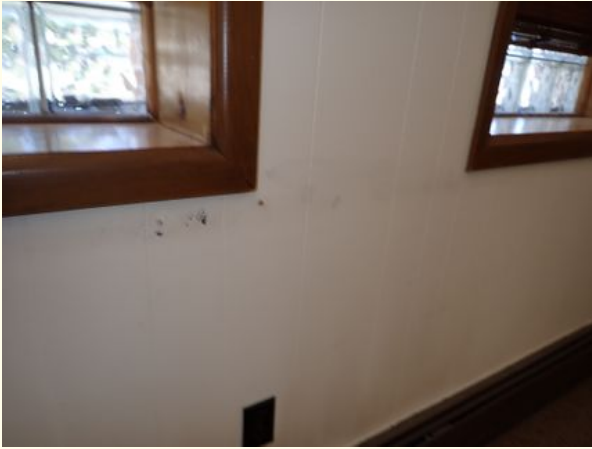
Damaged Wall Finishes

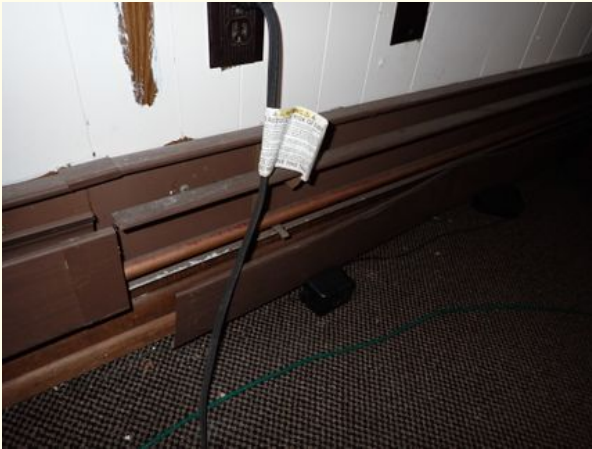
Loose Cover on Baseboard Heater

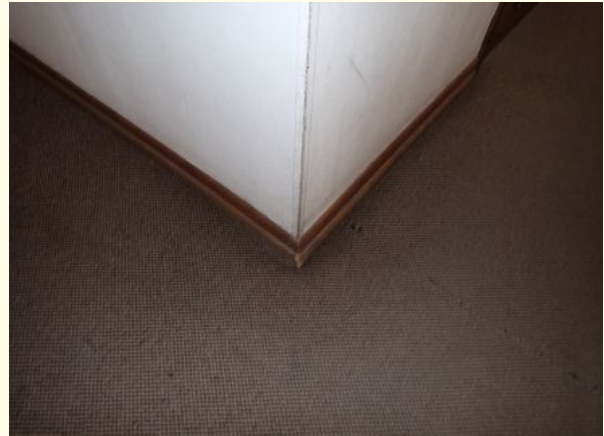
Worn Wall Areas

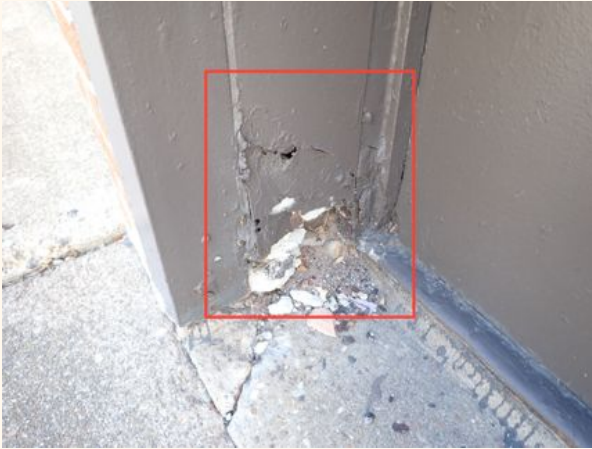
🔧 (WDS-3) Repair: The lower portion of the doorframe on the exterior entry door are deteriorated and elevated moisture levels were measured. In order to reduce the potential for further moisture related damage, it is recommended that a qualified carpenter evaluate and replace the deteriorated portions of the doorframe, possibly with materials that are less affected by moisture like PVC lumber.

Deteriorated Doorframes

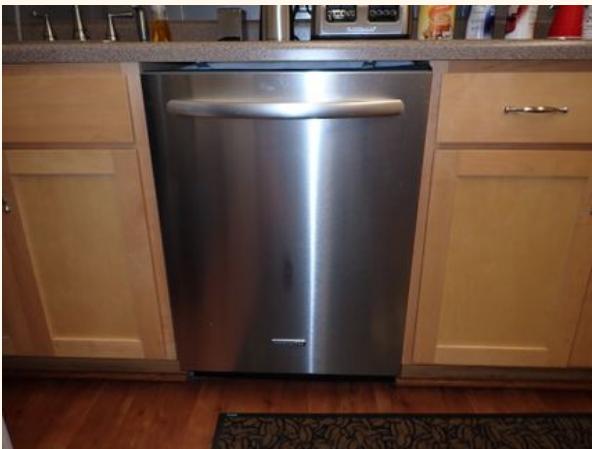
🔧 (IA-1) Repair: The dishwasher does not have a switched disconnect as required for electrical safety. In order to reduce the potential for electric shock, it is recommended that a qualified electrician install a 'kill switch' within sight of the dishwasher.

Shut-off Switch Missing on Dishwasher

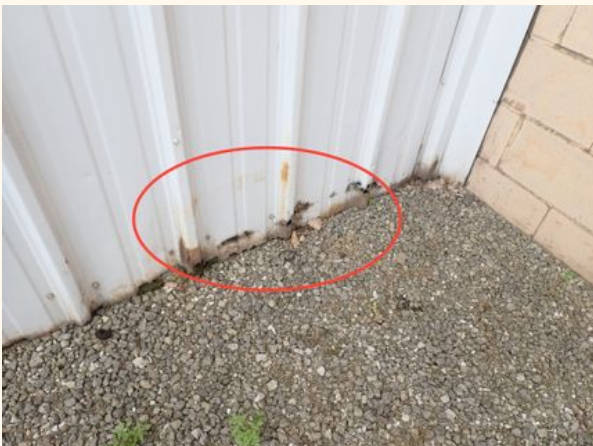
🔧 (O-2) Repair: Evidence of a rodent problem was noted in and/or around the structure. Any openings in the exterior walls and door frames that are 1/4" or more in size could allow mice into the home. A comprehensive evaluation and sealing of the building exterior is recommended in addition to the elimination of any existing mice from inside the structure and further evaluation by a qualified pest control contractor is recommended.

Corroded Holes in Exterior Metal Siding

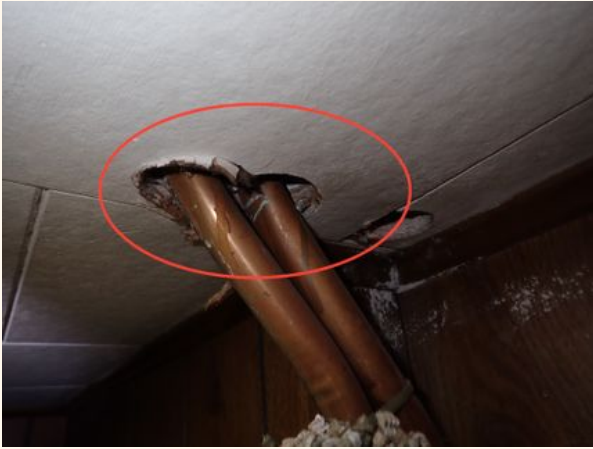
🔧 **(O-4) Repair:** Fibrous panels were noted in the ceiling of some office areas above the drop ceiling. Portions of these panels are damaged and the presence of remaining sections of these panels suggests that, whatever material was previously removed was not done in accordance with existing safety standards. The improper removal of asbestos material can result in asbestos fibers in the dust and air in the home. If this material is made of asbestos, in order to assess any possible health risk posed by these conditions, further evaluation by a licensed and competent environmental remediation contractor would be recommended.

Older Ceiling Panels

In order to determine if asbestos is present in this material, it may be possible for the buyer/property owner to carefully collect a small sample of the material to send to a lab for analysis. Here is a link to a Chicago testing lab that may be able to perform this testing: [Indoor Science Testing Lab](#)
