This report is prepared exclusively for **Small Commercial Condominium**
Inspected On: **2022-11-07**

This property is a commercial storefront in a newer condominium building. The unit has no parking space in the garage and limited exposure so there apparently is a reduced share in the monthly assessment fees. The building has a number of deferred maintenance items and there is a noticeable musty smell in the rear stairwell from moisture intrusion via the split faced block walls on the structure. The items in the report that are related to the condominium association should be shared with the members of the association in order to determine if they are having moisture leakage issues and if there are long range plans for reducing moisture intrusion into the building.

Mark Hughes – IL License 450-011855 – Expires 11/30/2022

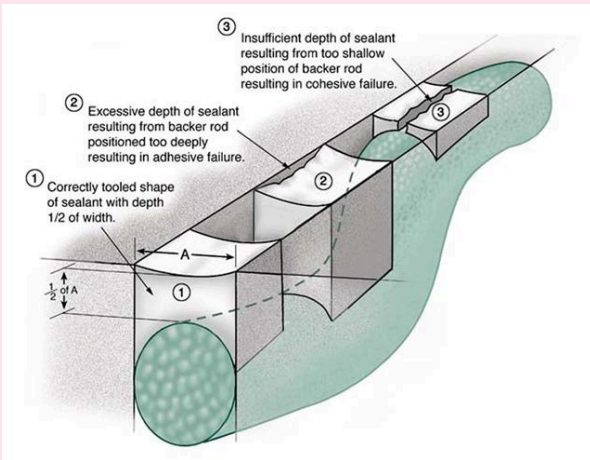
Caulk Joint Example

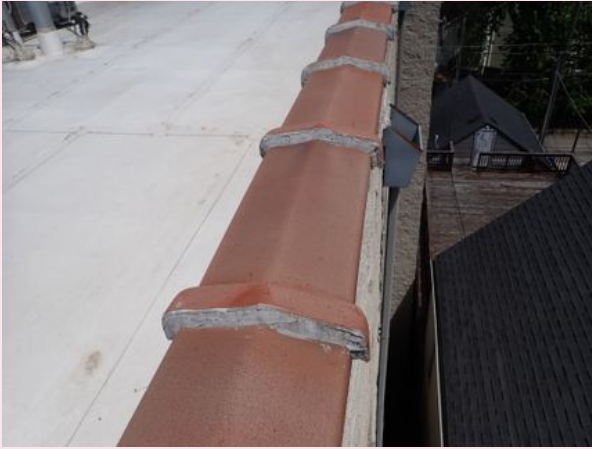
The butt joints between the individual sections of clay tile coping have been sealed with cement mortar. The mortar is cracking and the joints are open which creates a risk for moisture saturation/damage to the masonry walls below. The coping tiles serve to protect the underlying brick masonry walls from wetting/drying and freezing/thawing damage and should be neatly joined and properly sealed in order to perform this function. The coping tiles should be repaired or replaced as needed by a qualified masonry or roofing contractor. It is recommended that the individual clay tiles be removed and reinstalled using backer rod and polyurethane caulk to seal the joints.

Clay Tile Caps

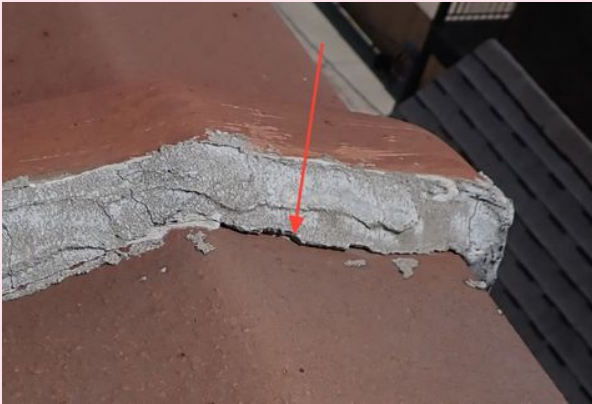
Unsealed Cap Joints

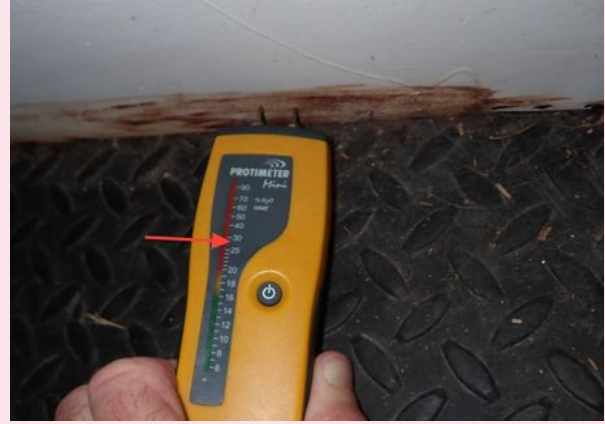
Active Moisture Levels in Stained Trim

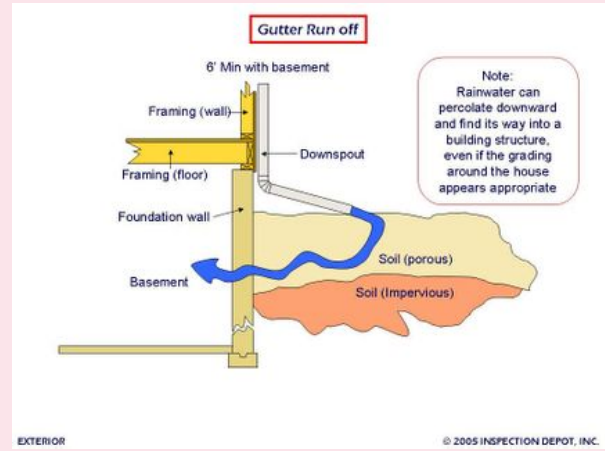
Problems with Close Downspout Discharge

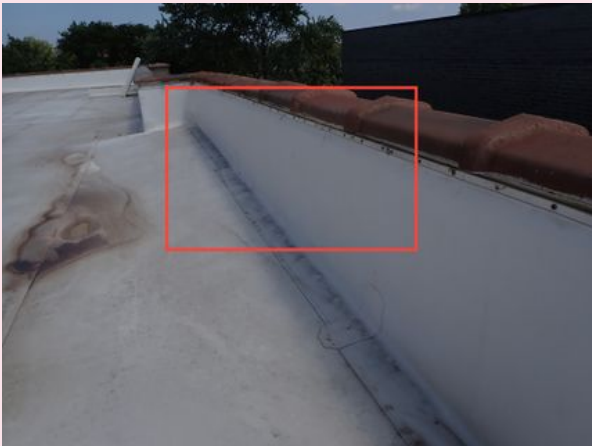
Best roofing practices call for the roof covering to be held back and terminated along the parapet wall typically between 12" and 36" depending on the height of the parapet wall itself. When the membrane is wrapped up and over the parapet top it prevents moisture from draining/evaporating at that side and will reduce mortar and brick life on the opposite side as moisture seeks pathways to drain or evaporate. It is recommended that the membrane be removed and terminated at an appropriate height on the parapet wall with appropriate base and counterflashing. Once the roofing has been removed the masonry parapet walls should be evaluated by a qualified masonry restoration contractor and mortar repairs should be expected where the roof concealed masonry details.

Parapet Walls Covered

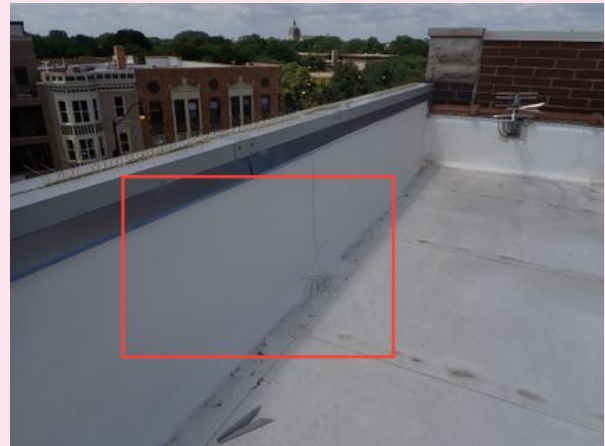
Front Parapet Wall Covered

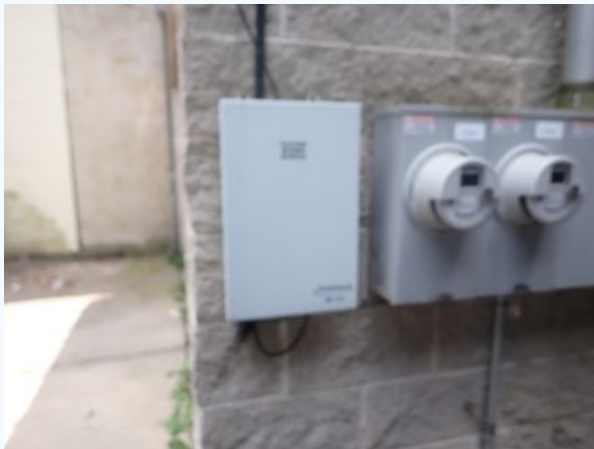
Low Voltage Communication Equipment

🔍 **(ESGCDAF-1) Due Diligence:** The evaluation of the low-voltage equipment in the home: alarm, communication, audiovisual, etc., is beyond the scope of the home inspection and should be performed by a qualified low-voltage electrical contractor. In order to reduce the potential for confusion and to reduce clutter around the home, any wiring, panels, cabinets, etc. for any equipment that is no longer in use should be removed.

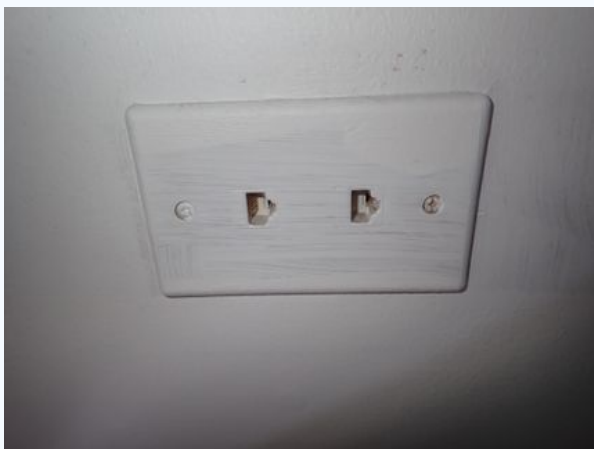
Low Voltage Communication Equipment

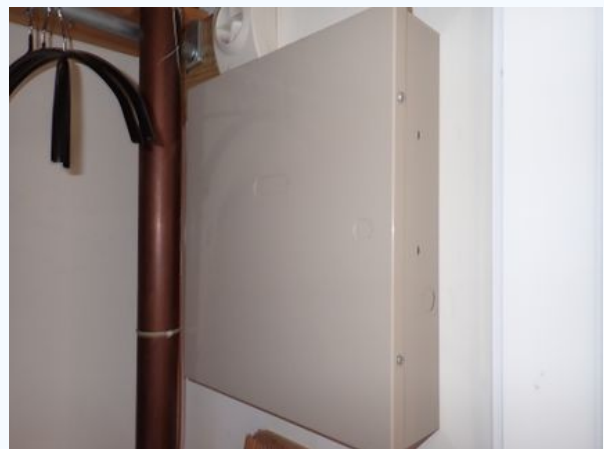
Low Voltage Alarm System

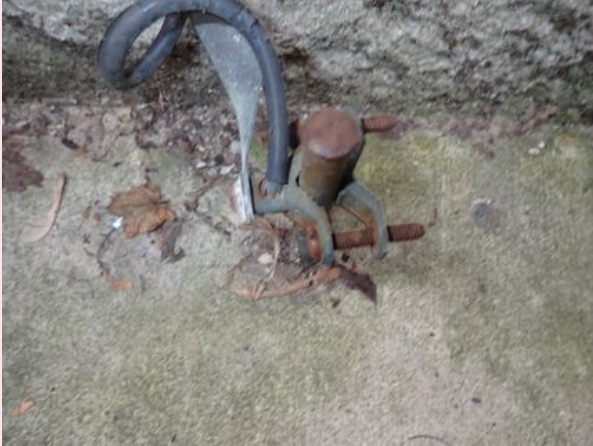
The clamp securing the grounding wire to the driven ground rod is intended for a pipe connection and does not provide adequate connectivity to the ground rod. In order to ensure

Improper Clamp on Ground Rod

proper grounding of the electrical system, it is recommended that a qualified electrician evaluate and repair the grounding system by installing an acorn style grounding clamp or by other approved means.

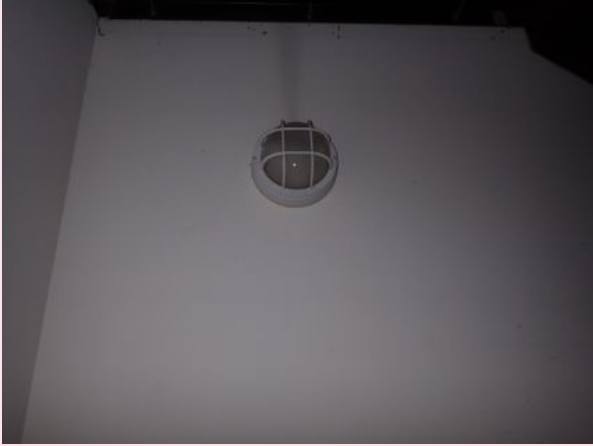
There were numerous burned out bulbs in the rear stairwell leaving it extremely dark which

Dark Lights in Rear Stairwell

creates potential fall hazards that may present a liability concern for the condominium association and the bulbs should be replaced as soon as practical

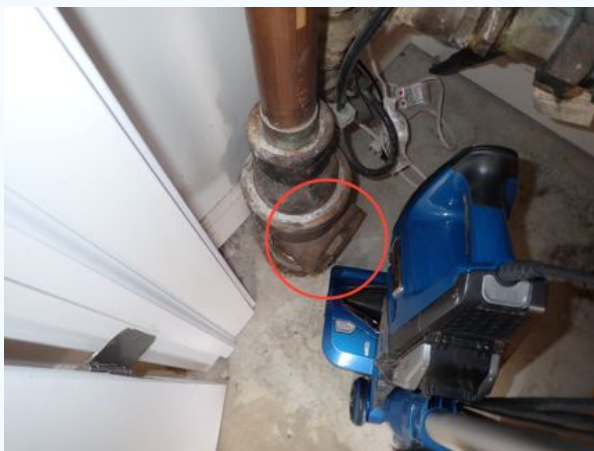
Clean-out in Unit

🔍 (PSDFAV-1) **Due Diligence: A video camera sewer scope is recommended.** An evaluation of the sewer line below the ground is beyond the scope of this inspection. Due to the age and location of the building, a sewer scope is recommended to further evaluate the sewer line and the below ground connections between the building and the municipal sewer line. Sewer scopes are done using video cameras and can reveal the materials, condition and reliability of the sewer line. If the association hasn't had one done recently or since the buildings construction, I recommend having a sewer scope performed.

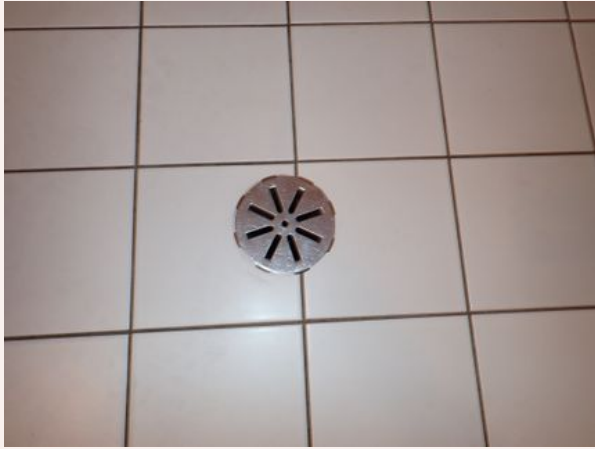
Floor Drain in Bathroom

🔧 (PSDFAV-2) **Recommended Maintenance: FYI:** Traps on floor drains without a continuous source of moisture can dry out and should be regularly monitored and re-filled with water as needed to prevent the migration of sewer gas into the home. **The application of several drops of mineral oil can retard the evaporation of the water 'plug' in the floor drain trap.**

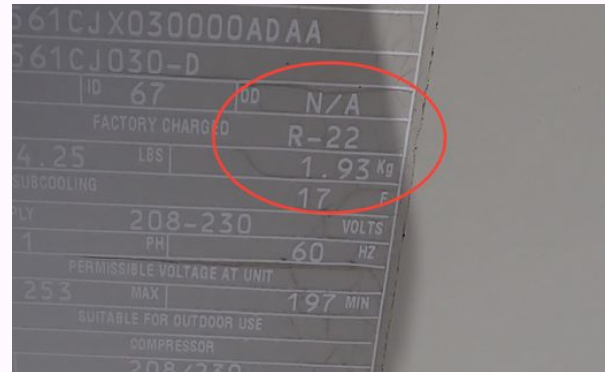
R-22 Refrigerant Used in AC Condenser

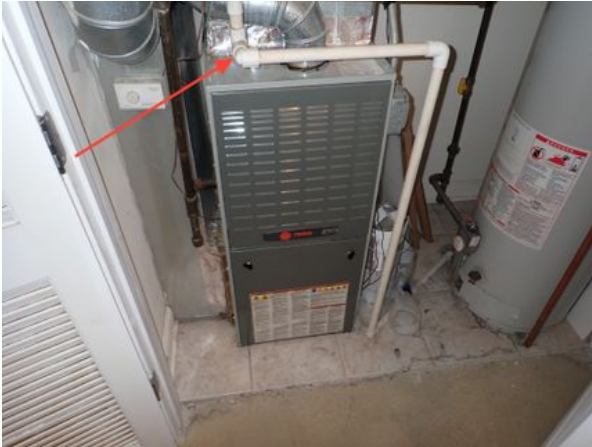
Condensate Drain on Furnace

🌿 **(HACVAGAS-4) Efficiency:** Splashing, leaking and energy losses can occur in the evaporator drain pan from air backflow through the drain pipe for the A/C condensation. The installation of a trap on the condensate drain by a qualified HVAC contractor is recommended downstream of it's penetration from the furnace casing and upstream of the humidifier drain (if one is installed).

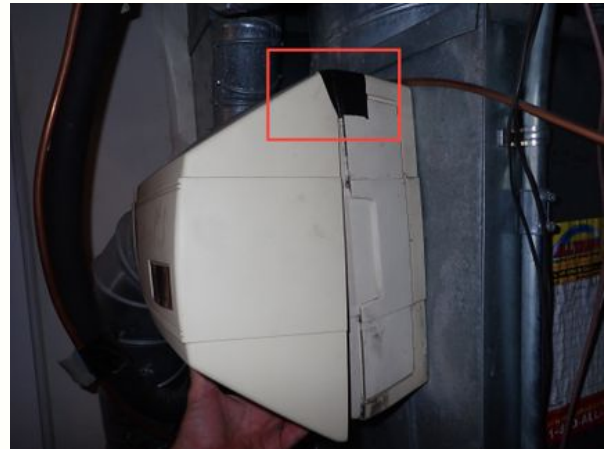
✂️ **(HACVAGAS-8) Note:** The humidifier has been taped shut and does not have a water panel and does not appear to be in operation in this commercial unit. However, there is a bedroom and shower in the unit and if it is occupied, it is highly recommended that the humidifier be made operational and that the following information be utilized: In order to avoid mineral and biological growth build up and for improved performance and

Sealed Humidifier

indoor air quality, the humidifier water panels should be replaced at least once during the heating season (typically at the beginning of each heating season). An indoor hygrometer of decent quality is recommended to effectively evaluate indoor humidity levels. The humidistat for the humidifier should then be adjusted in order to keep moisture levels within the desired comfort range during winter that is typically between 35-45% relative humidity. Summer humidity levels should not exceed 50% if possible. **Note: during periods of very cold weather, the humidity scale on the humidistat may provide too much moisture as the furnace will be cycling much more frequently, thus adding more moisture to the air. Care should be taken to "throttle" back moisture levels during these times.**

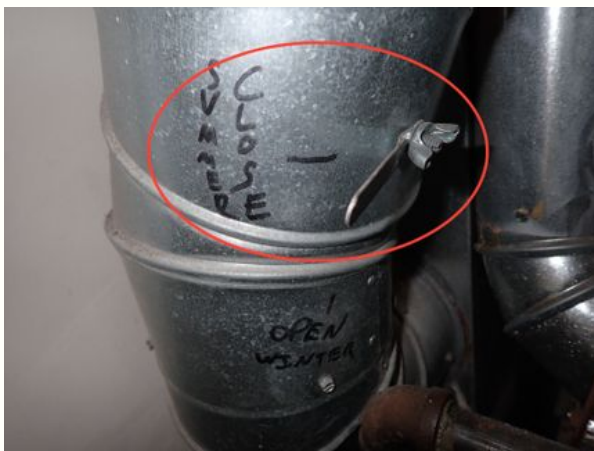
Seasonal Duct Damper on Humidifier

✦ **(HACVAGAS-11) Note:** A humidifier duct damper must be positioned seasonally (summer/closed and winter/open settings) on the humidifier's bypass duct in order to prevent return air from bypassing the evaporator coil. In order to maximize energy efficiency and indoor air comfort, a duct damper is essential on bypass style humidifier such as this.

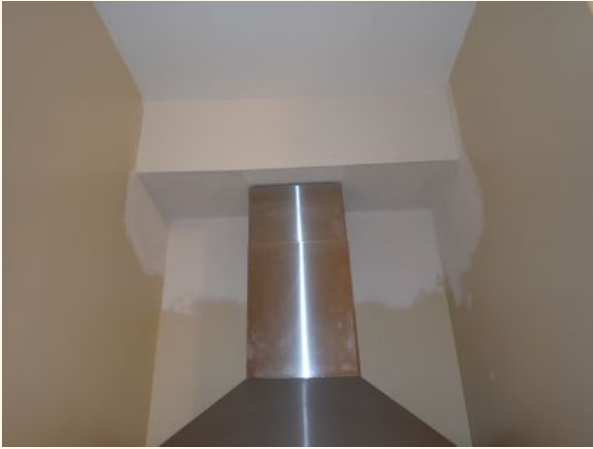
Unfinished Walls in Kitchen Area
