This report is prepared exclusively for **Large Commercial Office Building**
Inspected On: **2022-11-08**

This was an inspection of a large multi-story office building. The structure was built approximately 12 years ago and there were several ongoing concerns, mostly related to moisture that were damaging portions of the structure. Please read the report carefully in order to gain an understanding of the concerns regarding the property.

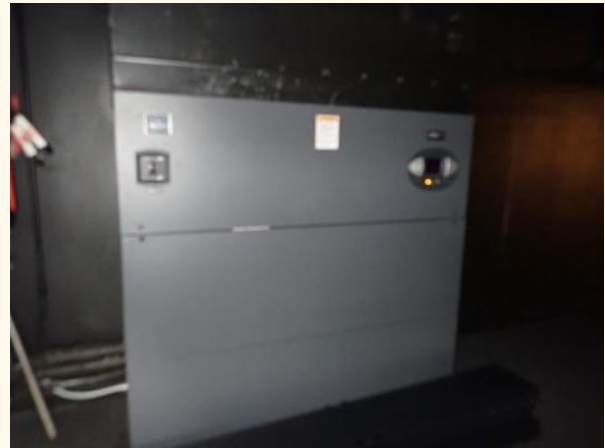
🔧 (HACVAGAS-4) Repair: There were several former server rooms that had massive stand-alone air conditioning units installed specifically to keep these rooms at the temperatures needed to keep thermal runaway from occurring while the servers were running. It is doubtful that these systems would be needed and the systems should be removed.

Room Air Conditioning Units

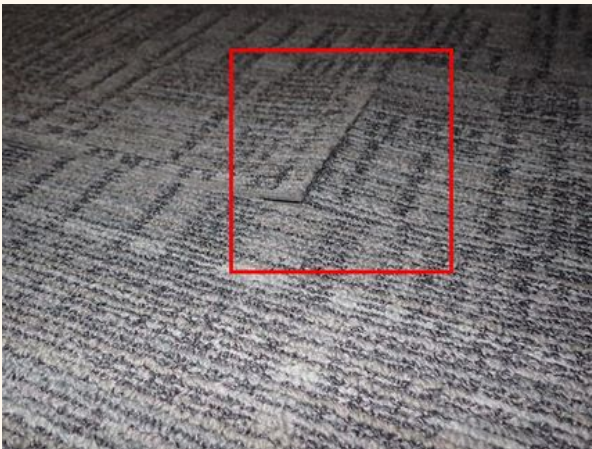
Loose But Intentionally Removable Carpet Squares

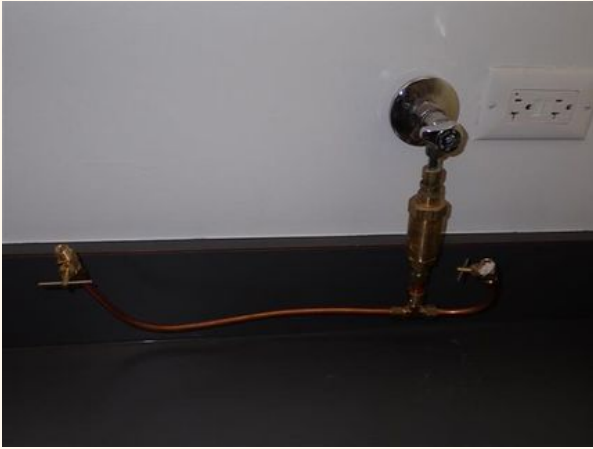
Water Supplies for Coffee Makers, Etc.

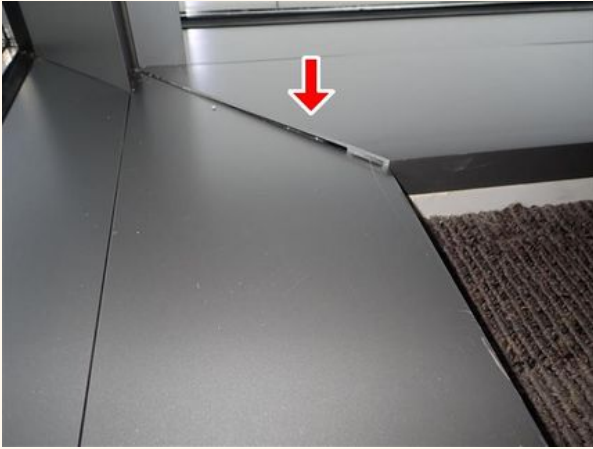
Separated Window Trim

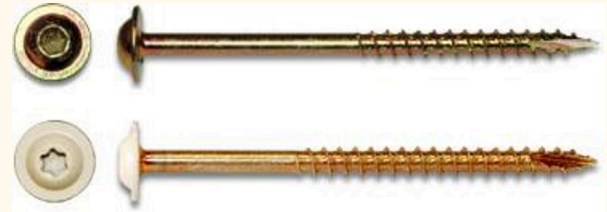
Drywall Screws Used to Secure Some Cabinets

Cabinet Screws

🔧 (IAF-2) Repair: The screws used to fasten some of the cabinets to the wall framing are not the recommended washer head screws. In order to reduce the risk of the cabinets pulling through the existing fasteners and loosening or becoming detached, the existing screws should be removed and replaced.

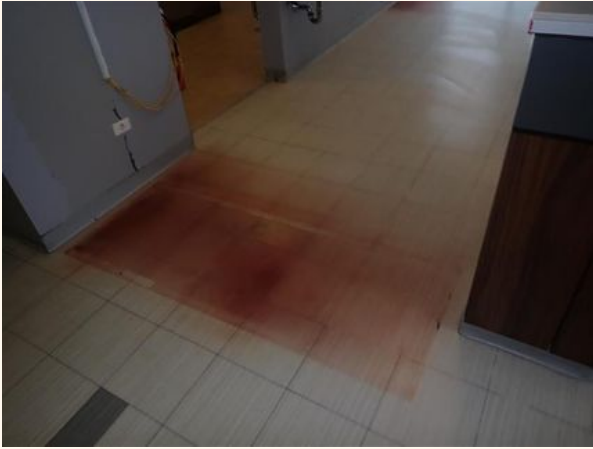
🔧 (IAF-3) Repair: There was a small cafeteria in the lower level of the building and the features in that space are deteriorated and very specific in use and many of the features were de-commissioned and could not be tested or evaluated. Unless a food service space will be opened up in this location, the features should be removed and the space re-habilitated with appropriate finishes.

Damaged Flooring

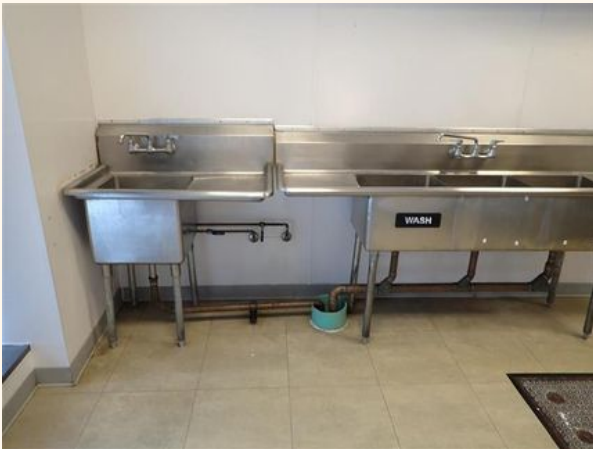
Industrial Sink Equipment Could Not be Evaluated

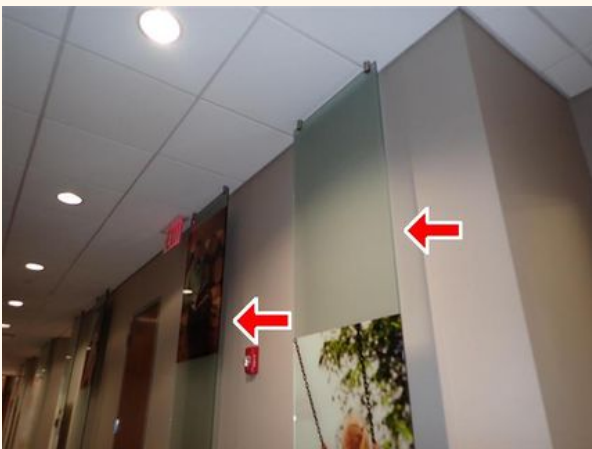
Large Glass Panels in Hallway

🔧 (WDS-1) Repair: There were large glass display panels in one of the hallways on the lower level. There were no markings on the panels that indicate that they are made of tempered glass. If the panels are to remain in use it should be confirmed that they are made of tempered glass, otherwise, if they are not, in order to reduce the potential for injury, it is recommended that the panels be removed.

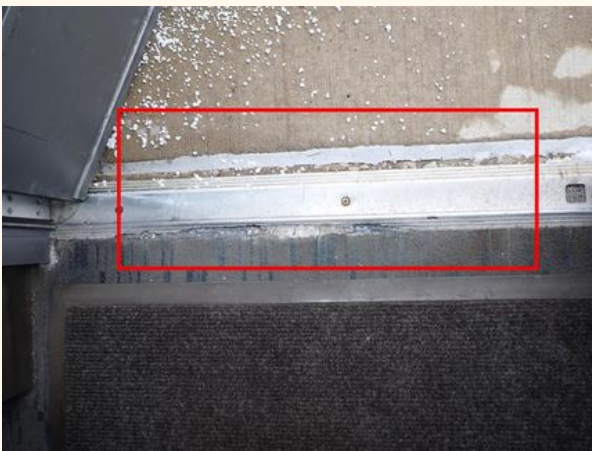
Deteriorated Threshold

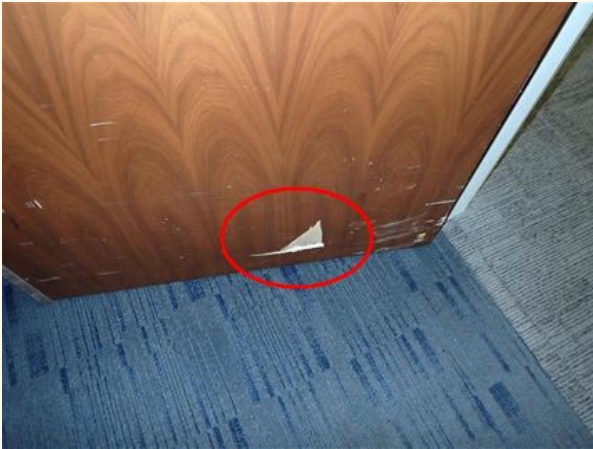
Damaged Door

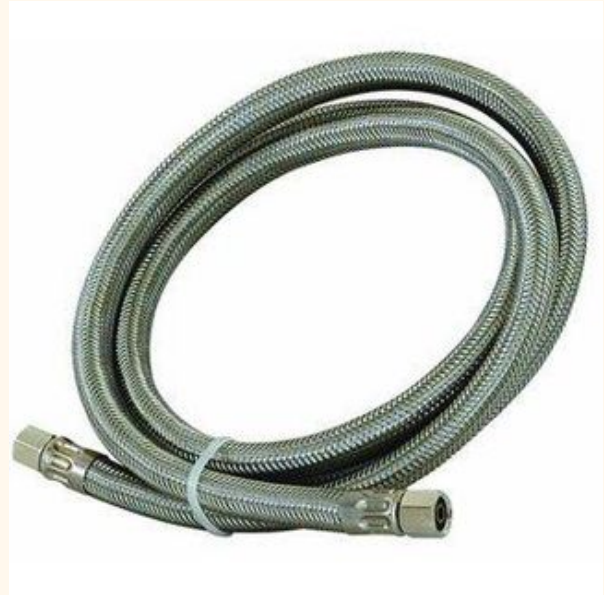
🔧 (IA-2) Repair: A refrigerator that was removed had a copper water supply line that is flexible and easily damaged. For optimal resistance against leakage and water related damage to the surrounding finishes, the copper water supply tubing should be replaced with braided stainless steel tubing if a new refrigerator is installed.

Copper Water Supply Utilized for Removed Refrigerator

Fridge Tubing

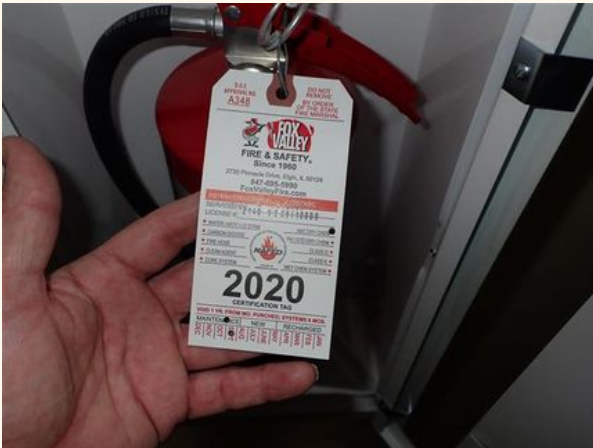
🔧 (O-2) Repair: There were numerous fire extinguishers noted throughout the building. Many of the extinguishers appear to have been regularly maintained, however, some expired extinguishers were noted. All equipment that is part of the sale of the property that is required for use in the structure should be evaluated and serviced as needed for re-certification.

Expired Extinguishers
