This report is prepared exclusively for **Any Client**  
Inspected On: **2022-12-06**

This inspection was a Property Condition Assessment of a 15 year old 40 unit condominium building. There have been a number of problems occurring since the building was built and there have been significant expenditures to rectify some of the problems. The building is at a critical juncture as the reserve funds are low and there are still a number of concerning issues to address. This PCA will be used to drive a Reserve Study that will look at upcoming expenditure needs and the need to adjust the monthly assessment to cover the needed upcoming improvements.

# The Scope and Purpose of a Property Condition Assessment

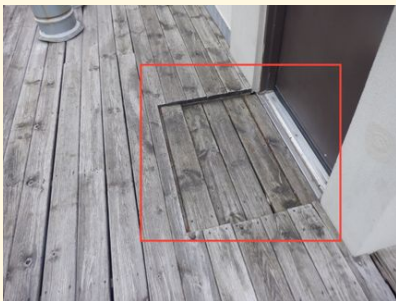
**FINAL NOTE:** When the deck is replaced the level of the deck should meet the rooftop door access thresholds. The existing sloped transitions should be avoided as they present trip hazards that can result in injury and drive moisture into the door openings.

*Sloped Transitions*

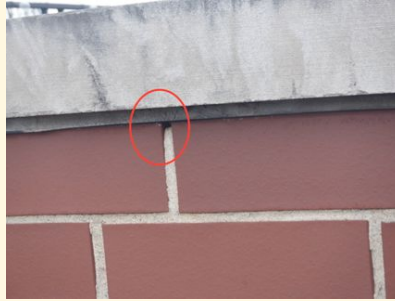
**🔧 (EWGCE-3) Repair:** Some of the masonry joints on this relatively new structure are poorly formed, especially at the head joint. Proper masonry installation requires a skilled brick layer that can properly fill and finish the head joints on each course of masonry and failure to achieve this results in openings that may allow excessive moisture to enter the structure. In order to reduce the potential for moisture related damage, it is recommended that a qualified masonry contractor evaluate the entire structure and re-point the joints as needed.

*Open Head Joint*

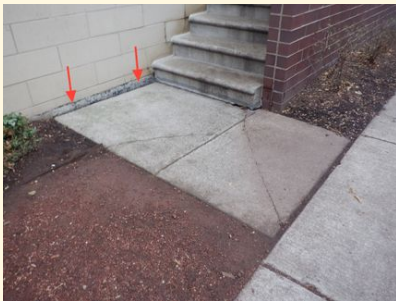
**🔧 (EWGCE-12) Repair:** Settlement of some of the front walk areas was noted and the rainwater runoff may further exacerbate settlement of the walk and stairs. There was also potential settlement of at least one of the stairs and walls. It's highly likely that these areas were adjacent to the large excavation needed for the foundation of the structure. Typically this void is backfilled with material that is difficult to compact and there may be some settlement over time. In some cases the slabs can be raised via various methods, however, some of the slabs are cracked and eventual replacement may be needed as it appears to have already been done on several other walk areas. Also, the grade adjacent to the front steps and walks does not drain away from the structure and ponding areas were noted adjacent to some of the walks that further exacerbates the walk settlement. All areas adjacent to the structure should drain away from the structure and once the walks are raised or replaced the landscape areas should be re-graded by a qualified landscaping contractor.

*Reverse Sloped Walk*

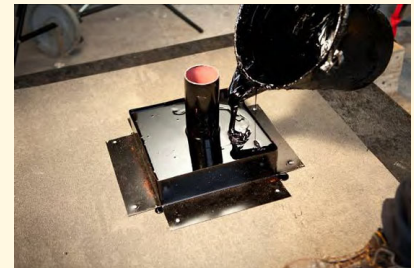
*Rubber Boot Roof Penetration  
Example*

*Pourable Sealant Example*

**⚠️ (RCFRD-6) Repair:** The penetrations through the modified bitumen roof covering are sealed with caulk and/or roofing tar which is a high maintenance, unapproved, high risk means of sealing a hole in the roof. When the roof is replaced, in order to reduce the potential for damaging and mold causing moisture to enter the structure, the installation of rubber boots flashings or pitch pocket flashings by a qualified roofing contractor is recommended.

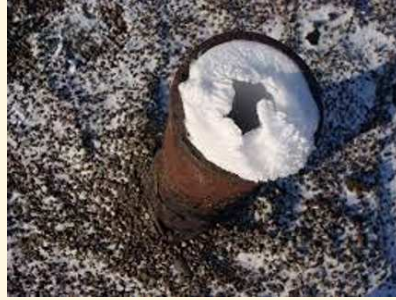
Also, at least one of the narrower diameter plumbing vent pipes has material stuffed into the pipe that was most likely intended to eliminate the potential to drop objects into the pipes, however, they can restrict airflow. During extreme freezing temperatures in the winter this restriction can allow venting air to freeze and hoar frost formations can occur that can block the vent piping. Blocked

*Hoar Frost Example*

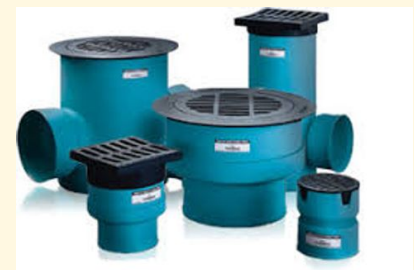
*Drainage Structures*

**🔧 (PSDFAV-7) Repair:** There are small drains adjacent to the lower level exterior entry doors that are easily clogged or overwhelmed by heavy rains. In order to reduce the potential for moisture related damage, it is recommended that a qualified plumber or concrete repair contractor install a larger drainage grate in the walk areas.

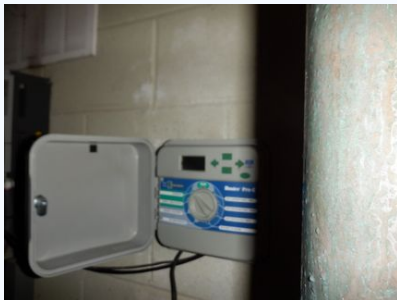
**🔍 (PSDFAV-9) Due Diligence:** There is a planter watering system that was not evaluated as part of this inspection. In order to reduce the risk for extensive frost damage, these systems must be drained of water prior to freezing winter conditions and some components require annual servicing and/or certification. Some of the components appear to be exposed and/or possibly damaged and it is unknown if these items are still actively used. Also , the backflow preventer that was found in the basement may be a part of this system and did not appear to be recently serviced and in order to continue the function of the system it should be evaluated and serviced as needed.

*Sprinkler Controls*

*RPZ (if for sprinkler) Requires Annual Servicing*

*Exposed Irrigation Components*

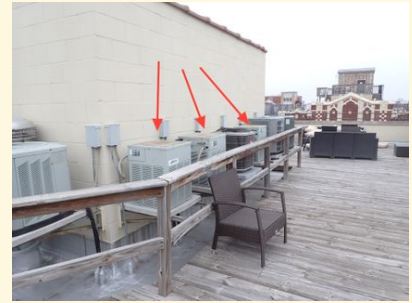
**🔧 (HACVAGAS-2) Repair:** The vents for many of the gas appliances in the units discharge adjacent to some of the A/C condensers. It was noted that nearly every A/C condenser next to a vent pipe has been replaced, while many of the A/C condensers away from the vent piping are original. It appears that the heated exhaust gases may be shortening the life of some of these A/C condensers and in order to prolong the life of these units the vent pipes should be raised an appropriate height above

*New A/C Condensers Noted in These Locations*

*Numerous Original Units Still Functioning*

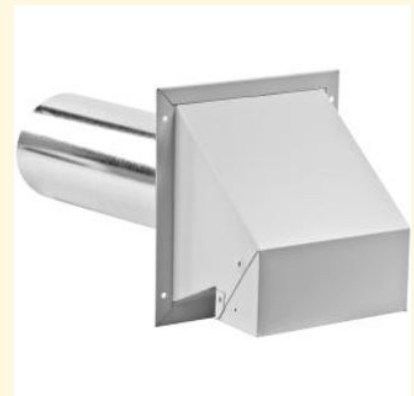
*Proper Exhaust Damper Example*

**🔧 (IVAE-2) Repair:** The existing cheap plastic vent and/or dryer dampers are warped and are open to the exterior which creates the potential for cold air to enter and condense on warmer interior components and for flying pests to enter the open dryer venting. In order to reduce the potential for corrosion and moisture related damage and unwanted visitors, all dryer and exhaust vent dampers on the exterior walls should be replaced with high-quality, gasketed, vent dampers.

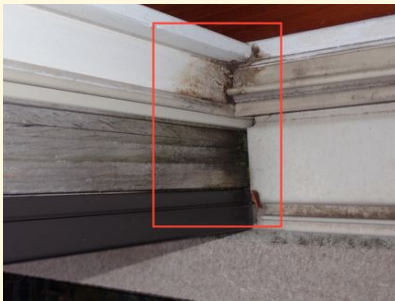
*Deteriorated Doorframe*

**🔧 (WDS-2) Repair:** Moisture related staining and elevated moisture levels were noted in the doorframe on the sliding door in at least one upper level unit. Given that the sliding doors are now 15 years old, the seals are beginning to become compromised and leakage is developing and will more than likely progress further. In order to reduce the potential for moisture related damage, it is recommended that consideration be given to replacing the sliding doors in the not too distant future. Some of the sliding doors that are in lower or more protected balconies may have less deterioration and replacement of those doors can wait, however, the more deteriorated ones should be replaced with doors that are made from materials that are less affected by moisture. The doorframes should be monitored and if excessive deterioration is noted, especially on the bottom portion of the doorframe, the bottom portion should be replaced with materials that are less affected by moisture like PVC lumber. For recommendations on more energy efficient sliding doors, here is a link to a webpage from the US Dept of Energy that discusses energy efficient doorframes: [ENERGY STAR Most Efficient 2022 — Sliding Glass \(Patio\) Doors](#)

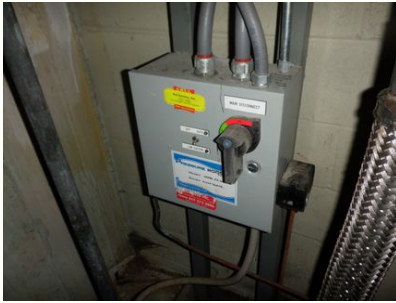
🔧 (O-1) Note: The building has five hydraulic elevators. These elevators are highly complex and are excluded from the scope of this building inspection. Elevators require periodic and/or annual inspections based on the authority having jurisdiction and while a maintenance person was on site and noted that the elevators are serviced monthly, major cost concerns may be close with these elevators. The key to the operation of these elevators are the hydraulic pumps that drive the elevator mechanism. According to the service person these pumps have a lifespan of 12 to 15 years and it appears one of the pumps had to be replaced recently and most likely the others will be needing replacement soon. Other components like the Door Equipment, Elevator Controllers and

Hydraulic Cylinders may also need to be replaced in the next 10 to 15 years.

*Elevator Controls*

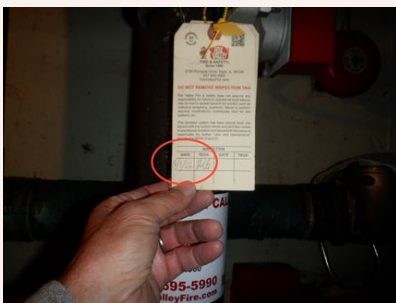
*Maintenance Tag is Current*

(O-3) **Recommended Maintenance:** The structure has a fire suppression system that most likely has components that require annual inspections and/or servicing. In order to ensure proper operation of the fire suppression system, it is recommended that the regular servicing that appears to be occurring be continued.

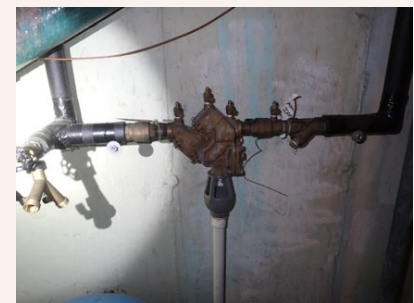
*RPZ Requires Annual Servicing*
